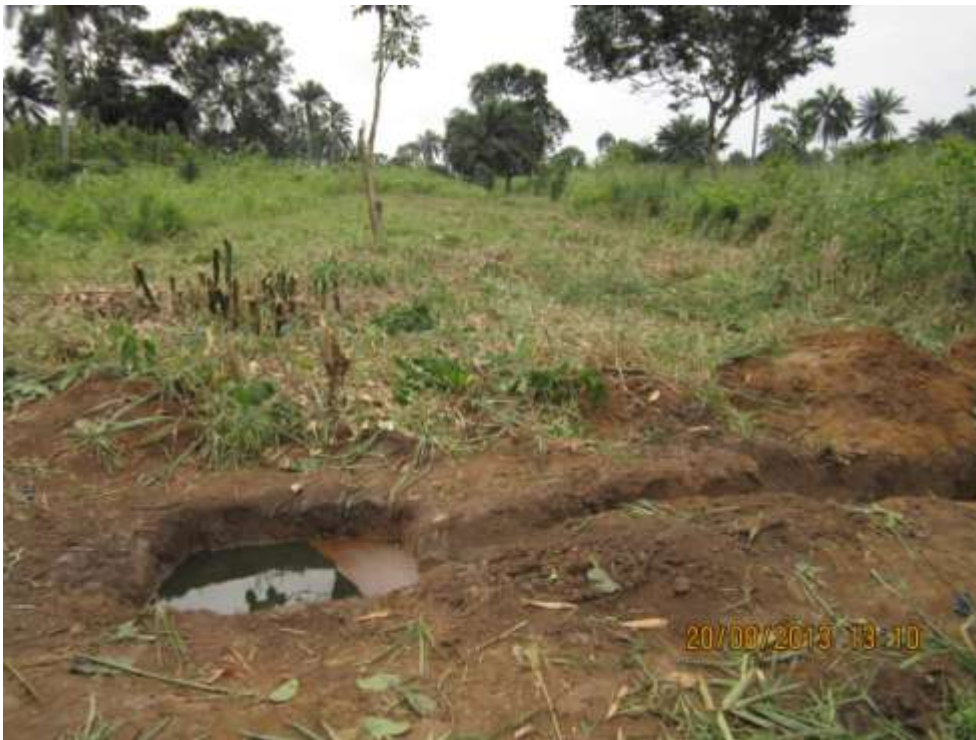
Overview: Part of spill impact on 24" Nkpoku-Bomu Trans Niger pipeline right of way at Bera. Picture was taken during Joint Investigation of 20th August 2013.

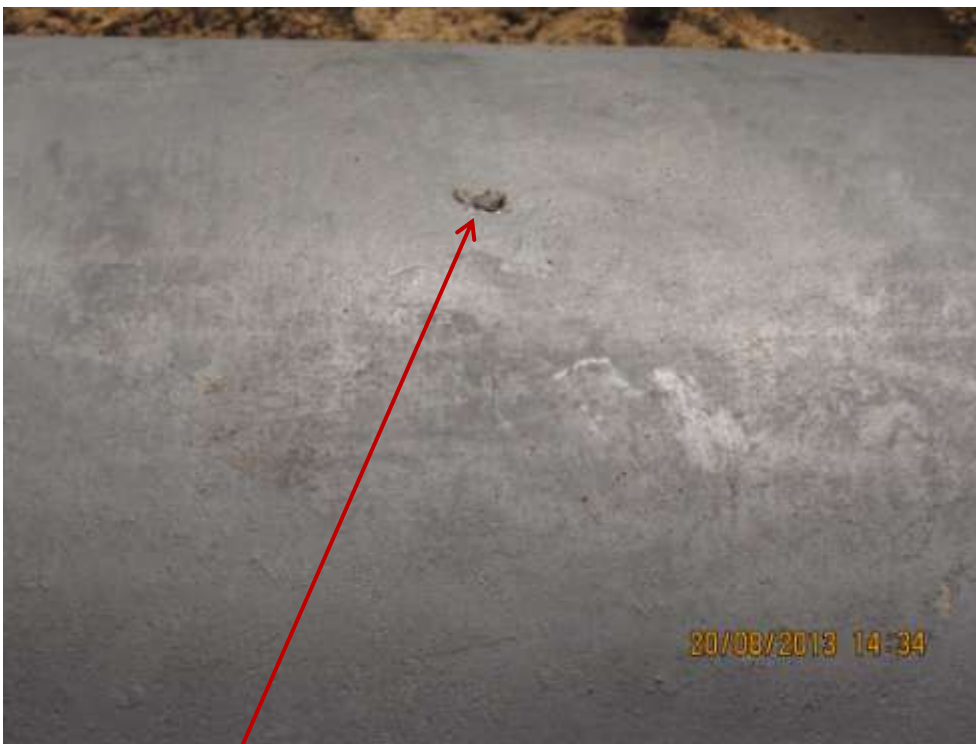
Close up: Drilled hole on 24" Nkpoku-Bomu Trans Niger pipeline at Bera. Picture was taken during Joint Investigation of 20th August 2013.
