THE SHELL PETROLEUM DEVELOPMENT COMPANY OF NIGERIA LIMITED.

JOINT INVESTIGATION REPORT FOR INCIDENT NO: 1082291 JIV report S/N: 0365

1. Spill incident Number: 1082291 2. Type of incident* OIL SPILL
 3. Name of Location 6" AWOBA FLOWSTATION - MANIFOLD PIPELINE
 4. Name of nearest community AWOBA 5. State: RIVERS 6. LGA DEGEMA
 7. Type of Production facility/Installation OIL PIPELINE 8. Asset owner/District PIPELINE/SWAMP

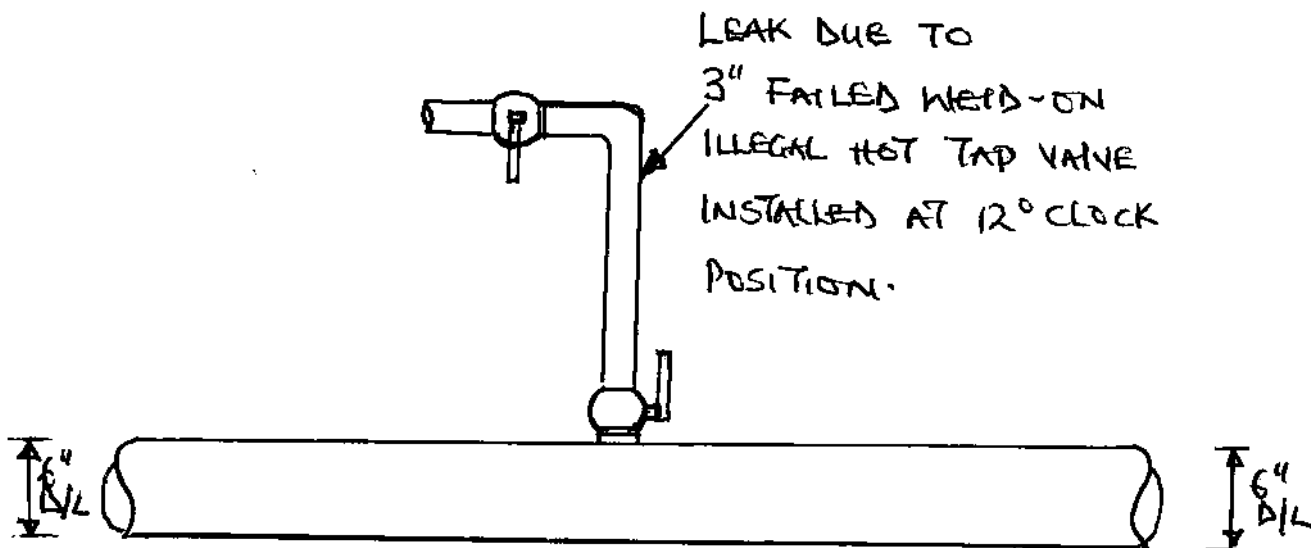
SECTIONAL VIEW OF 6" ANOBA FLOWSTATION - MANIFOLD PIPELINE AT ANI

SHOWING:- FAILED WELD-ON ILLEGAL HOT TAP VALVE!

e. Description of leak point (tick as applicable);
 Drilled hole Hack saw cut Tear (_____),
 Complete Rupture Inward dent, Well head tampering
 Failed Weld-on illegal hot tap valve, Failed Clamp Missing Pipeline/Flowline
 Crude oil theft (illegal bunkering) point, Third party tampering with Clamp
 Third party tampering with valve setting, Third party tampering with flange,
 Corrosion Saver-pit over flow, Surge vessel overflow,
 Bulging Outward Flare System/Bund wall failure Accidental 3rd party
 equipment impact Valve Failure com unit failure Cold vent
 Relief valve failure Others (specify) _____

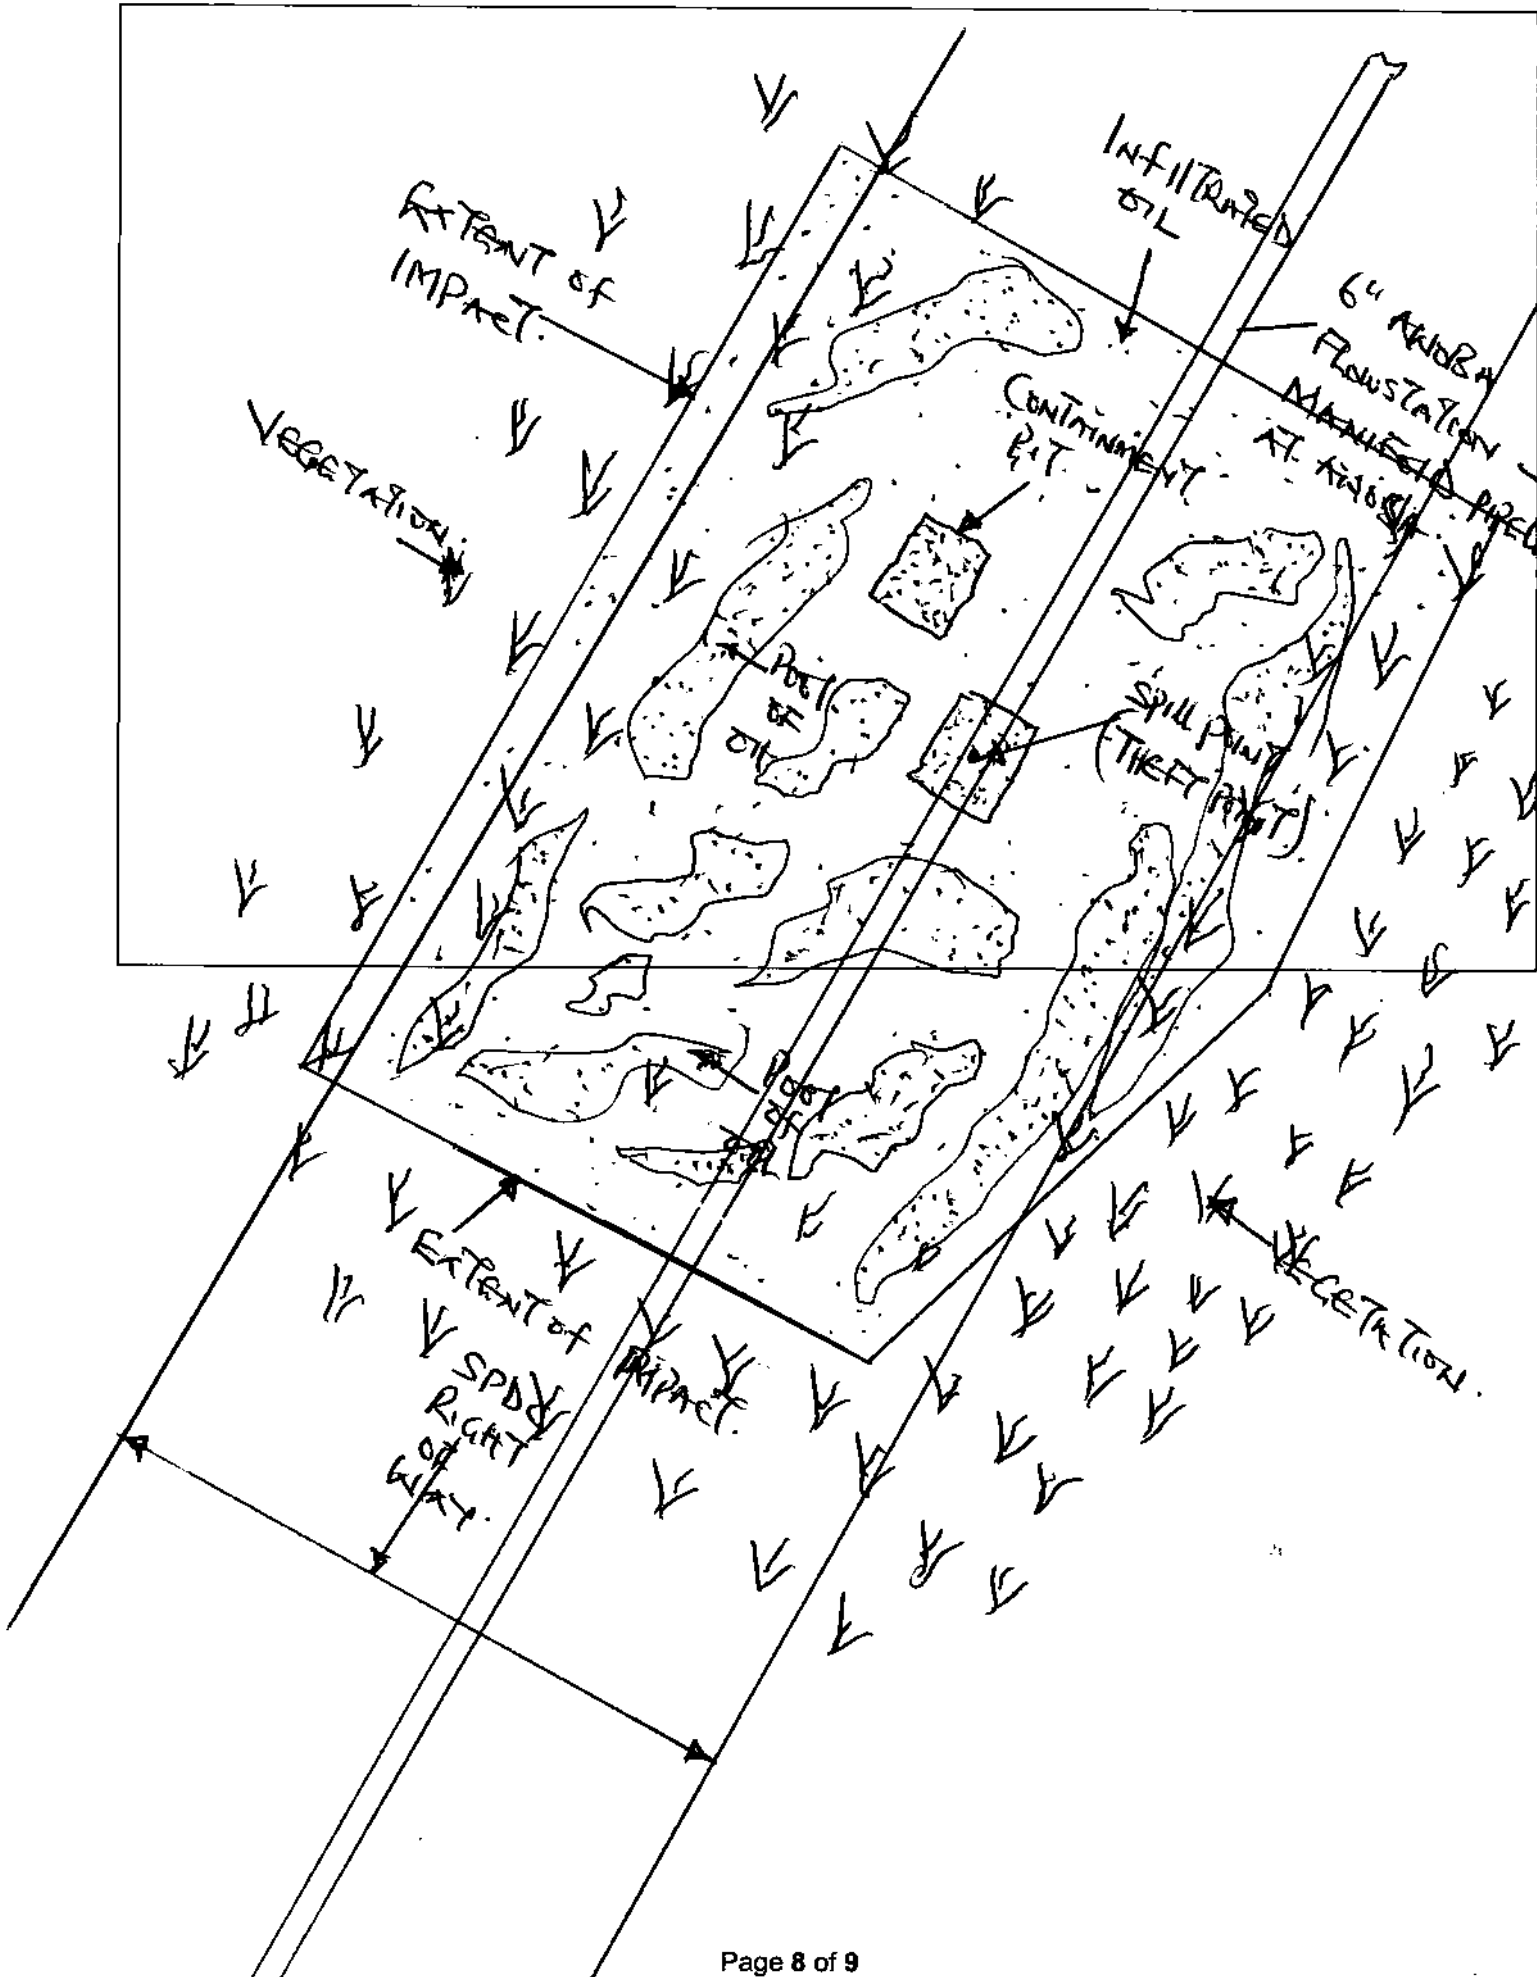
28. Appendix 1: Overview sketch of the site

Location: 6" AWORA FLOWSTATION - MANIFOLD PIPELINE AT AWORA
