JOINT INVESTIGATION REPORT FOR INCI	DENT NO: 10850	3Ψ JIV report S/N: 0200	
(Note: As practicable as possible the JIT rep	port is to be signed in the fi	•

A. GENERAL INFORMATION:			
1. Spill incident Number: <u>108 50 6</u>	4 2.Type of	incident* OIL SPILL	
3. Name of Location 26" OTUMA	RA - ESCRAY	IOS PIPELINE

JOINT INVESTIGATION REPORT FOR INCIDENT NO: 1085064 JIV report S/N: 0200

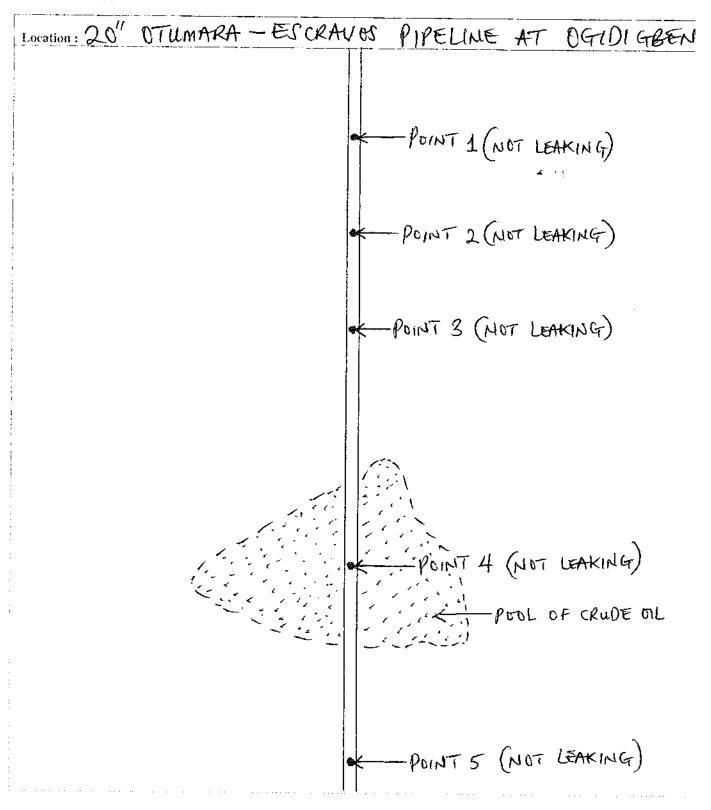
28. Appendix 1: Overview sketch of the site

NOTE: THE FIVE POINTS (ILLEGAL HOT TAP VALUES) OBSERVED WERE NOT LEAKING AT AT THE TIME OF JIV BUT, THERE WAS CRUDE OIL IMPART ON AND AROUND INCIDENT POINT 4, DUE TO ILLEGAL BUNKERING AND ILLEGAL LOCAL REFINERY ACTIVITIES ADJACENT TO SPOC RIGHT OF WAY
