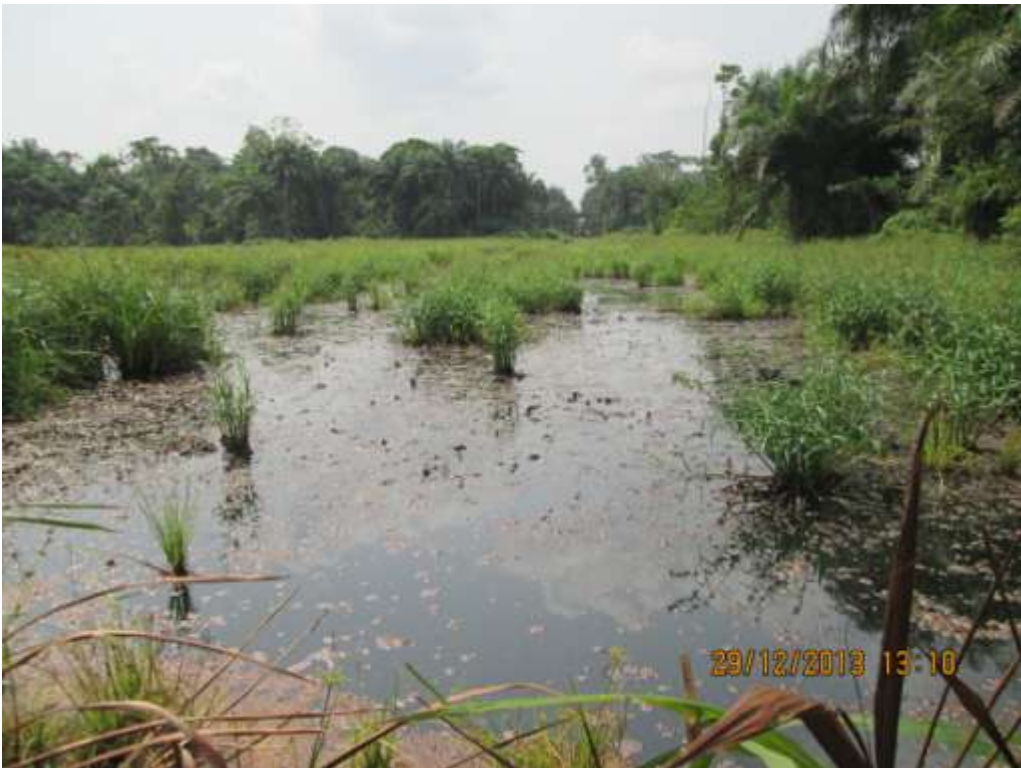
Overview: Part of spill impact on 16" Nunriver – Kolocreek Pipeline right of way at Oporoma. Picture was taken during Joint Investigation of 29th December 2013.

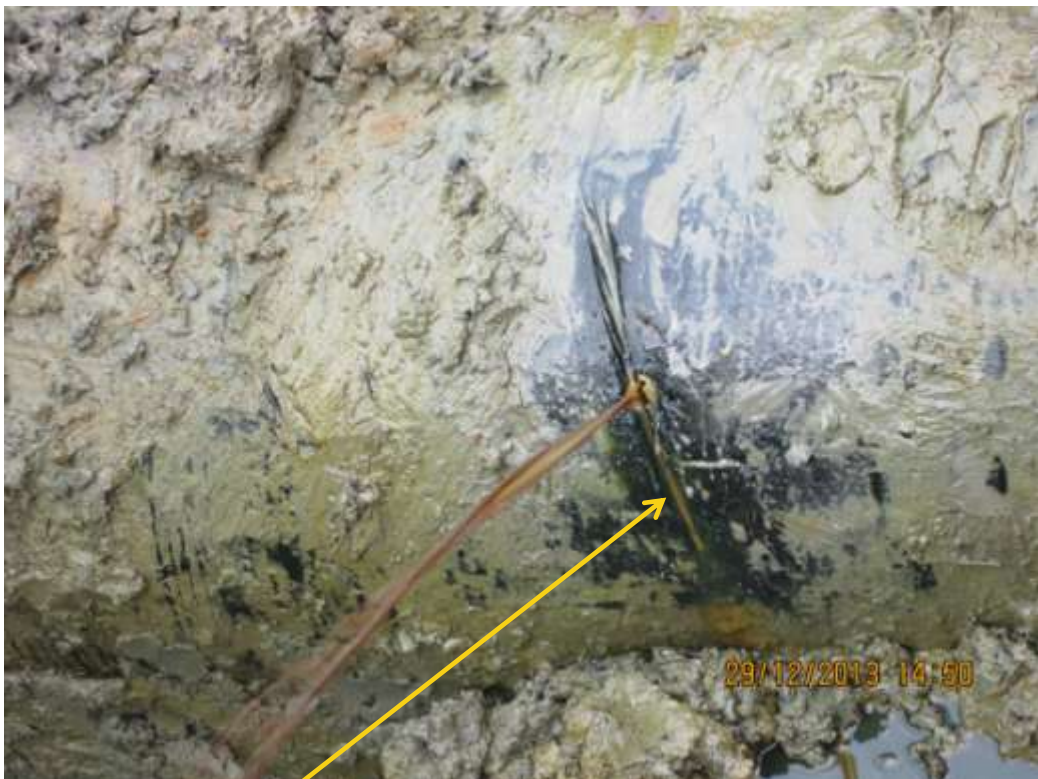
Close-up: Hacksaw cut on 16" Nunriver – Kolocreek Pipeline at Oporoma. Picture was taken during Joint Investigation of 29th December 2013.
