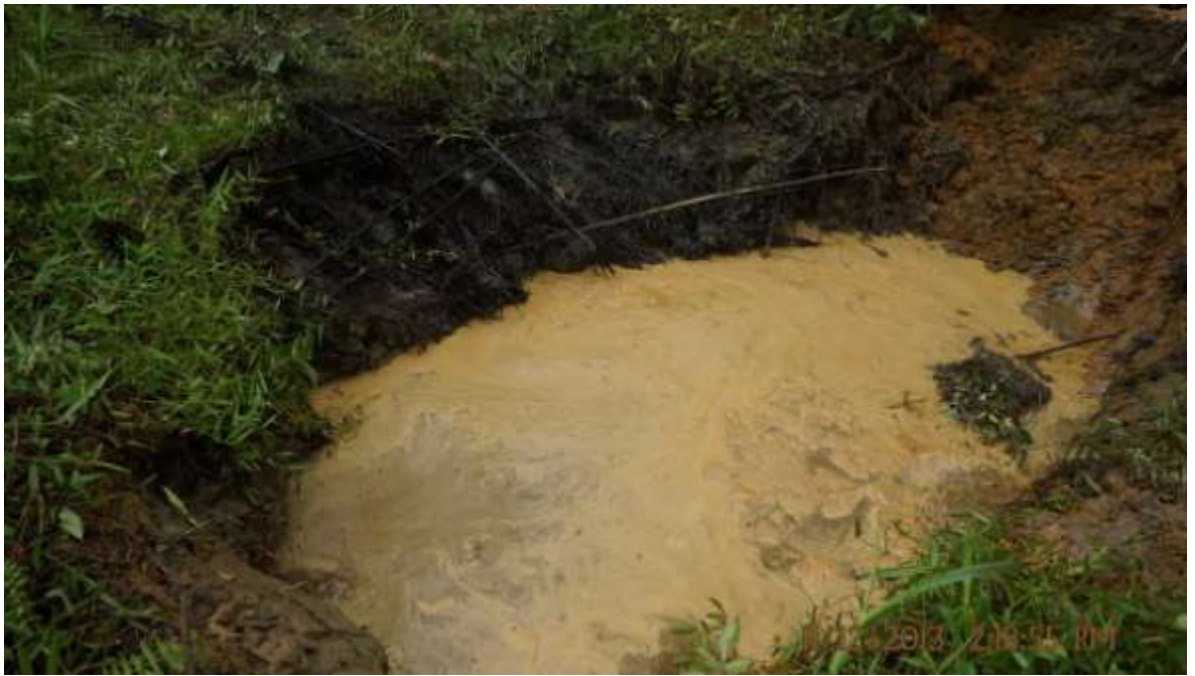
Overview: Part of spill impact on 20" Otumara - Escravos Pipeline right of way at Ogidigben. Picture was taken during Joint Investigation of 11th December 2013.

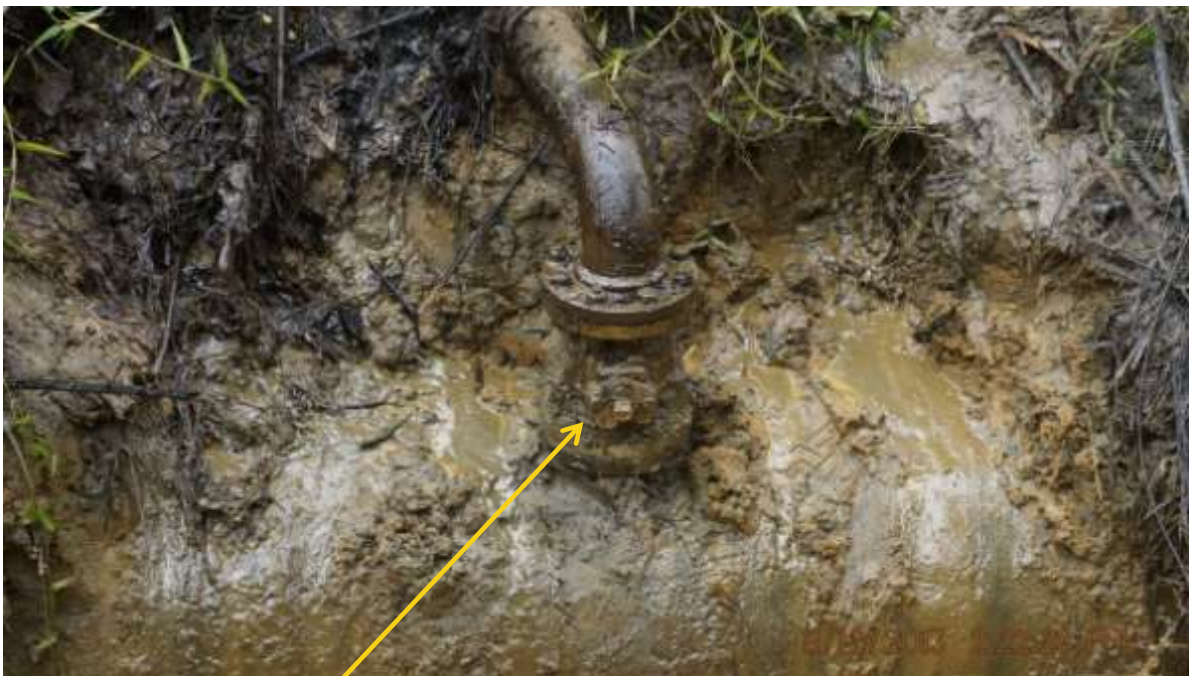
Close-up: Illegal fitting on 20" Otumara - Escravos Pipeline at Ogidigben. Picture was taken during Joint Investigation of 11th December 2013.

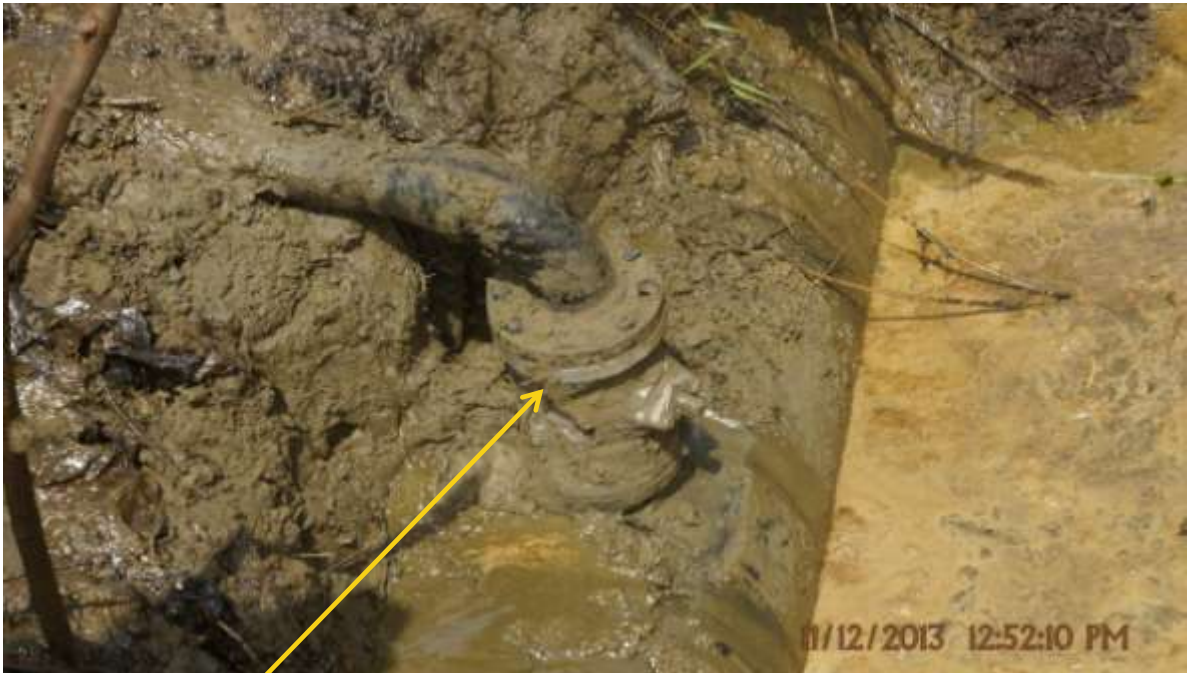
Close-up: Illegal fitting on 20" Otumara - Escravos Pipeline at Ogidigben. Picture was taken during Joint Investigation of 11<sup>th</sup> December 2013.
