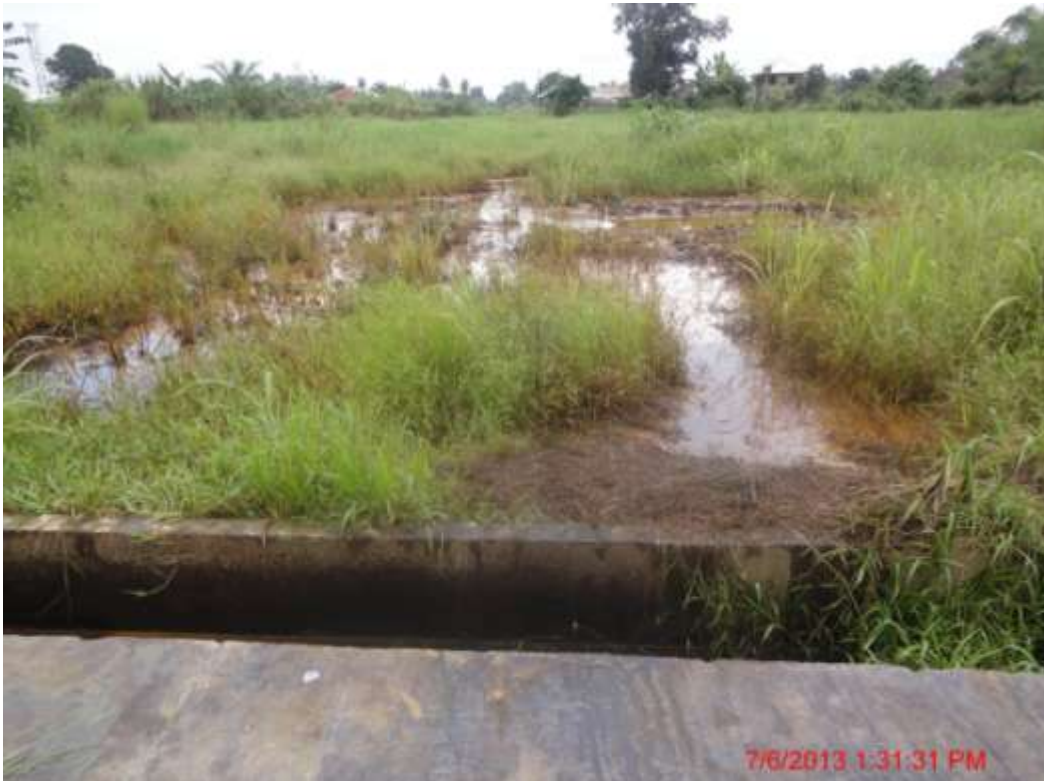
Overview: Part of spill impact on 14" Okordia-Rumuekpe pipeline right of way at Ikarama. Picture was taken during Joint Investigation of 7<sup>th</sup> June 2013.

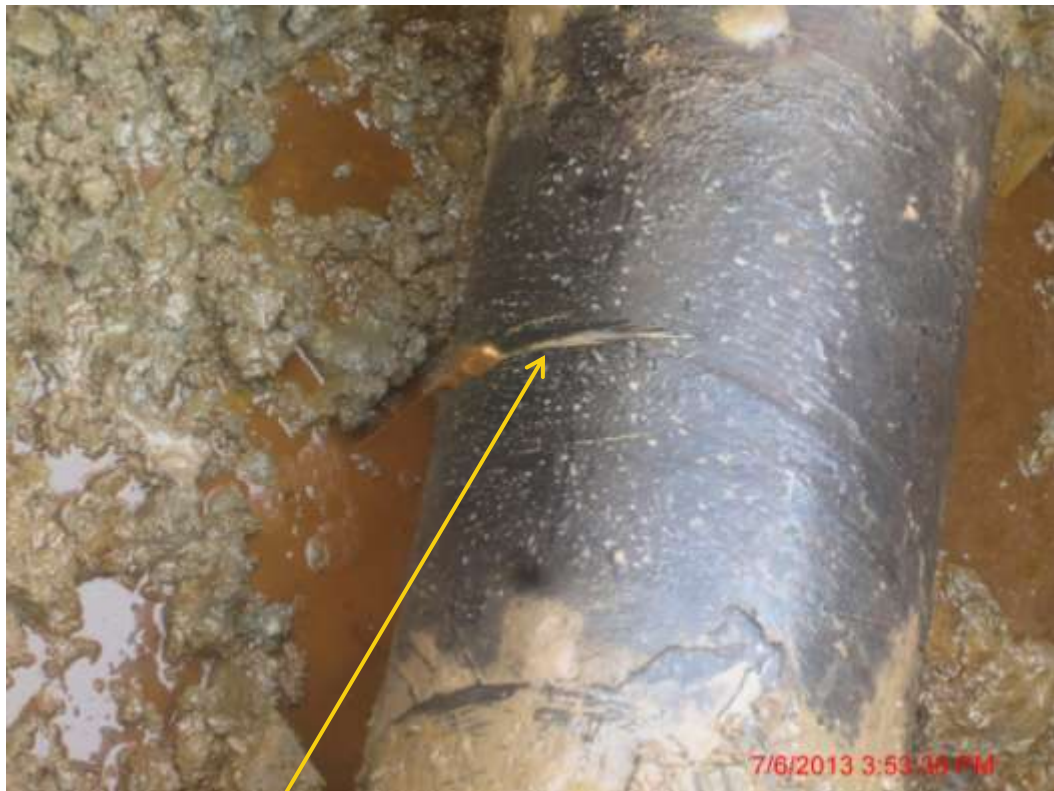
Close up: Hacksaw cut on 14" Okordia-Rumuekpe pipeline at Ikarama. Picture was taken during Joint Investigation of 7<sup>th</sup> June 2013.
