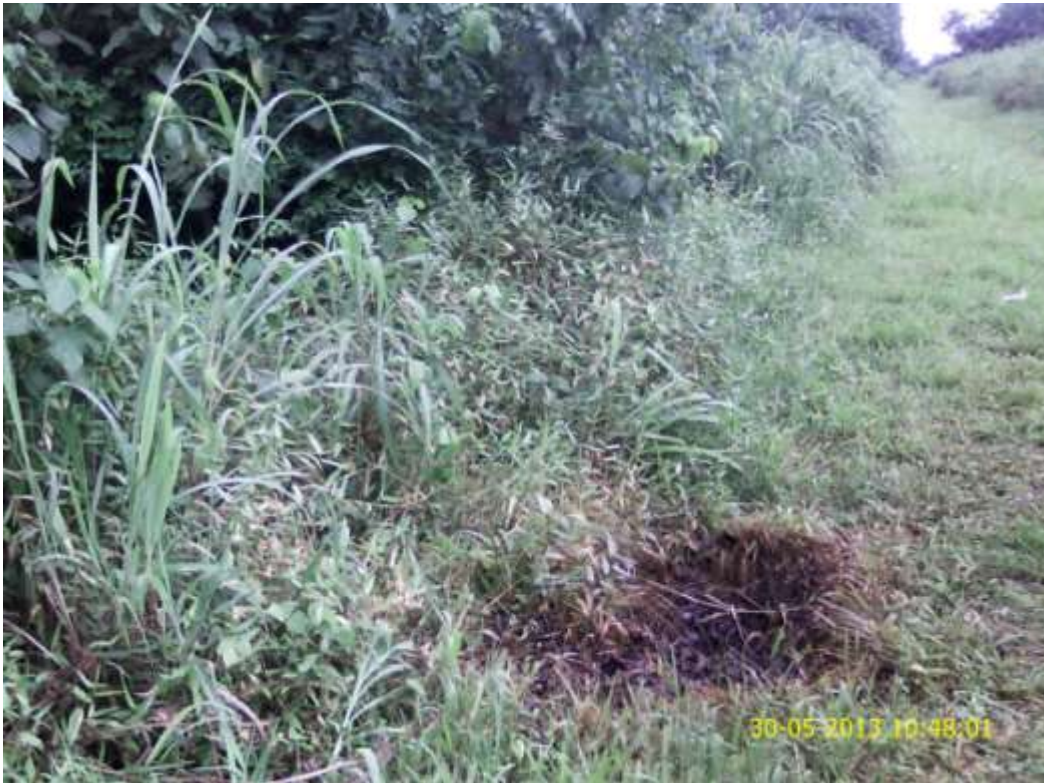
Overview: Part of spill impact on 12" Adibawa-Okordia pipeline right of way at Ikarama. Picture was taken during Joint Investigation of 30th May 2013.

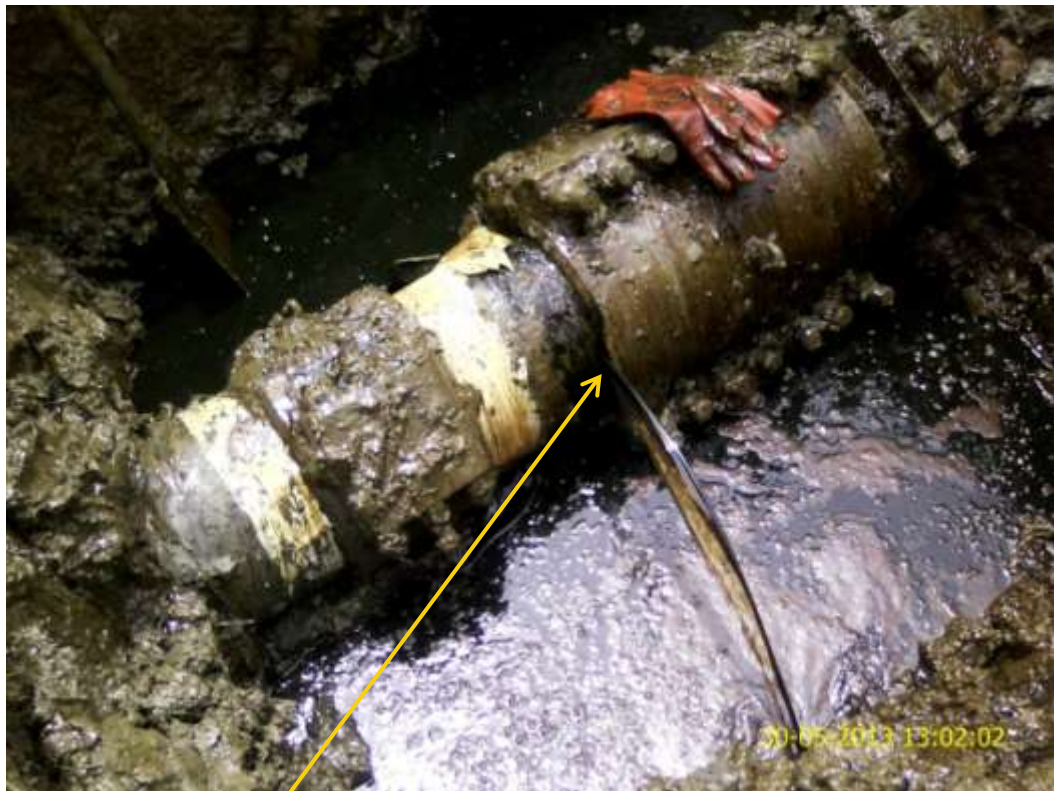
Close up: Spill due to hacksaw cut on 12" Adibawa-Okordia pipeline at Ikarama. Picture was taken during Joint Investigation of 30th May 2013.
