Overview: Part of spill impact on 28" Nkpoku-Bomu Pipeline right of way at Gio. Picture was taken during Joint Investigation of 5th November 2013.

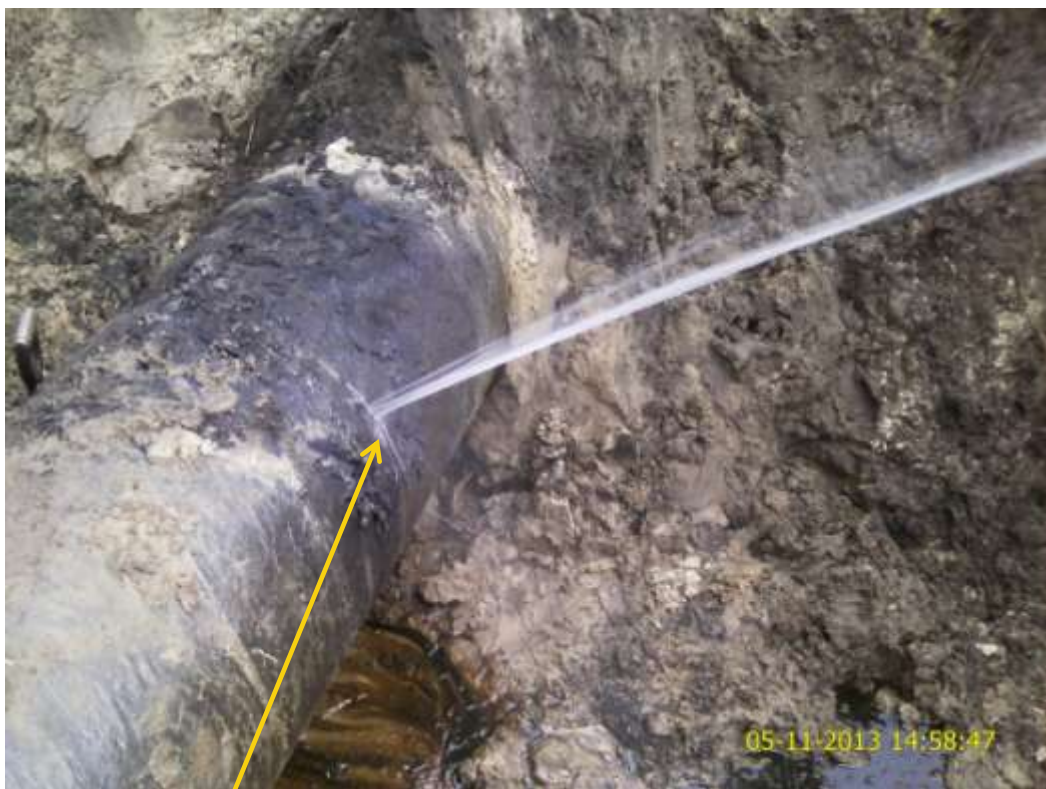
Close-up: Drilled hole/hacksaw cut on 28" Nkpoku-Bomu Pipeline at Gio. Picture was taken during Joint Investigation of 5th November 2013.
