JOINT INVESTIGATION REPORT FOR INCIDENT NO: 1054635 JIV report S/N: 0282

A. GENERAL INFORMATION:			
1. Spill incident Number: 10546	35 2.Type o	fincident* OIL SPIL 2	
3. Name of Location 14" OKOR	DIA - RUMU	EXPT AKININIA R	15
4. Name of nearest community AKIN	11MA 5. State: R17	HERS 6. LGA ATTOADA h	<i> </i> 6 5

ECTION OF 14" OKORDIA - RUMINERPE AKINIMA RISER AT

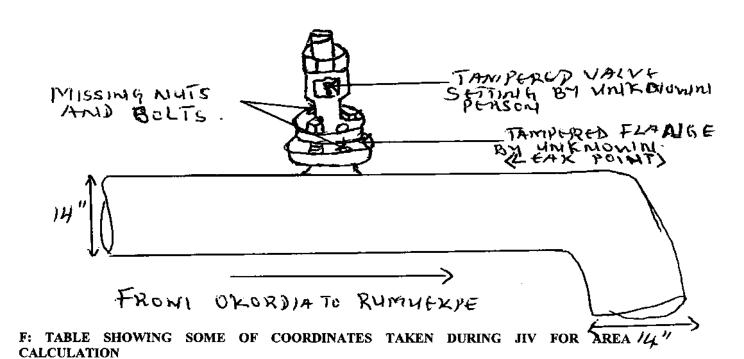
KININIA SHOWING POSITION OF TAMPERED FLANGE AND

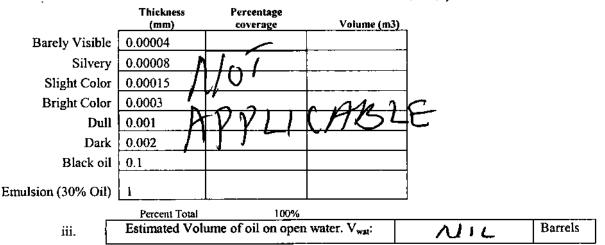
ii. Table of average depth of oil on water based on coloration (

**Spill Factors from USCG FOG (2000 Edition)

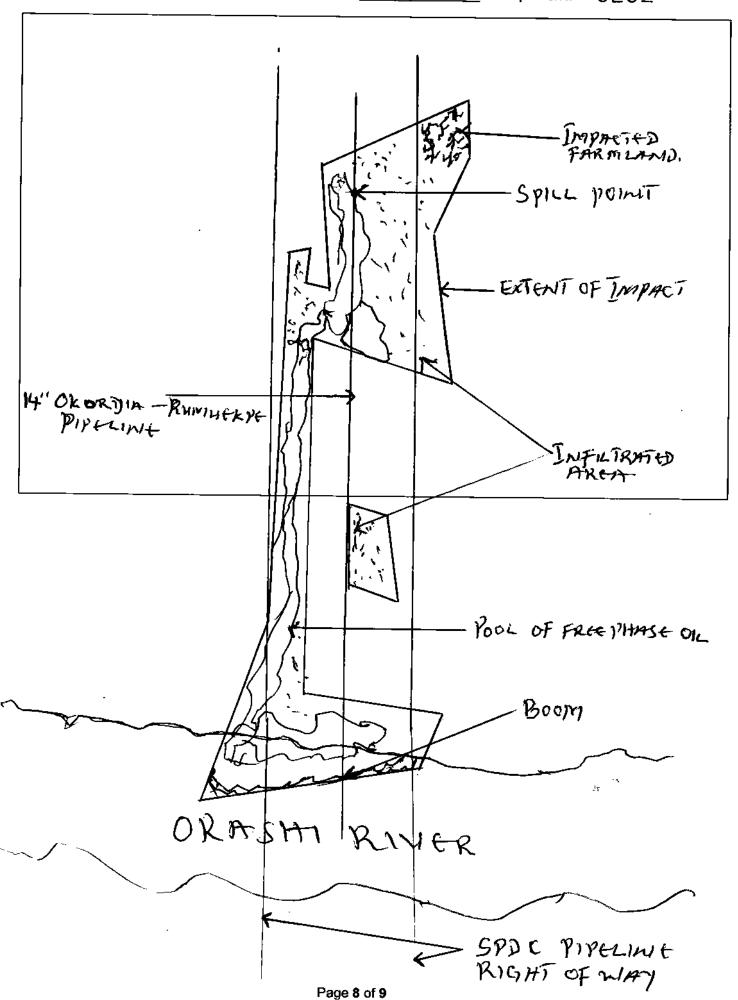
28. Appendix 1: Overview sketch of the site

Location: 14" DKORDIN	- RUMUEKPE ALCINIMA RISER AT
	·
	•
	·
	•
1.	
1
