THE SHELL PETROLEUM DEVELOPMENT COMPANY OF NIGERIA LIMITED.

JOINT INVESTIGATION REPORT FOR INCIDENT NO: 1059071 JIV report S/N: 0326

1. Spill incident Number: 1059071 2. Type of incident* OIL SPILL/FIRE
 3. Name of Location 24" TRANS NIGER PIPELINE (NKPOKU-BOMU)
 4. Name of nearest community BIARA/KPITE 5. State: RIVERS 6. LGA TAI/GOKHANA
 7. Type of Production facility/Installation OIL PIPELINE 8. Asset owner/District PIPELINE

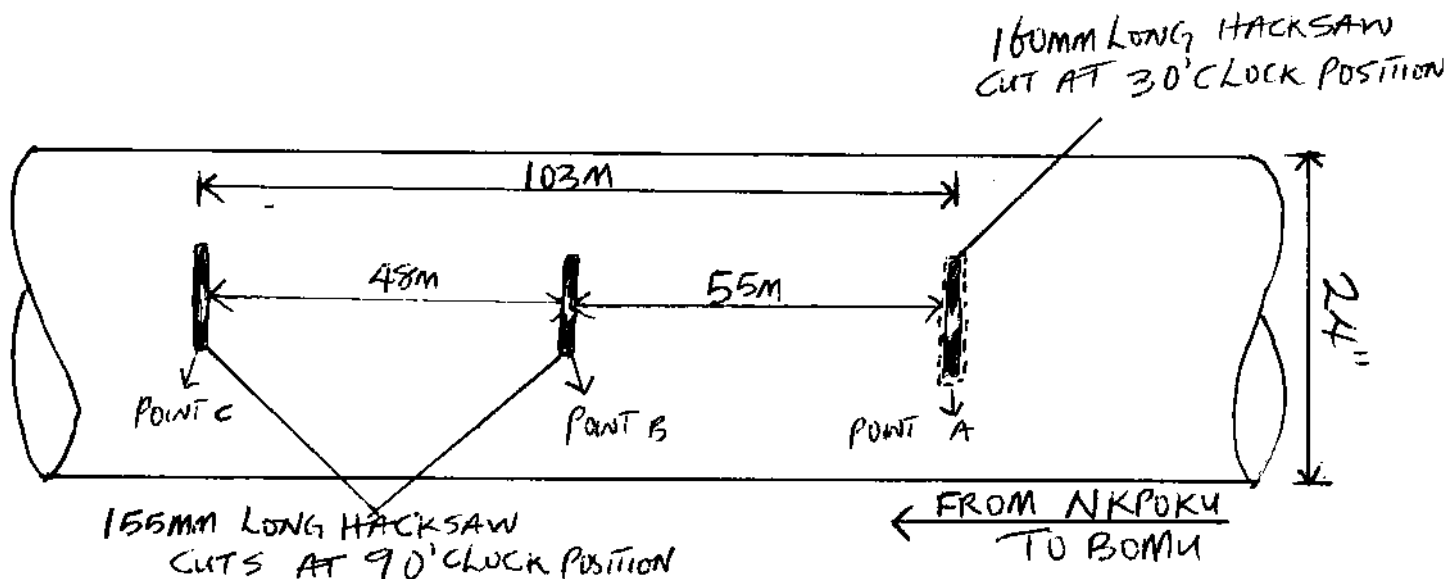
E. GRAPHIC DESCRIPTION OF LEAK POINT (while detail report of the leak point should be contained in the leak report, overview sketch of the site should be added as an appendix 1)

| <input type="checkbox"/> Drilled hole | <input checked="" type="checkbox"/> Hack saw cut | <input type="checkbox"/> Tear (_____), |

SECTION OF 24" NIKPOKU - BOMU TRANS NIGER PIPELINE AT BIARA/KPITE SHOWING HACKSAW CUTS AT SEVERAL POSITIONS

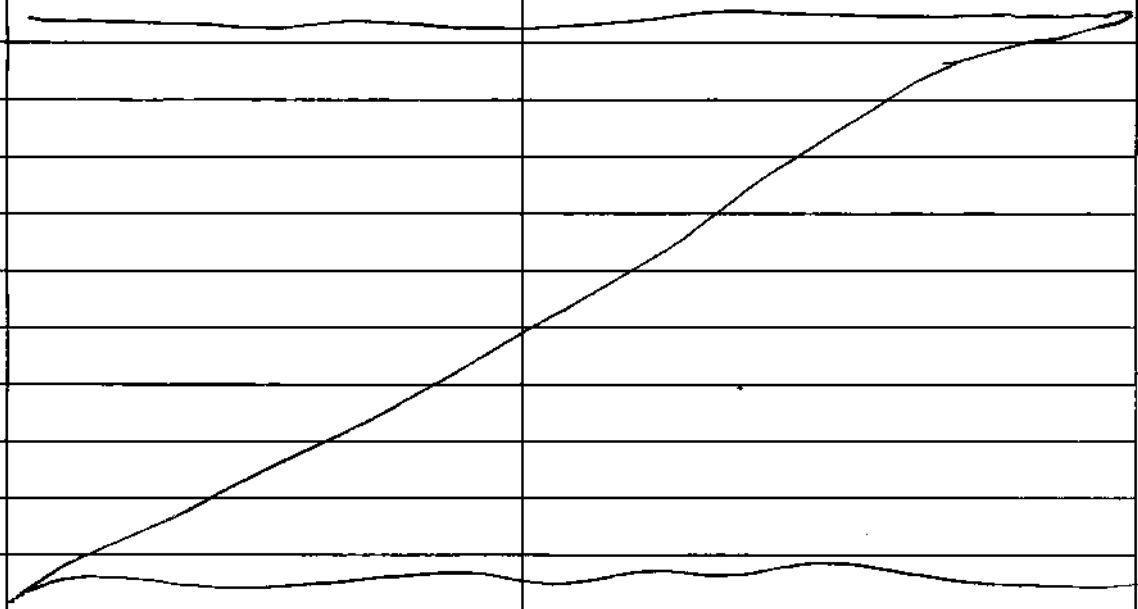
F: TABLE SHOWING SOME OF COORDINATES TAKEN DURING JIV FOR AREA CALCULATION

19. Impacted area boundary Coordinates (If more, Print and attach as an appendix)

S/N	Northing (m)	Easting (m)	
	78913.13	535354.16	} Area A
	78910.07	535344.91	
	78894.72	535344.89	
	78888.56	535351.04	
	78894.70	535354.13	
	78854.77	535354.06	} Area B
	78851.71	535344.81	
	78845.57	535344.80	
	78842.49	535350.96	
	78811.77	535350.90	} Area C
	78808.73	535332.41	
	78799.52	535329.31	
	78796.43	535338.55

- Total calculated area of impact 0.045 Ha
- Impact within SPDC R.O.W YES
- Impact outside SPDC R.O.W NIL

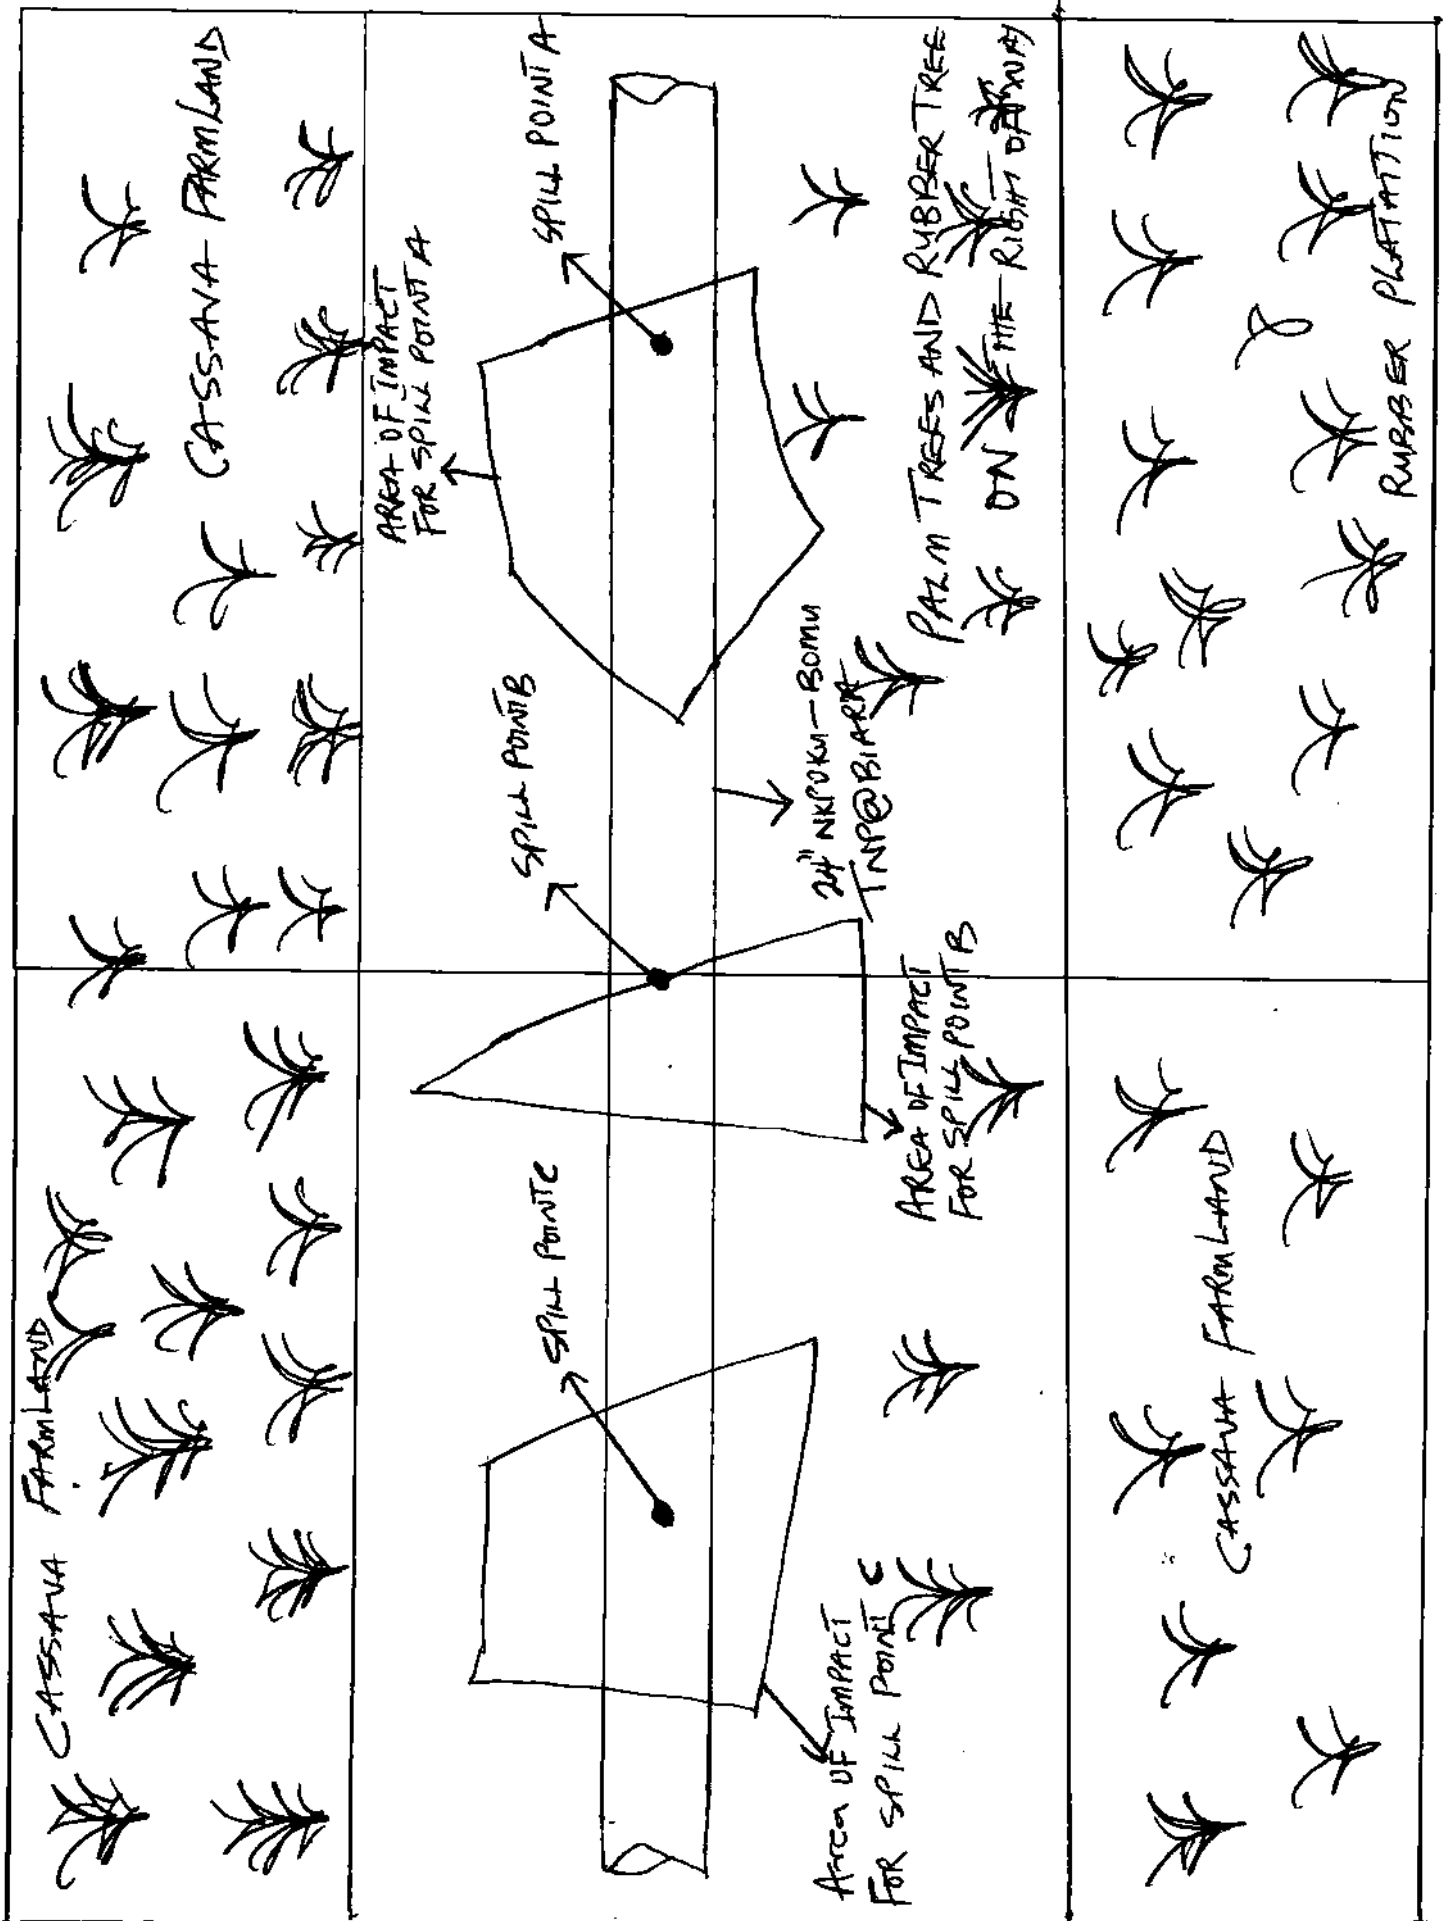
28. Appendix 1: Overview sketch of the site

Location: 24" NKPOKU - BOMU TRANS NIGER PIPELINE @ BIARA/PIPE
