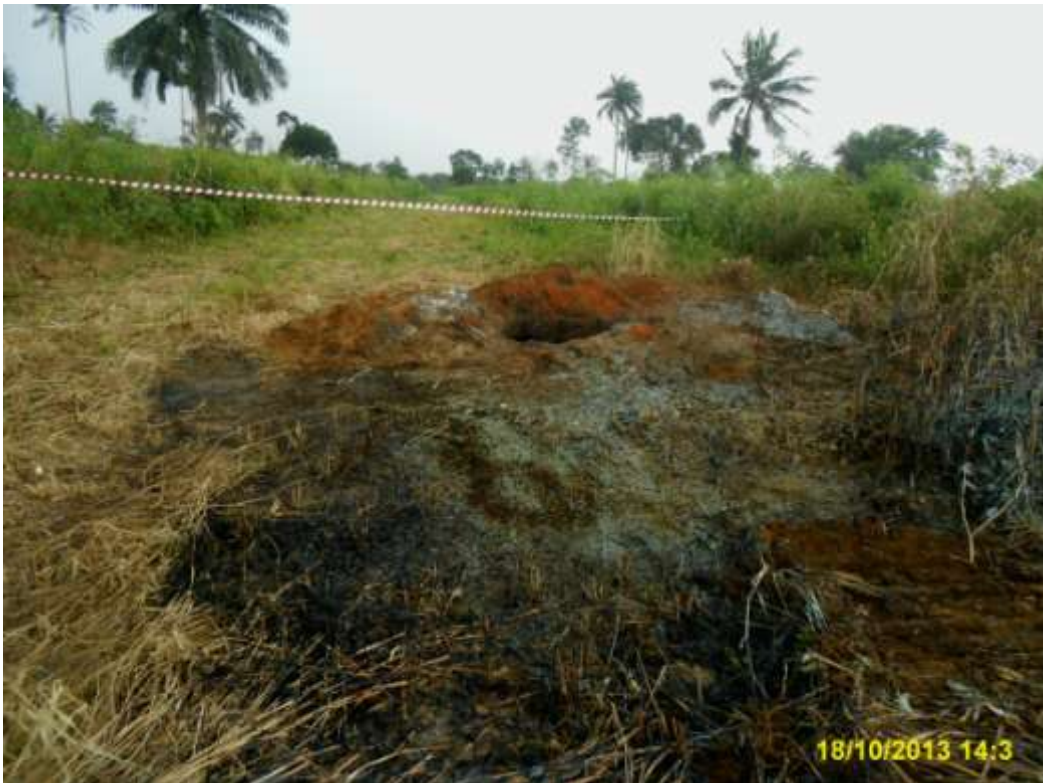
Overview: Part of spill/fire impact on 24" Nkpoku - Bomu Pipeline right of way at Biara. Picture was taken during Joint Investigation of 18th October 2013.

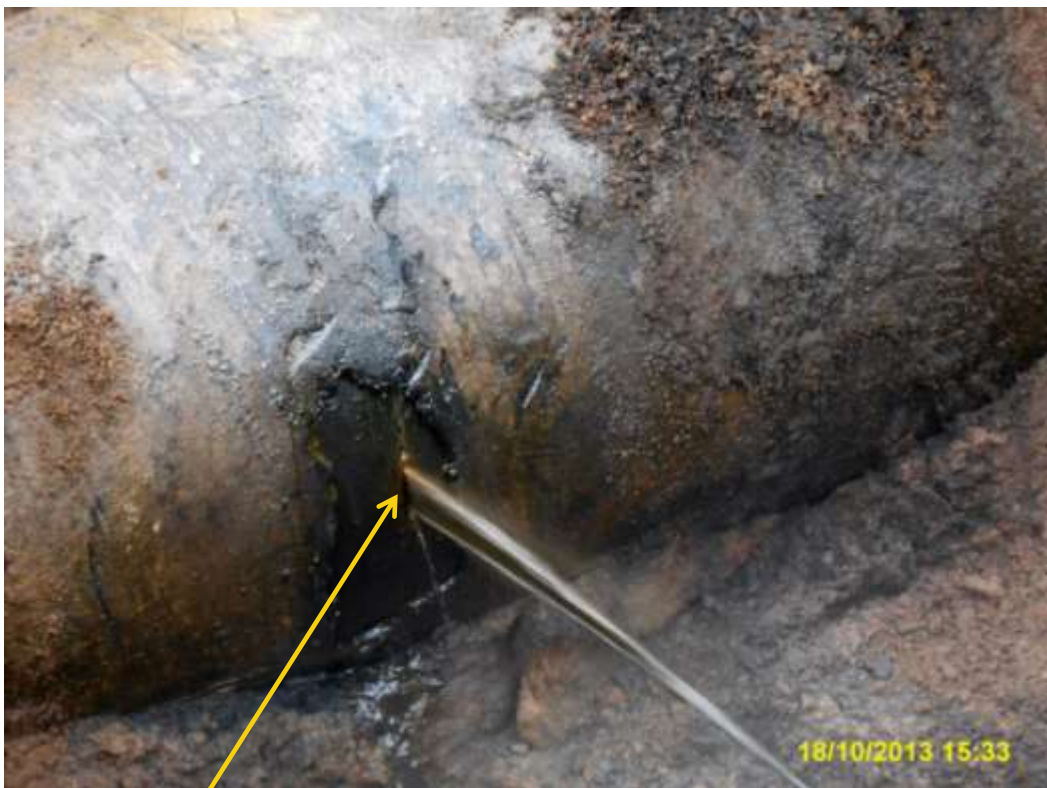
Close-up: Hacksaw cut on 24" Nkpoku - Bomu Pipeline at Biara. Picture was taken during Joint Investigation of 18th October 2013.
