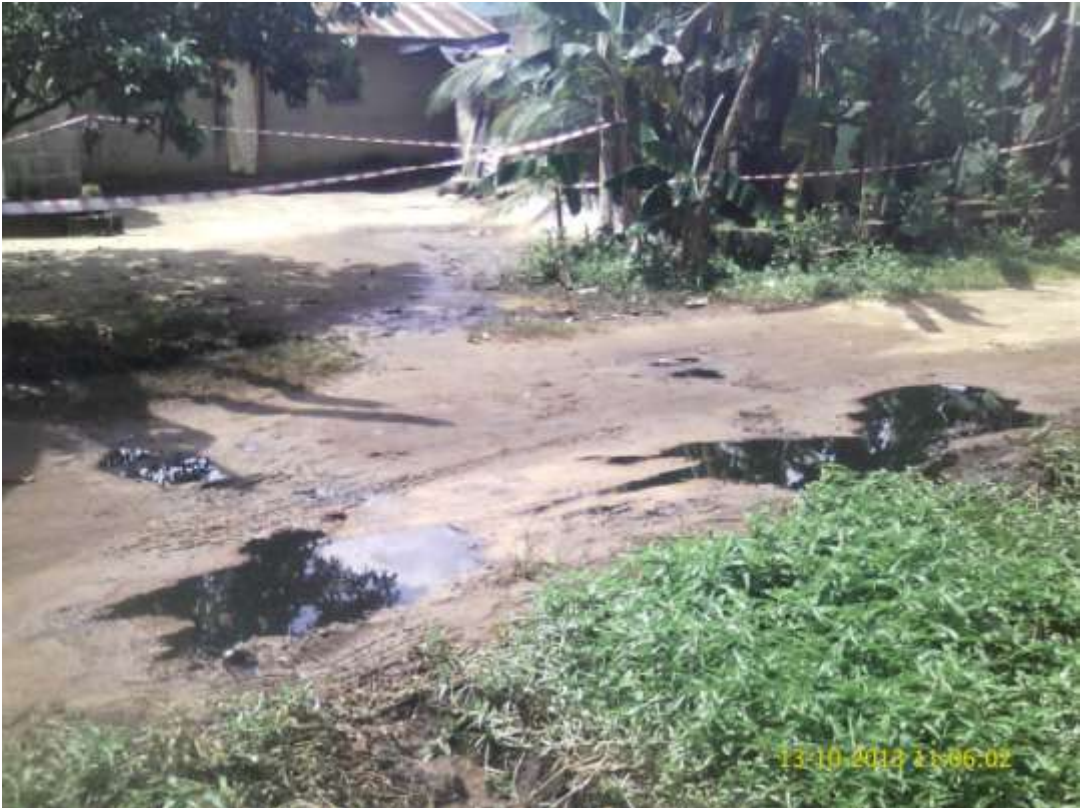
Overview: Part of spill impact on 6" Obigbo North – Ebulu pipeline right of way at Obolo. Picture was taken during Joint Investigation of 13th October 2013.

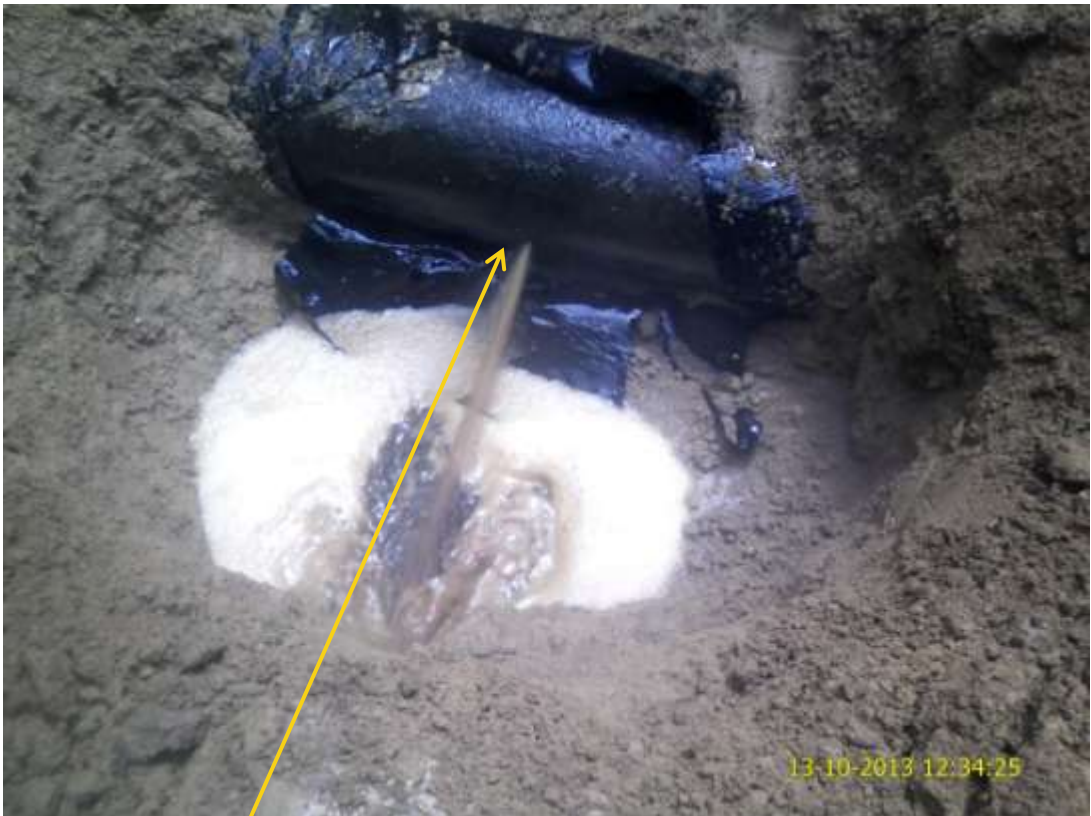
Close up: Spill due to corrosion on 6" Obigbo North – Ebulu pipeline at Obolo. Picture was taken during Joint Investigation of 13th October 2013.
