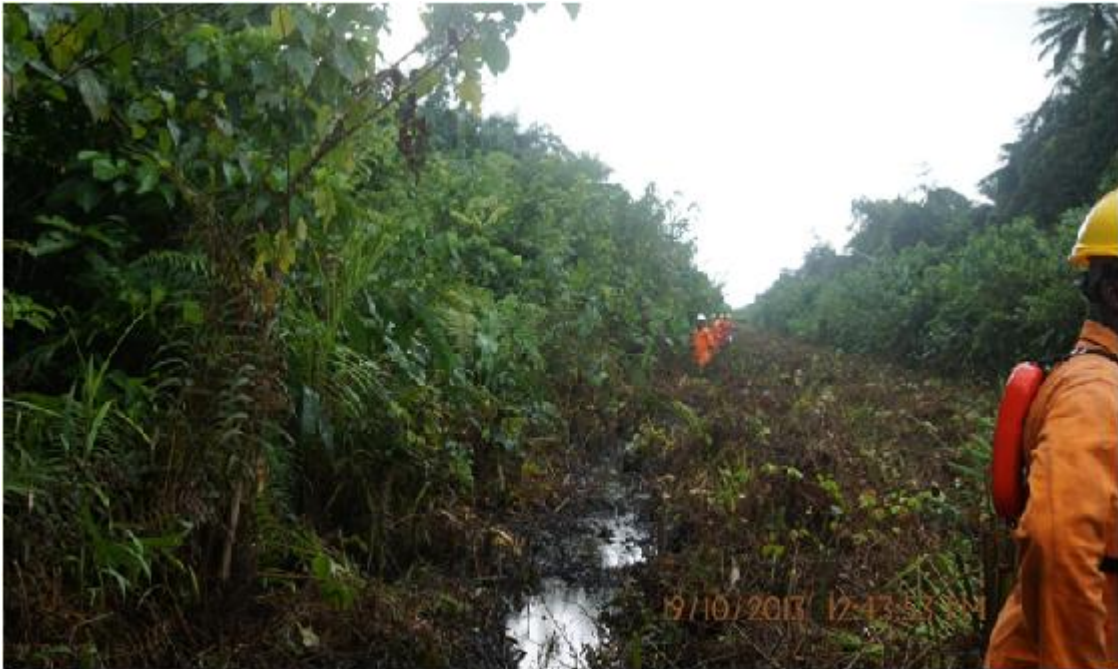
**Overview:** Part of spill impact on 20" Otumara-Escravos pipeline at Ogidigben. Picture was taken during Joint Investigation of 19th October 2013.

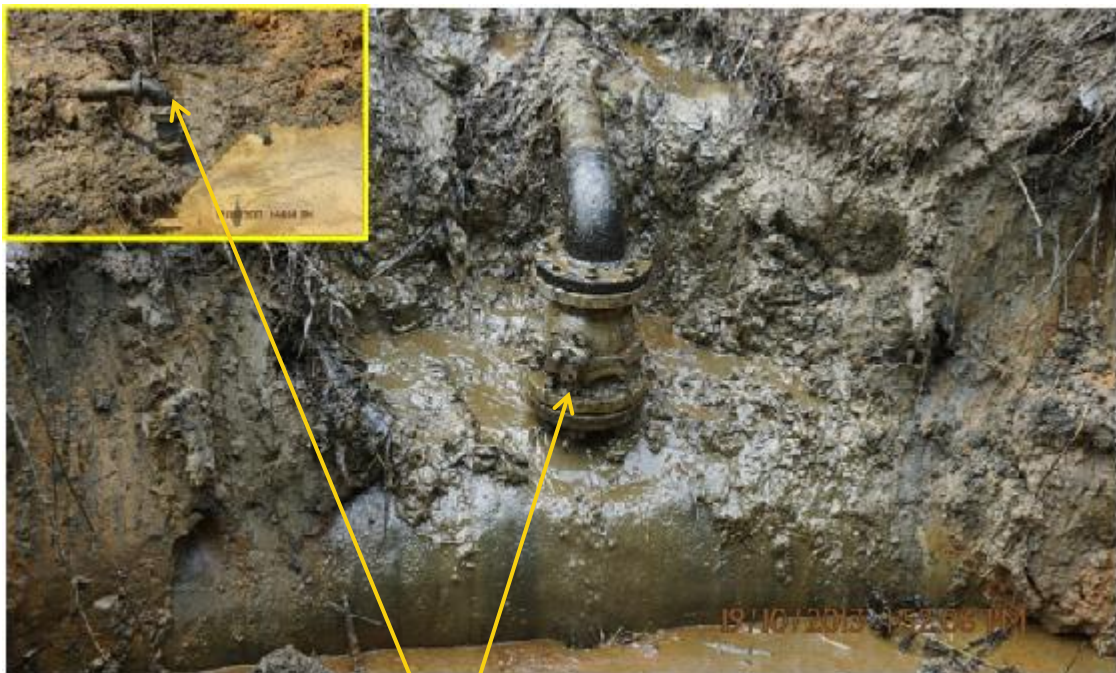
**Close up:** Spill Points 1 & 2 - Illegal fittings 20m apart on 20" Otumara-Escravos pipeline at Ogidigben. Picture was taken during Joint Investigation of 19th October 2013.
