**THE SHELL PETROLEUM DEVELOPMENT COMPANY OF NIGERIA LIMITED.**

JOINT INVESTIGATION REPORT FOR INCIDENT NO: 1154852 JIV report S/N: 0497

1. Spill incident Number: 1154852 2. Type of incident\* OIL SPILL  
 3. Name of Location KOLOCREEK WELL 3 T FLOWLINE  
 4. Name of nearest community OTUASEGA 5. State: BAYELSA 6. LGA OGBIA  
 7. Type of Production facility/Installation OIL FLOWLINE 8. Asset owner/District LAND 2

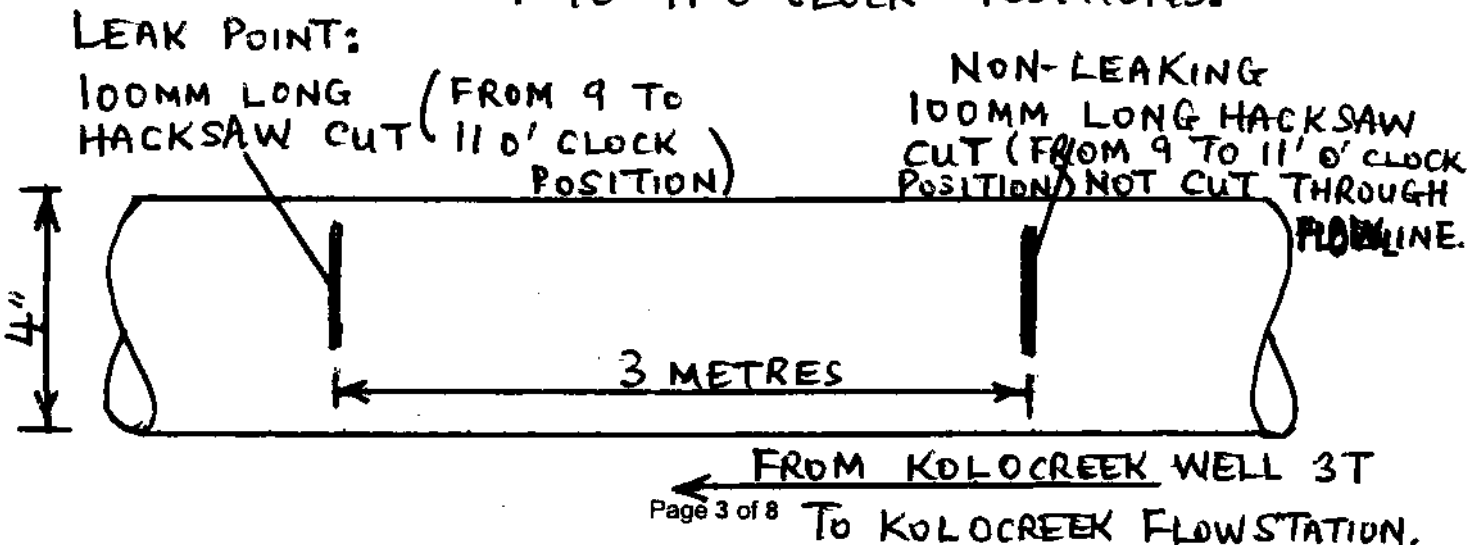
Additional observations around the spill point: THE SPILL POINT (BEING A HACKSAW CUT) WAS OBSERVED, IN A SEASONAL SWAMPY TERRAIN, 3 METRES AWAY FROM A SECOND HACKSAW CUT (NOT CUT THROUGH THE FLOWLINE). A BURROW PIT WAS OBSERVED IN THE VICINITY.

SECTION OF KOLOCREEK WELL 3T FLOWLINE AT OTUASEGA SHOWING 2 NO. HACKSAW CUTS FROM 9 TO 11 O' CLOCK POSITIONS.
