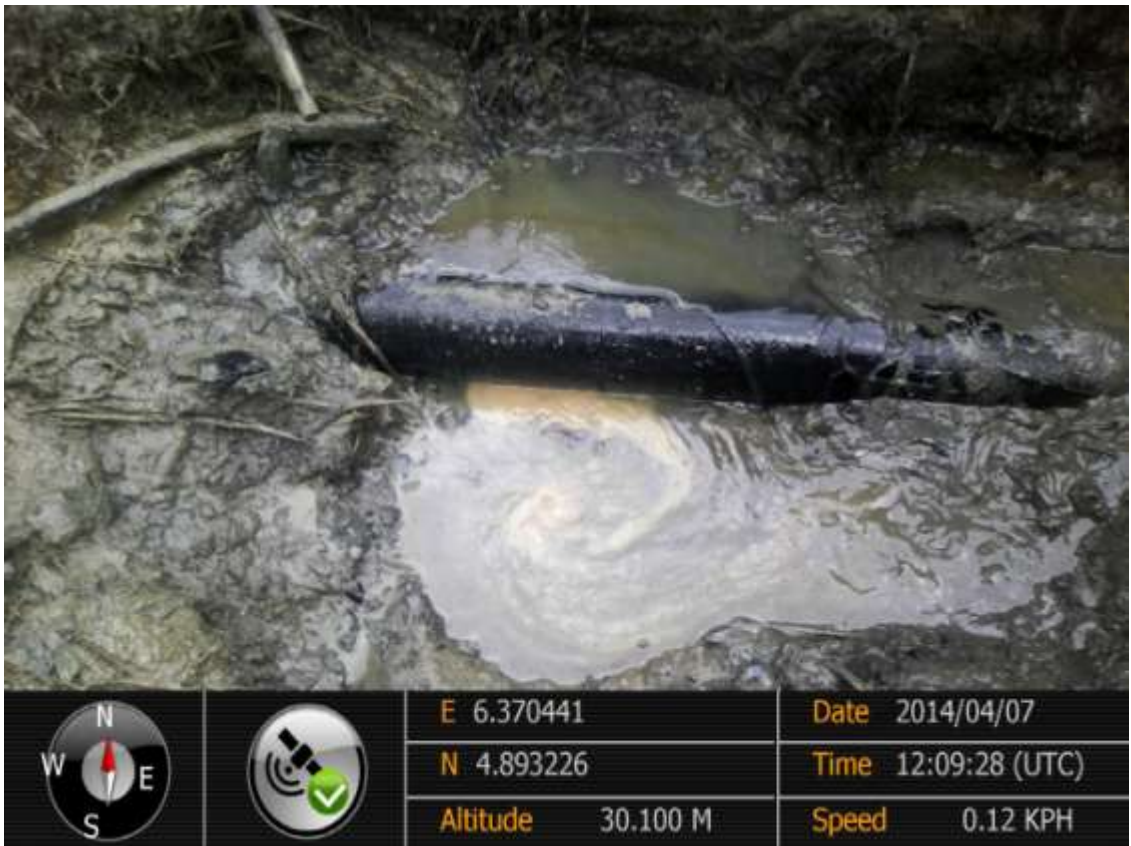
Overview: Part of spill impact on KoloCreek Well 3T Flowline right of way at Otusega. Picture was taken during Joint Investigation of 7th April 2014.

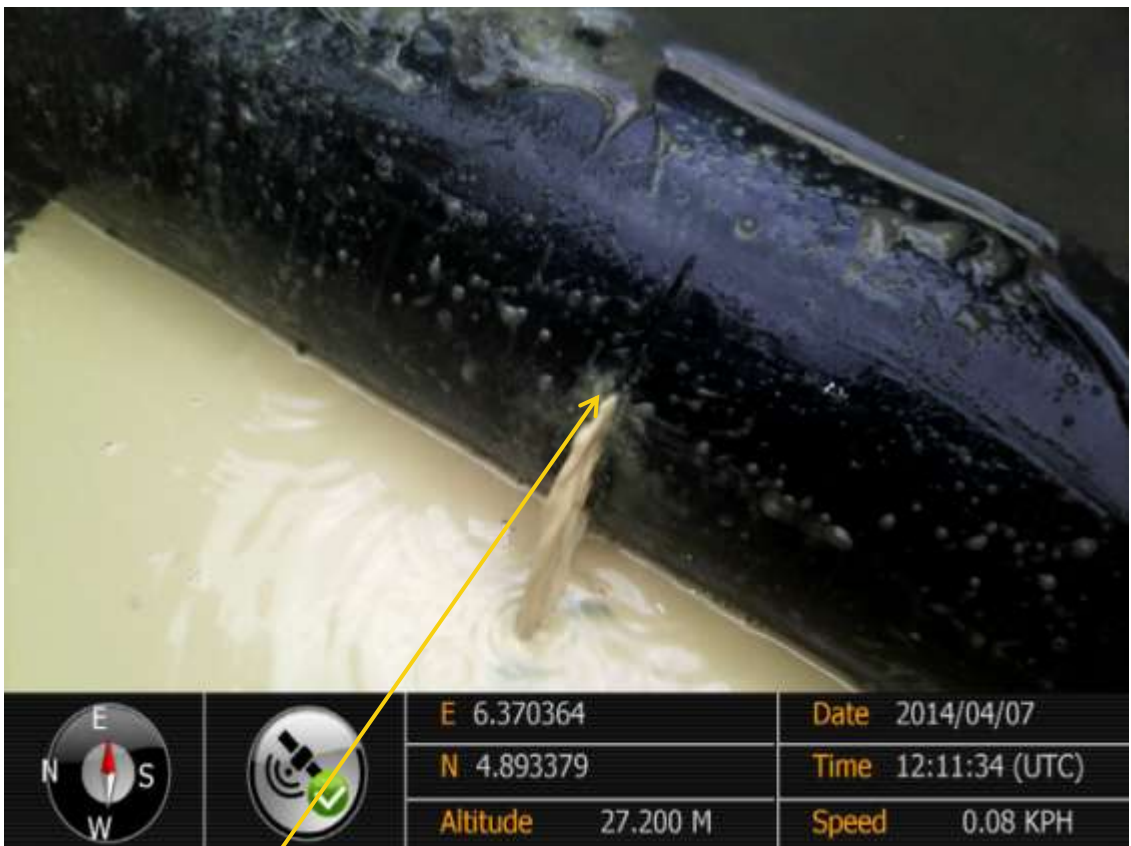
Close-up: Hacksaw cut on KoloCreek Well 3T Flowline at Otusega. Picture was taken during Joint Investigation of 7th April 2014.
