THE SHELL PETROLEUM DEVELOPMENT COMPANY OF NIGERIA LIMITED.

JOINT INVESTIGATION REPORT FOR INCIDENT NO: 1102878 JIV report S/N: 0379

1. Spill incident Number: 1102878 2. Type of incident* OIL SPILL
 3. Name of Location 24" NKPOKU - BOMU PIPELINE
 4. Name of nearest community B-DERE 5. State: RIVERS 6. LGA GOKANA
 7. Type of Production facility/Installation OIL PIPELINE 8. Asset owner/District PIPELINE

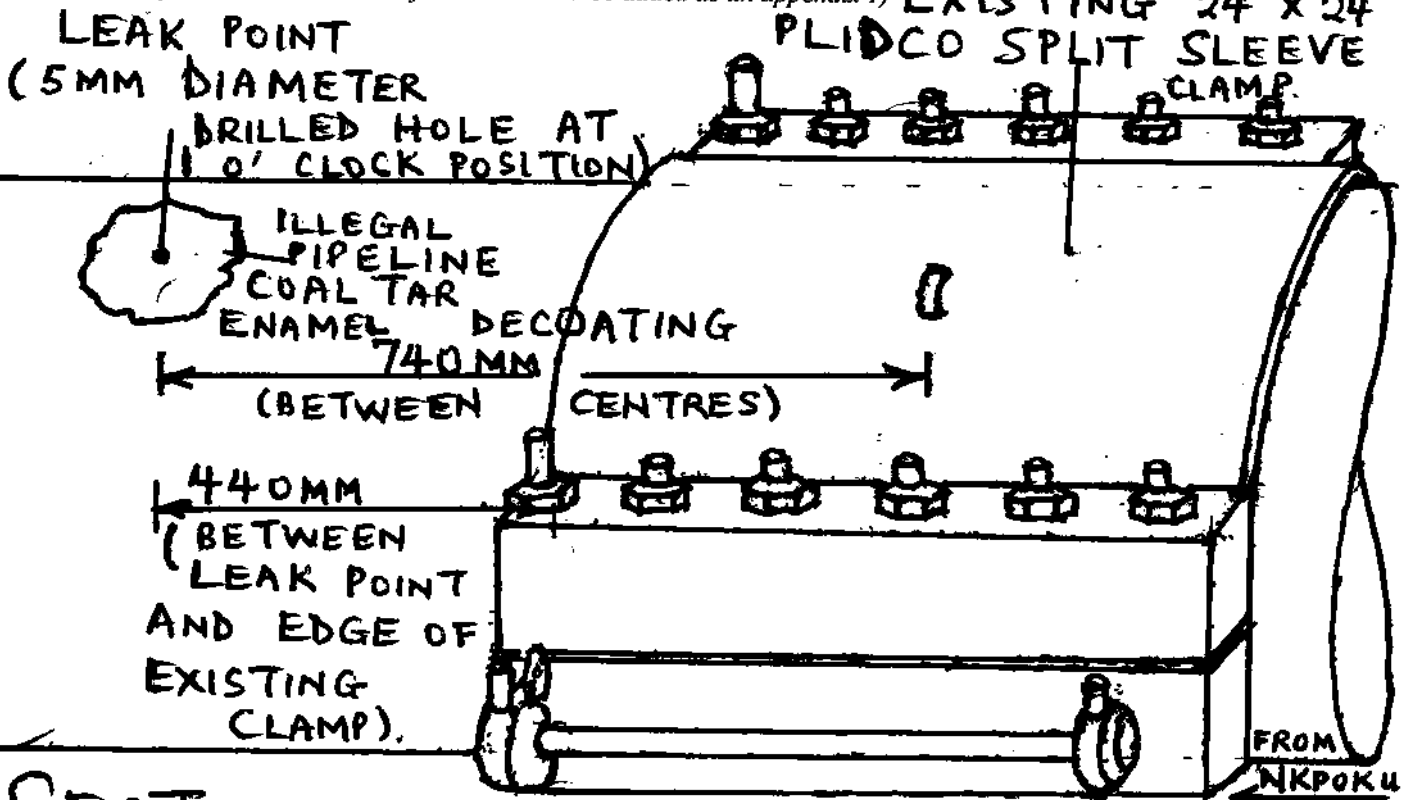
| <input checked="" type="checkbox"/> Drilled hole | <input type="checkbox"/> Hack saw cut | <input type="checkbox"/> Tear (_____) |

- Third party interference (Sabotage ; crude theft ; Line theft ; Accidental 3rd party damage
 Operational Others (including Mystery spills) _____

SECTION OF 24" NKPOKU - BOMU PIPELINE AT B-DERE SHOWING POSITION OF LEAK POINT ADJACENT TO EXISTING CLAMP.

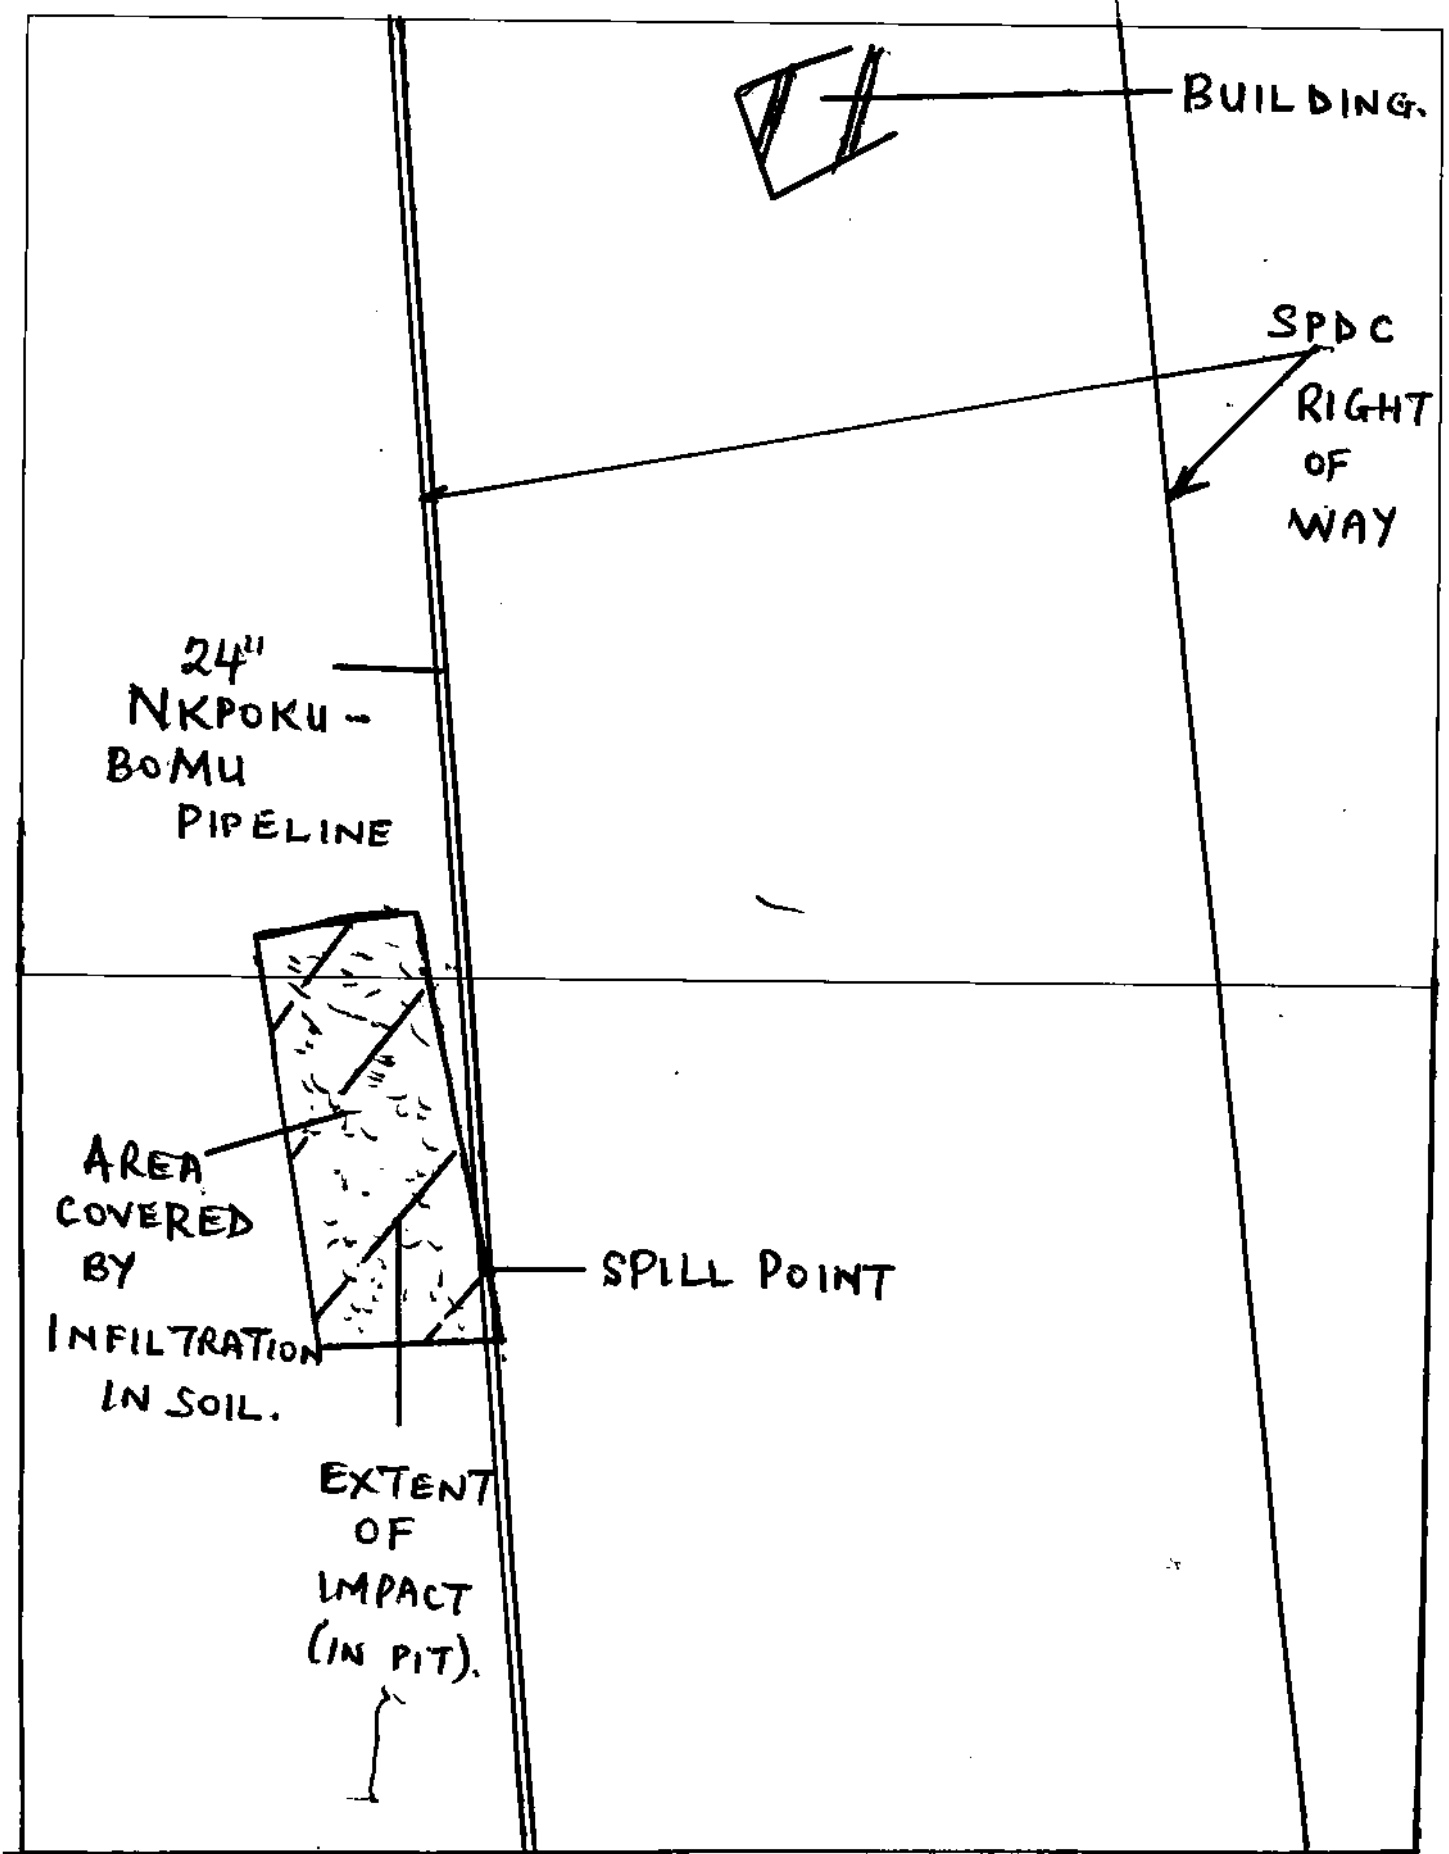
28. Appendix 1: Overview sketch of the site

Location: 24th NKPOKU - BOMU PIPELINE AT B-DERE
