THE SHELL PETROLEUM DEVELOPMENT COMPANY OF NIGERIA LIMITED.

JOINT INVESTIGATION REPORT FOR INCIDENT NO: 1207544 JIV report S/N 0508

1. Spill incident Number: 1207544 2. Type of incident: OIL SPILL
 3. Name of Location: 8th Umuechimm - Nkpany Pipeline
 4. Name of nearest community: OMUNNEI 5. State: RIVERS 6. LGA: IKWERRE
 7. Type of Production facility/Installation: ON PIPELINE 8. Asset owner/District: PIPELINE

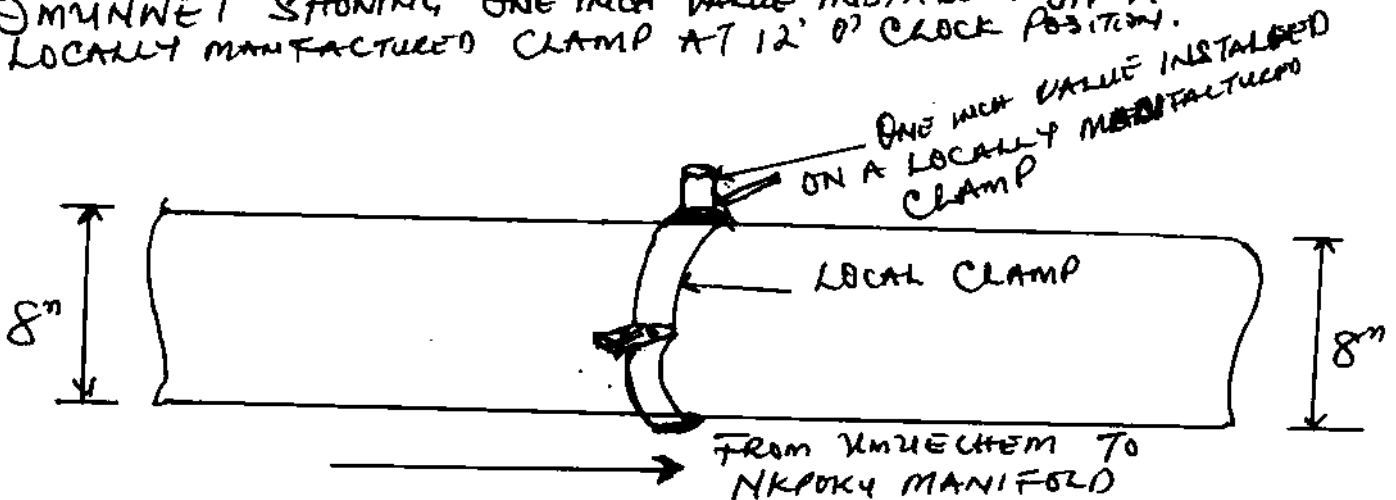
E. GRAPHIC DESCRIPTION OF LEAK POINT (while detail report of the leak point should be contained in the leak report, overview sketch of the site should be added as an appendix 1)

| <input checked="" type="checkbox"/> Failed Weld-on illegal hot tap valve. | <input type="checkbox"/> Failed Clamp | <input type="checkbox"/> Missing Pipeline/Flowline |
| <input checked="" type="checkbox"/> Crude oil theft (illegal bunkering) point. | | <input type="checkbox"/> Third party tampering with Clamp |

A SECTION OF 8" UMUECHEM - NKPOKY PIPELINE AT OMMUNWEI SHOWING ONE INCH VALVE INSTALLED ON A LOCALLY MANUFACTURED CLAMP AT 12 O' CLOCK POSITION.

RECOVERY OF FREE-PHASE OIL WAS DONE SIMULTANEOUSLY WITH REPAIRS ON AFFECTED SECTION OF THE PIPELINE

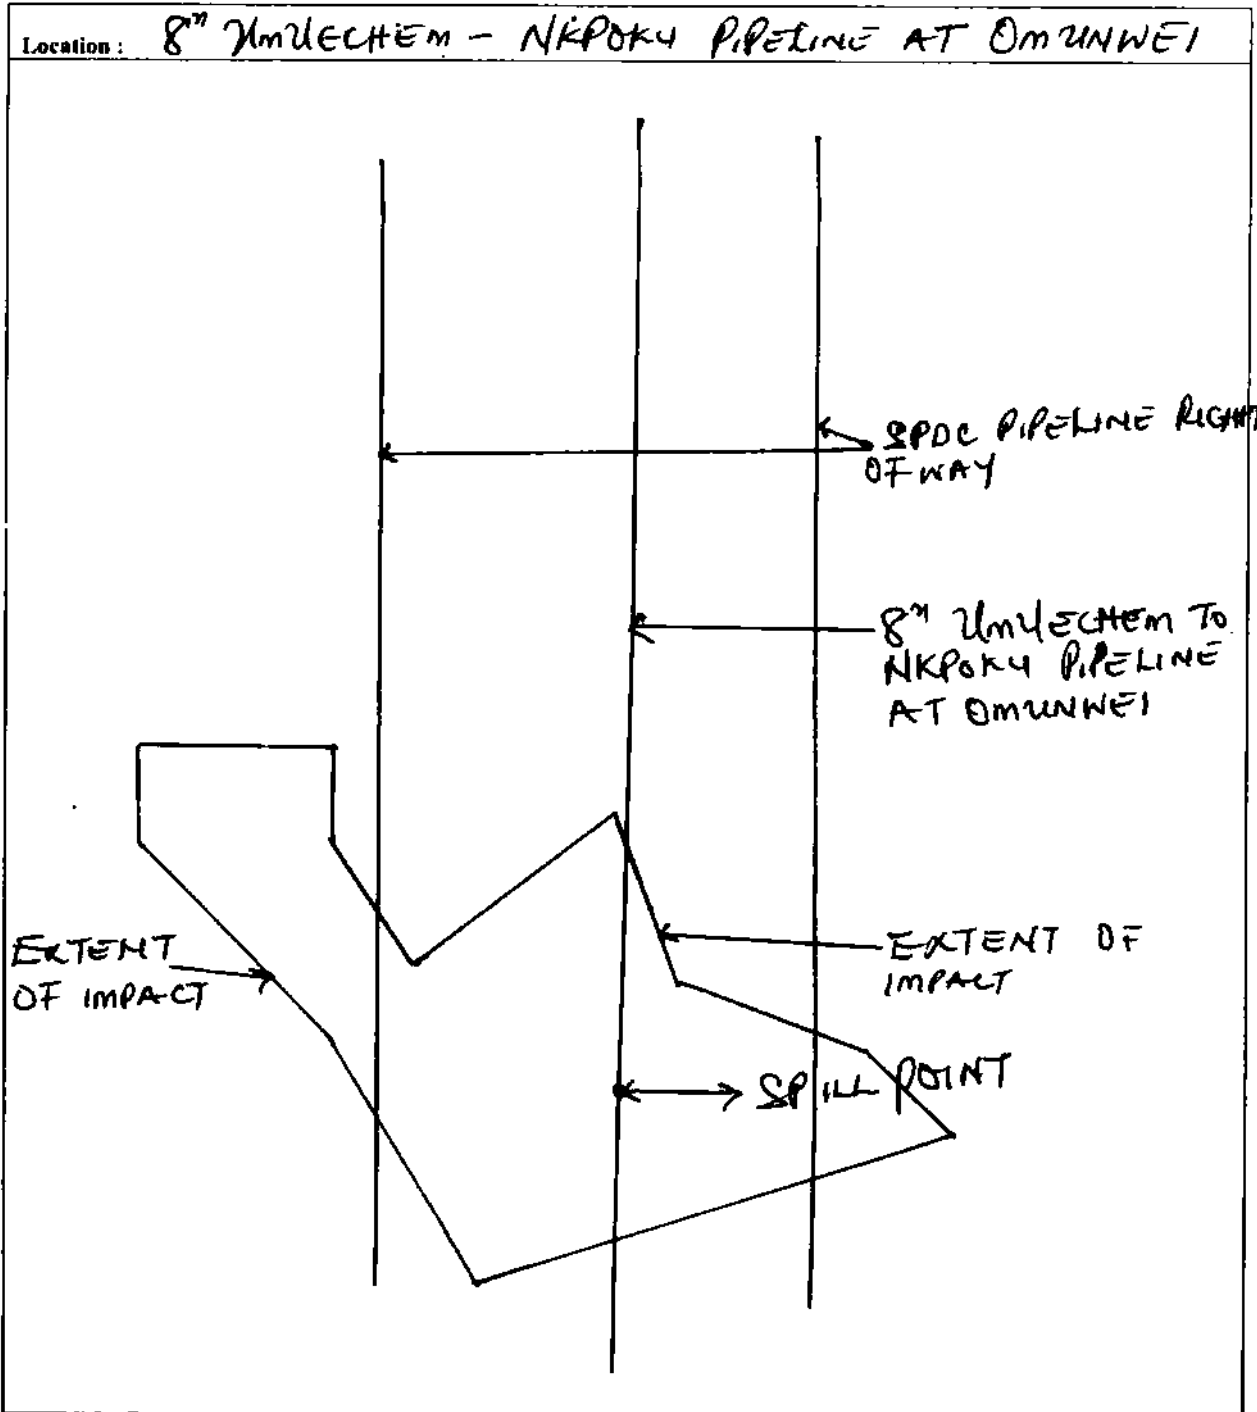
25. Appendix I: Overview sketch of the site

Additional observations around the spill point: THE SPILL WAS OBSERVED TO HAVE OCCURRED ON A CLEARED RIGHT OF WAY AND OUTSIDE THE RIGHT OF WAY
