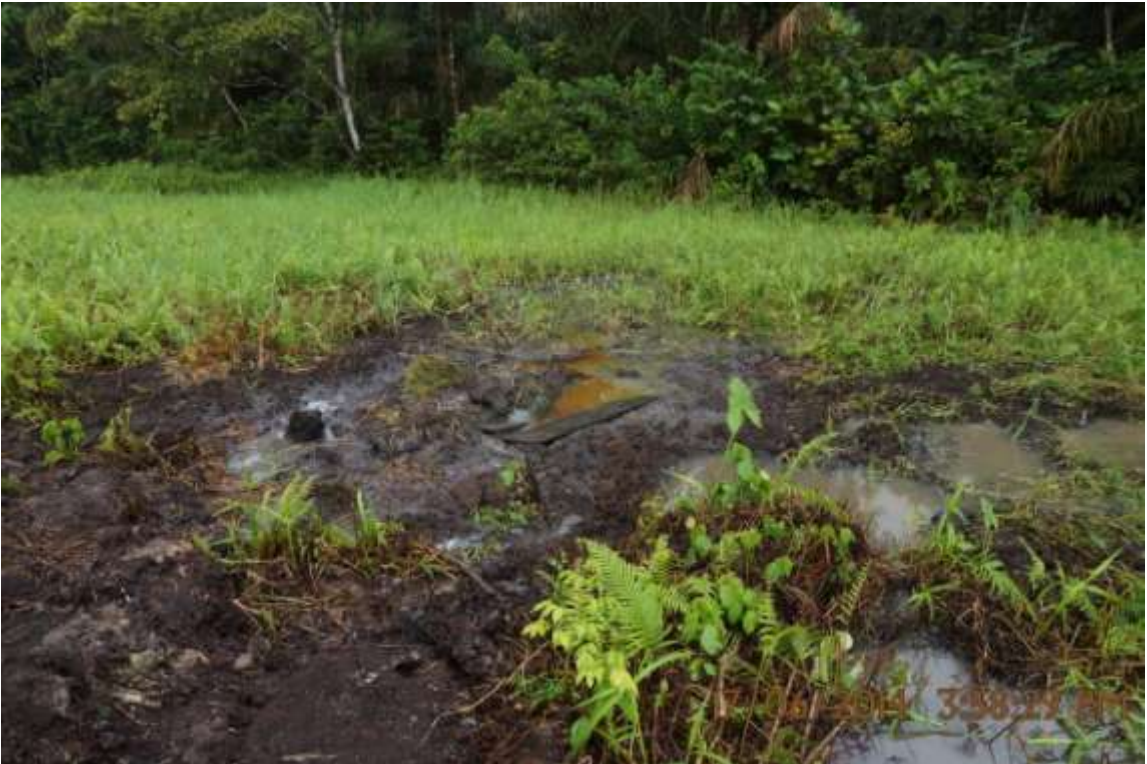
Overview: Part of spill impact on 20" Opukushi-Brass Creek Pipeline Right of Way at Tamogbene. Picture was taken during Joint Investigation of 17th June 2014.

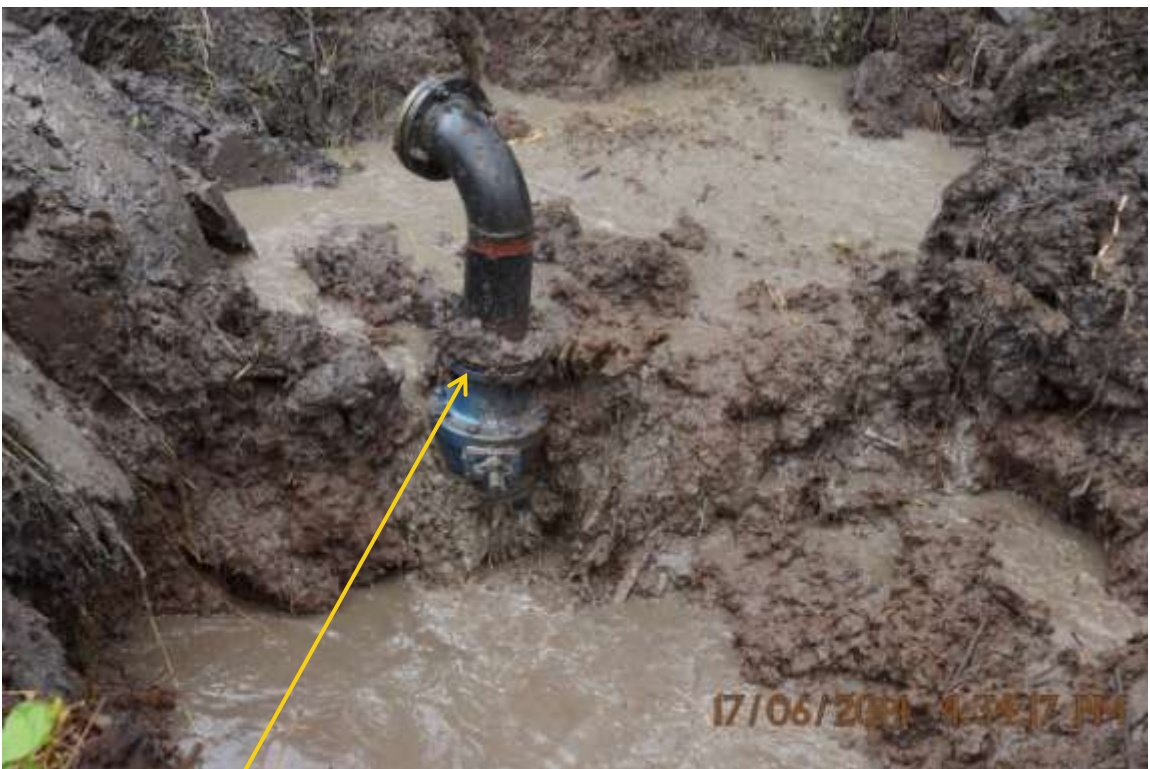
Close-up: Illegal fitting on 20" Opukushi-Brass Creek Pipeline at Tamogbene. Picture was taken during Joint Investigation of 17th June 2014.
