THE SHELL PETROLEUM DEVELOPMENT COMPANY OF NIGERIA LIMITED.

JOINT INVESTIGATION REPORT FOR INCIDENT NO: 1202107 JIV report S/N: 00597

1. Spill incident Number: 1202107 2. Type of incident* OIL SPILL
 3. Name of Location BELEMA WELL 7L WELL HEAD
 4. Name of nearest community BELEMA 5. State: RIVERS 6. LGA AKUKU-TORU
 7. Type of Production facility/Installation WELLHEAD 8. Asset owner/District SWAMP 2

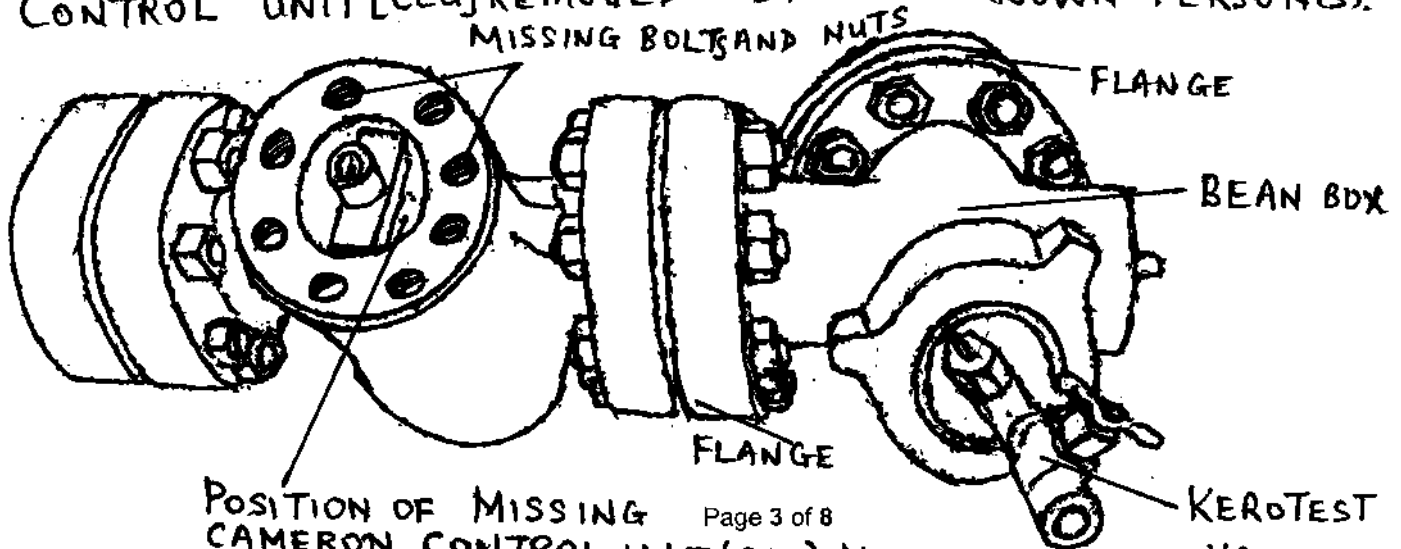
Additional observations around the spill point: **OIL BUBBLES WERE NOTICED INTERNALLY AT THE POSITION OF THE MISSING CAMERON CONTROL UNIT ON THE WELL 7L ARM (BEING THE SPILL POINT). THE BONNET GASKET AND ONE OF THE FLANGE BOLTS FOR THE MISSING CCU ON WELL 7L WAS FOUND ON THE WELL HEAD GRATING AS AT TIME OF INVESTIGATION. OIL STAINS WERE OBSERVED ON THE BODY OF THE**

WELL HEAD BUT ONLY LIGHT OIL SHEEN WAS OBSERVED AS SPILL TO THE ENVIRONMENT (ON WATER). ALSO, THE CCU ON THE WELL 7S ARM WITH TWO BOLTS WERE OBSERVED MISSING, BUT WITH NO OBSERVABLE SPILL IMPACT.

SECTION OF BELEMA WELL 7L (WELLHEAD) AT BELEMA SHOWING POSITION OF LEAK POINT (MISSING CAMERON CONTROL UNIT [CCU] REMOVED BY UNKNOWN PERSON(S). MISSING BOLT AND NUTS

POSITION OF MISSING CAMERON CONTROL UNIT (CCU) WHERE OIL BUBBLES WERE NOTICED AS AT TIME OF INVESTIGATION [LEAK POINT]
