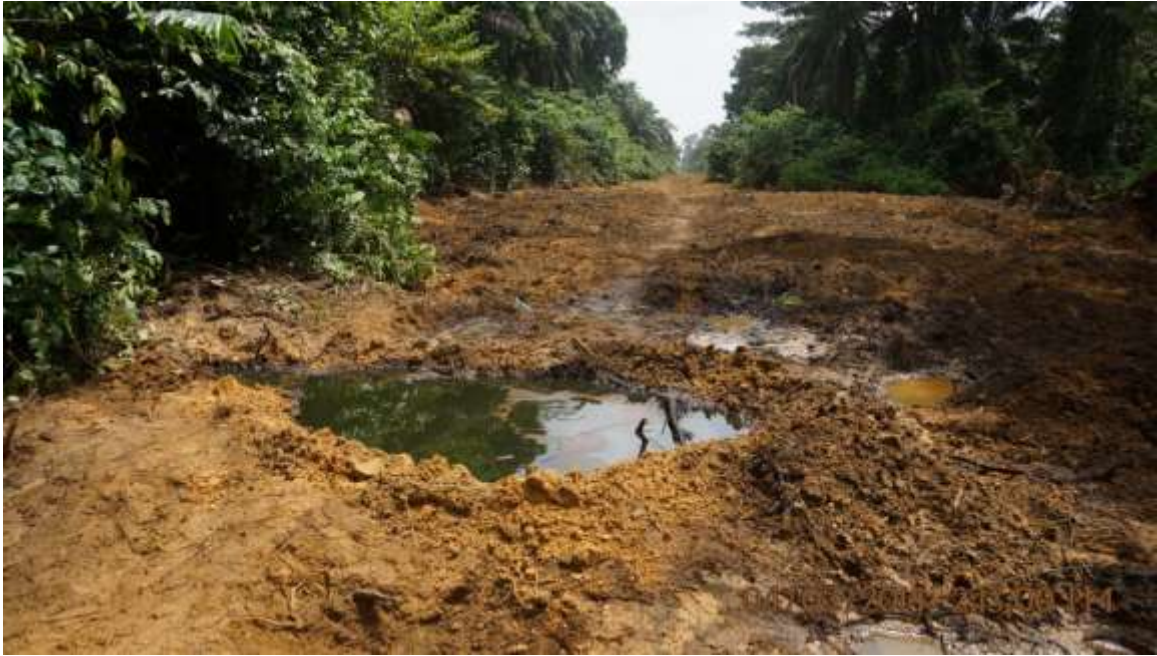
Overview: Part of spill impact on 20" Otumara-Escravos Pipeline right of way at Adjudaibo. Picture was taken during Joint Investigation of 4th March 2014.

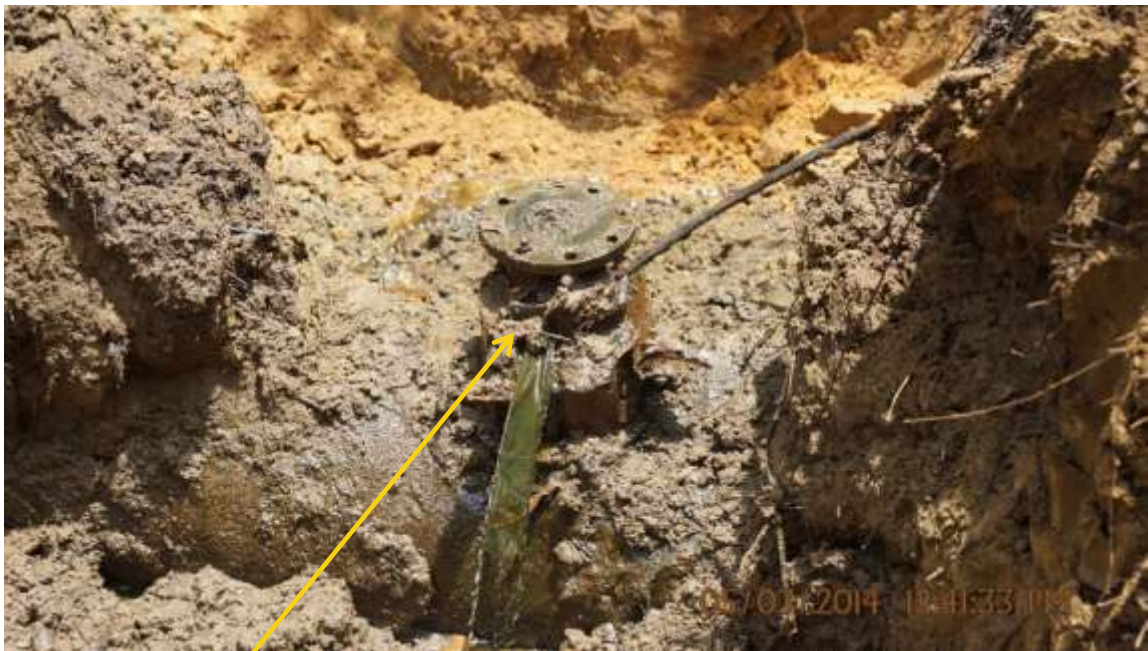
Close-up: Illegal fitting on 20" Otumara-Escravos Pipeline at Adjudaibo. Picture was taken during Joint Investigation of 5th March 2014.
