JOINT INVESTIGATION	N REPORT FOR INC	IDENT NO: 1134	ナユロ JIV repo	ort S/N: 0417
(Note: As practicable	e as possible the JIT re	eport is to be signed in t	the field by all the par	rticipating parties)

A. GENERAL INF	ORMATION:			
1. Spill incident Nun	nber: <u>11343</u>	2.Ty	pe of incident*	Hr >hr
3. Name of Location	24" NKPEK	cu - Bomu	TRANS NI	GER PIPELINE

SECTIONAL VIEW OF 24" NKPOKU - BOMY TRANS MIGHT PIPELIN AT BIARA SHEWING: ILLEGAL HACKSAW CUT.

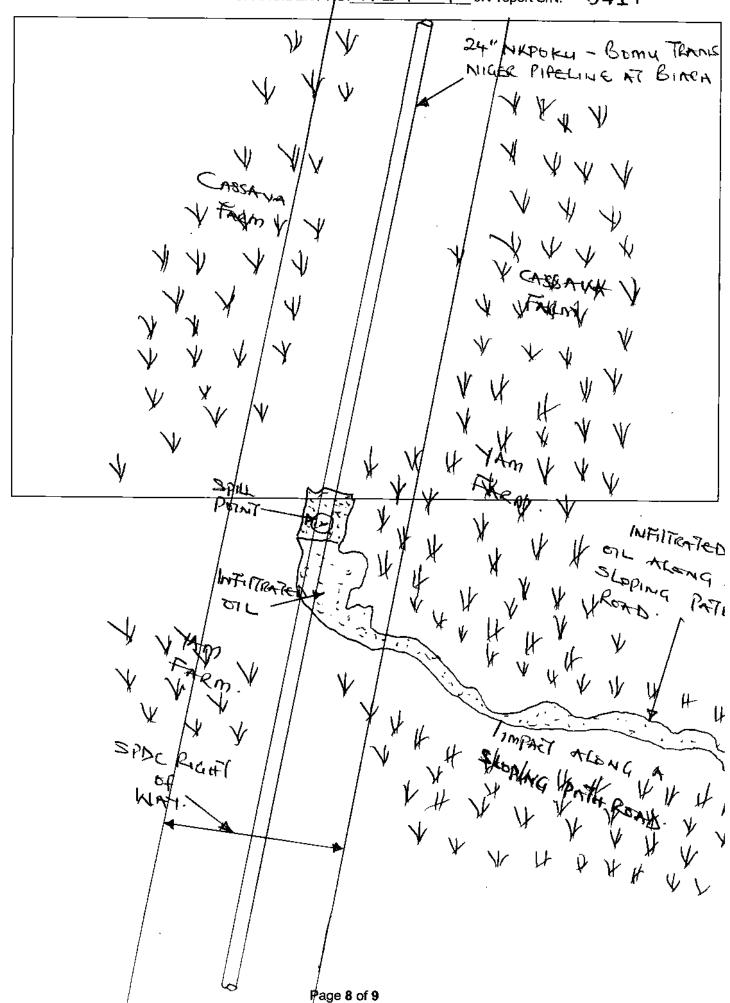
E. GRAPHIC DESCRIPTION OF LEAK POINT (while detail report of the leak point should be contained in the leak report, overview sketch of the site should be added as an appendix 1)

LEAR IS DUE TO
125mm/emant of HACKSAW

CUT WITH Effective CUT OF

60mm AT 90 CLOCK POSITION.
