THE SHELL PETROLEUM DEVELOPMENT COMPANY OF NIGERIA LIMTED. JOINT INVESTIGATION REPORT FOR INCIDENT NO: 1135909 JIV report S/N: (Note: As practicable as possible the JIT report is to be signed in the field by all the participating parties) A. GENERAL INFORMATION: 1. Spill incident Number: 1135 909 2. Type of incident* DIL SPILL 3. Name of Location 24" BOMN - BONNY PIJ' FLINT 4. Name of nearest community RODO WHET 5. State: RIVER 6. LGA GOKANA 7. Type of Production facility/Installation OIL PIPELINE 8. Asset owner/District PIPELINE **B. INCIDENT INFORMATION:** 9. Details of incident a. Date of incident: 6TH MARCH, 20TH b. Start date/time of investigation: 8TH MARCH 20TH c. Investigation End date: 8TH MARCH 20TH d. Description of spill point environment Loose soil ☐Firmed soil Recently excavated area Under water Swampy Exposed pipe surface ☐Well Platform (on Water) □Drill Rig e. Description of leak point (tick as applicable); ☐Drilled hole ☐ Hack saw cut Tear (Complete Rupture ☐Inward dent, ☐Well head tampering Failed Weld-on illegal hot tap valve, Failed Clamp ☐Missing Pipeline/Flowline Crude oil theft (illegal bunkering) point, ☐ Third party tampering with Clamp Third party tamperin

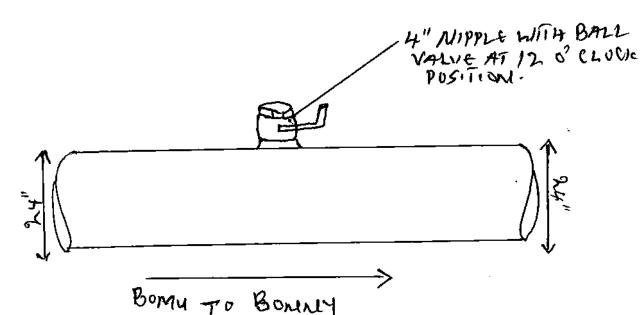
E. GRAPHIC DESCRIPTION OF LEAK POINT (while detail report of the leak point should be contained in the leak report, overview sketch of the site should be added as an appendix 1)

of 24" Bumu — Bound Piptline AT Bodo Wiff Stowin 6

CRUD+ OIL THEFT POINT AT 12 0' CLOCK POSITION.
