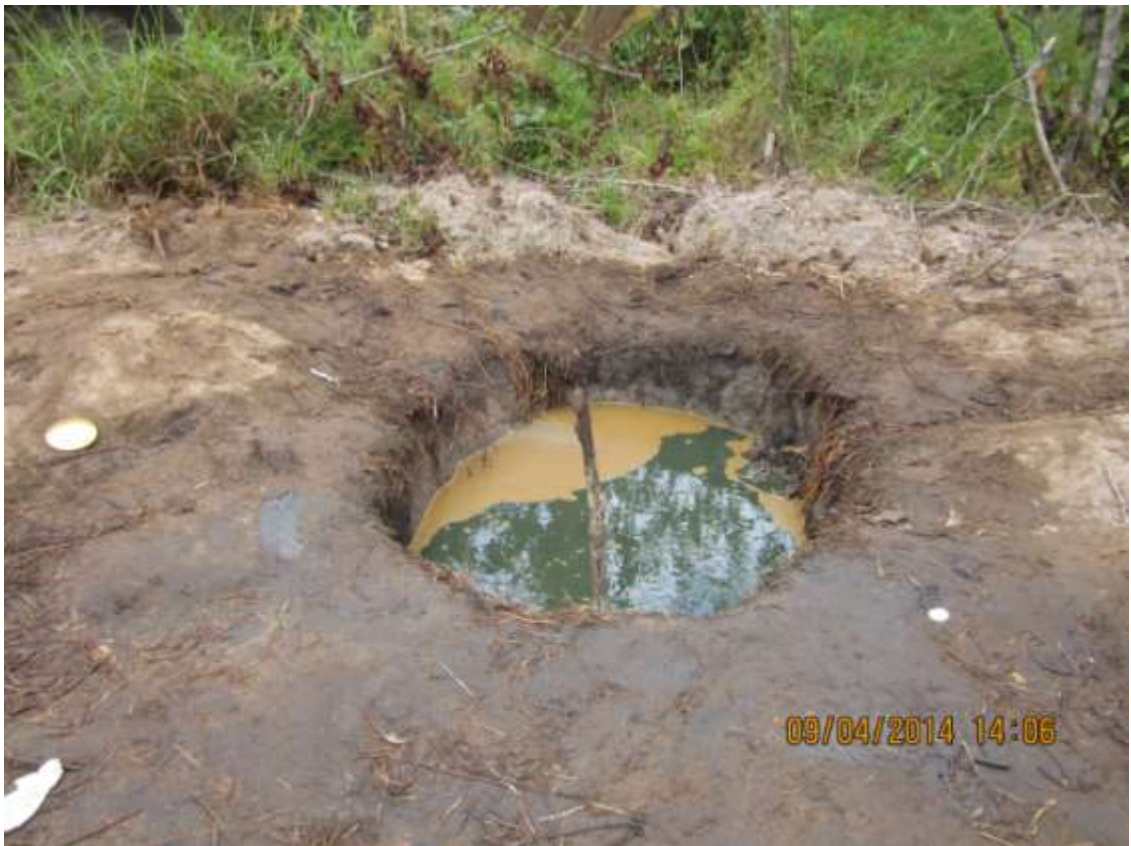
Overview: Part of spill impact on 20" Rumuekpe – Nkpoku Pipeline right of way at Omusunu/Ibaa. Picture was taken during Joint Investigation of 9th April 2014.

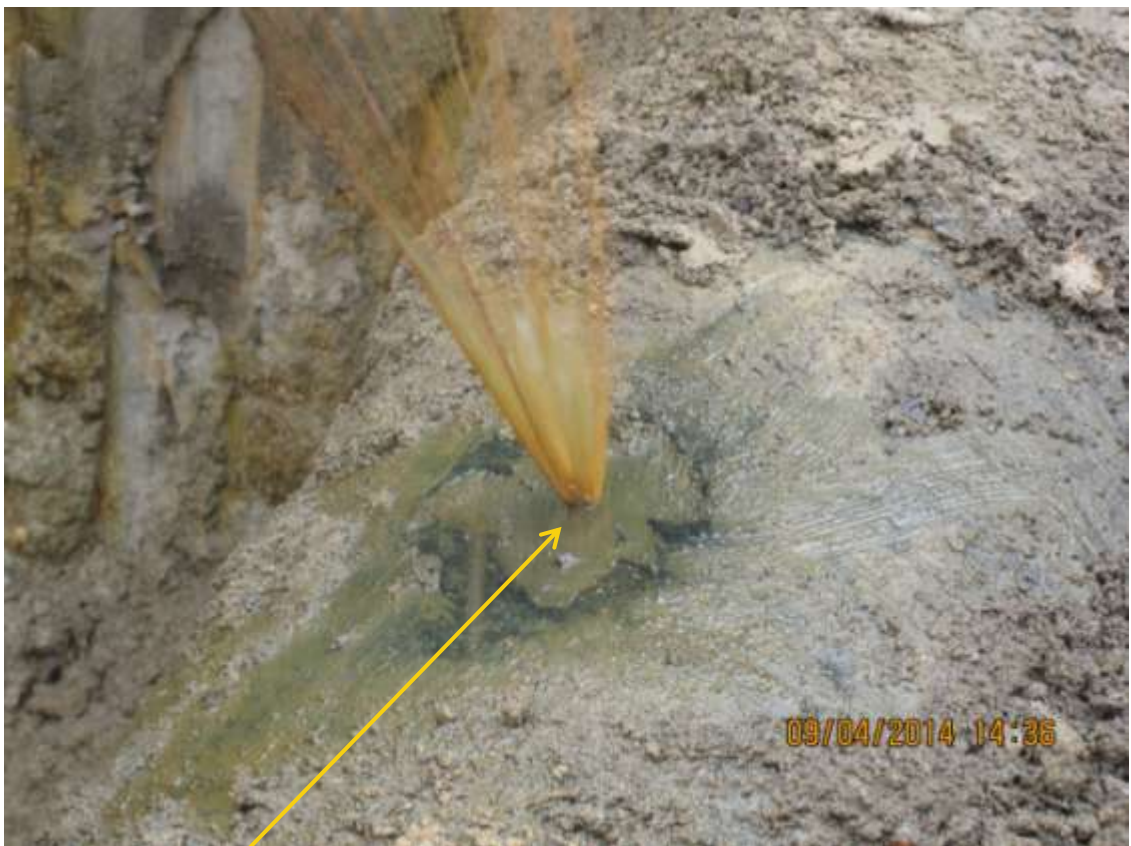
Close-up: Drilled hole on 20" Rumuekpe – Nkpoku Pipeline at Omusunu/Ibaa. Picture was taken during Joint Investigation of 9th April 2014.
