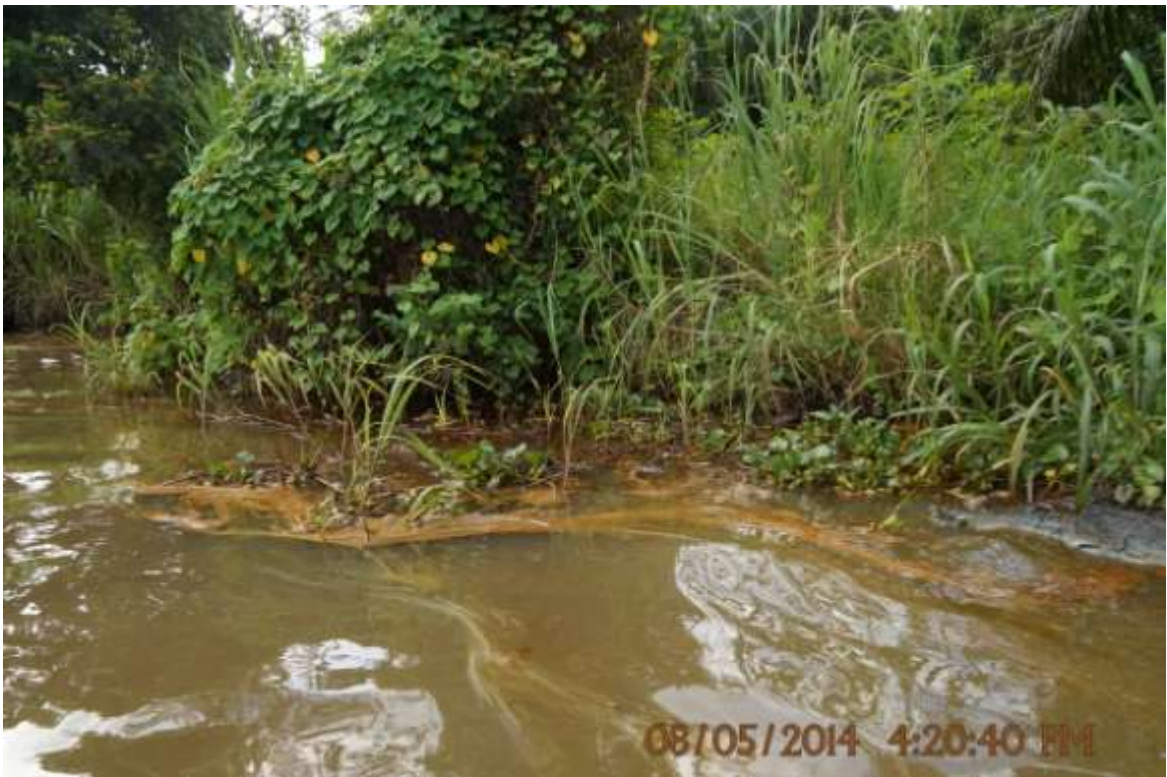
Overview: Part of spill impact on Benisede –Akono Well1S Flowline Right of Way at Ojobo. Picture was taken during Joint Investigation of 8th May 2014.

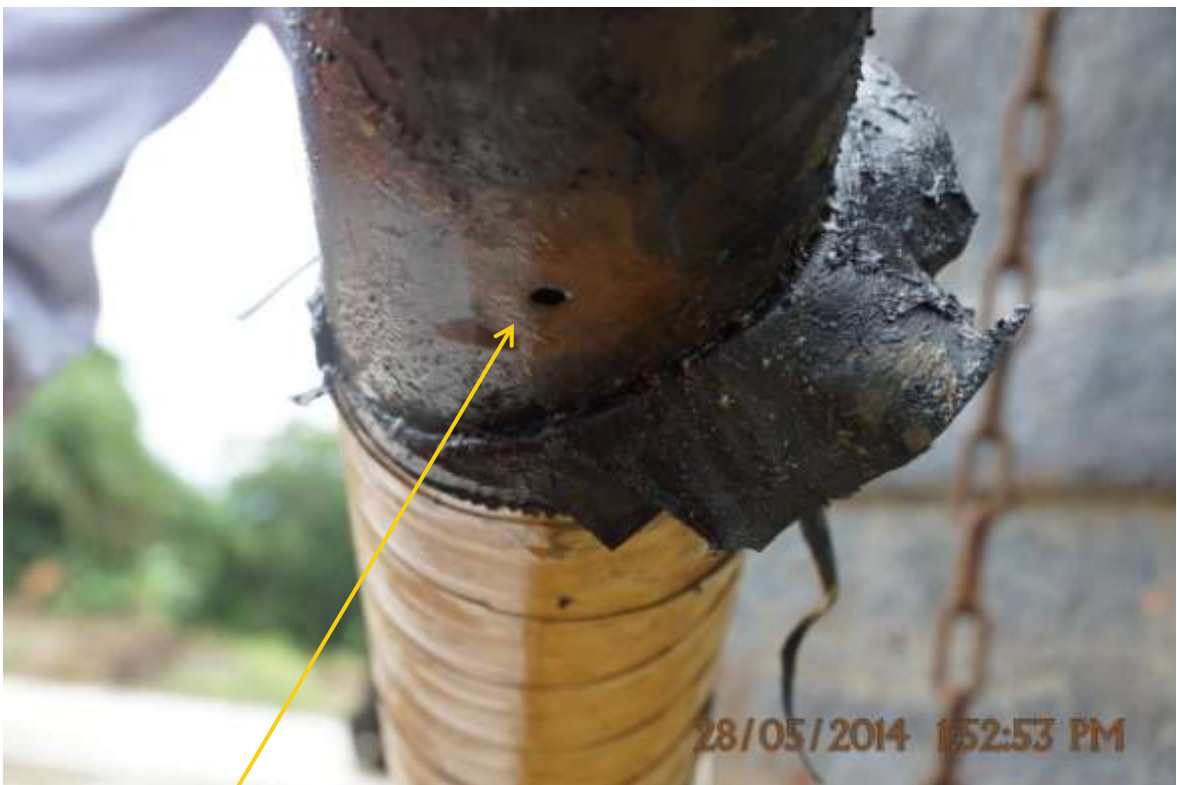
Close-up: Spill due to corrosion on Benisede –Akono Well1S Flowline at Ojobo. Picture was taken during Joint Investigation of 28th May 2014.
