Overview: Part of spill impact on 10" Diebu Creek – Nun River Pipeline Right of Way at Oporoma. Picture was taken during Joint Investigation of 16<sup>th</sup> October 2014.

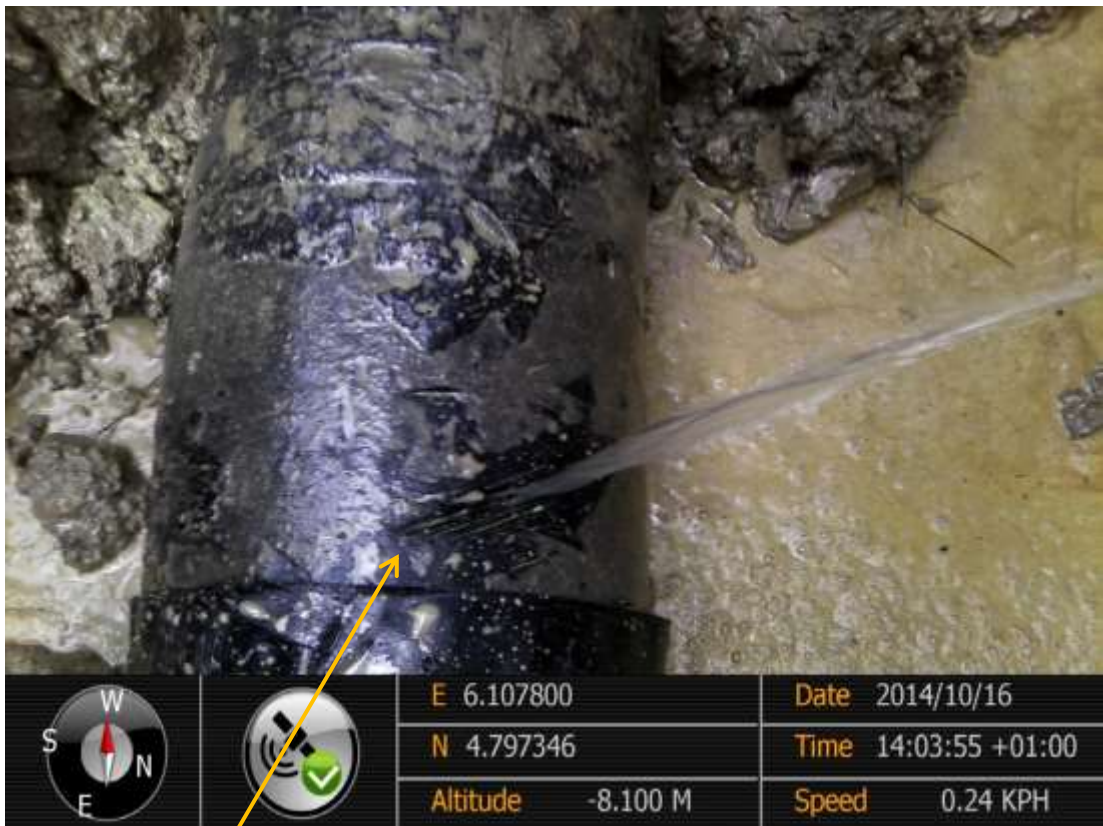
Close-up: Hacksaw cut on 10" Diebu Creek – Nun River Pipeline at Oporoma. Picture was taken during Joint Investigation of 16<sup>th</sup> October 2014.
