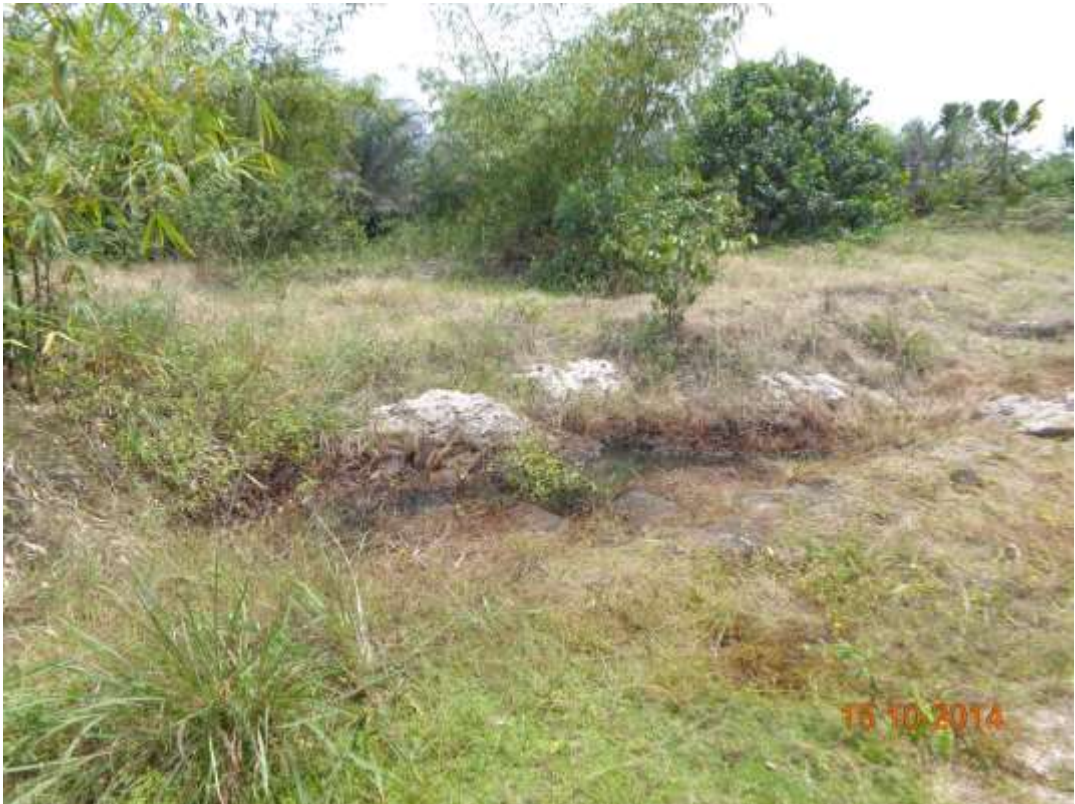
Overview: Part of spill impact on 28" Nkpoku – Bomu Pipeline at Gio. Picture was taken during Preliminary site visit of 15th October 2014.

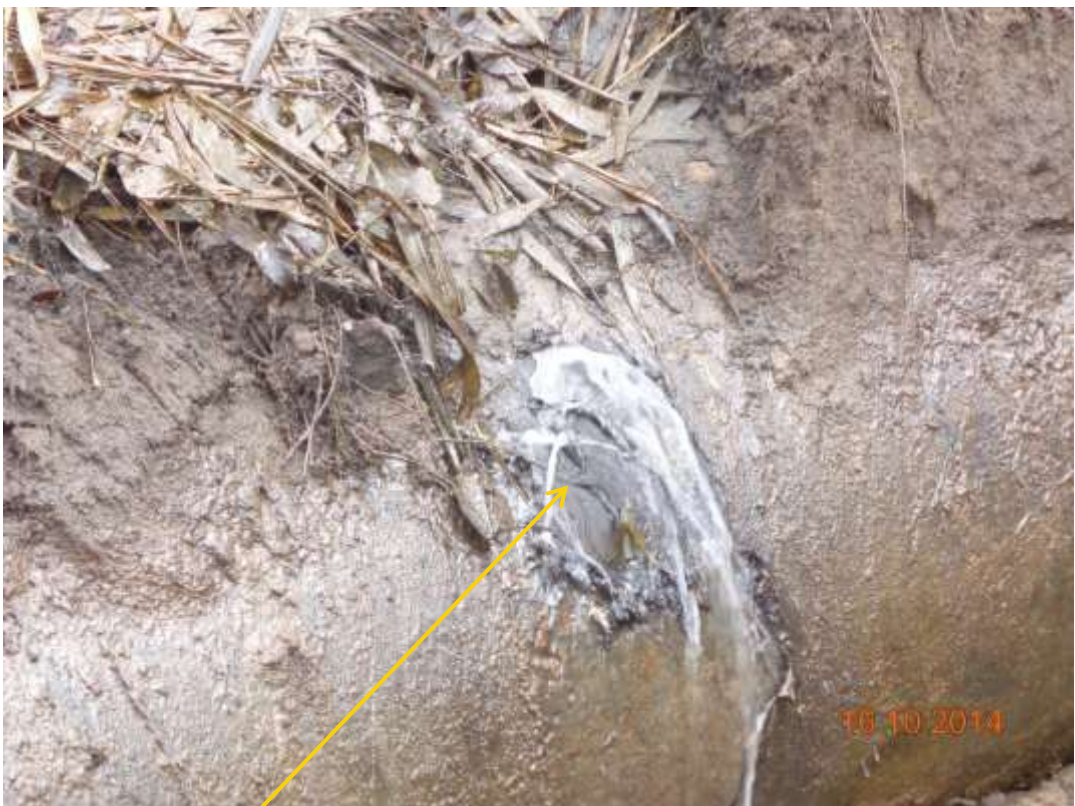
Close-up: Hacksaw Cut on 28" Nkpoku – Bomu Pipeline at Gio. Picture was taken during Joint Investigation of 16th October 2014.
