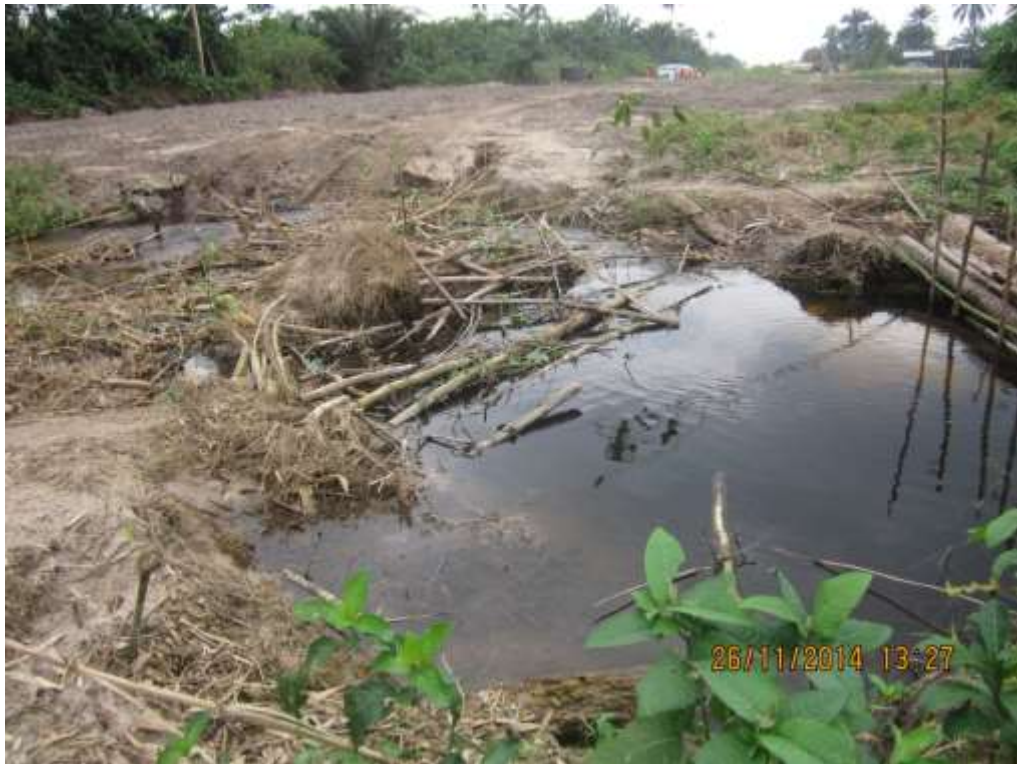
Overview: Part of spill impact on 28" Nkpoku-Bomu Pipeline Right of Way at Ekporo. Picture was taken during Joint Investigation of 26<sup>th</sup> November 2014.

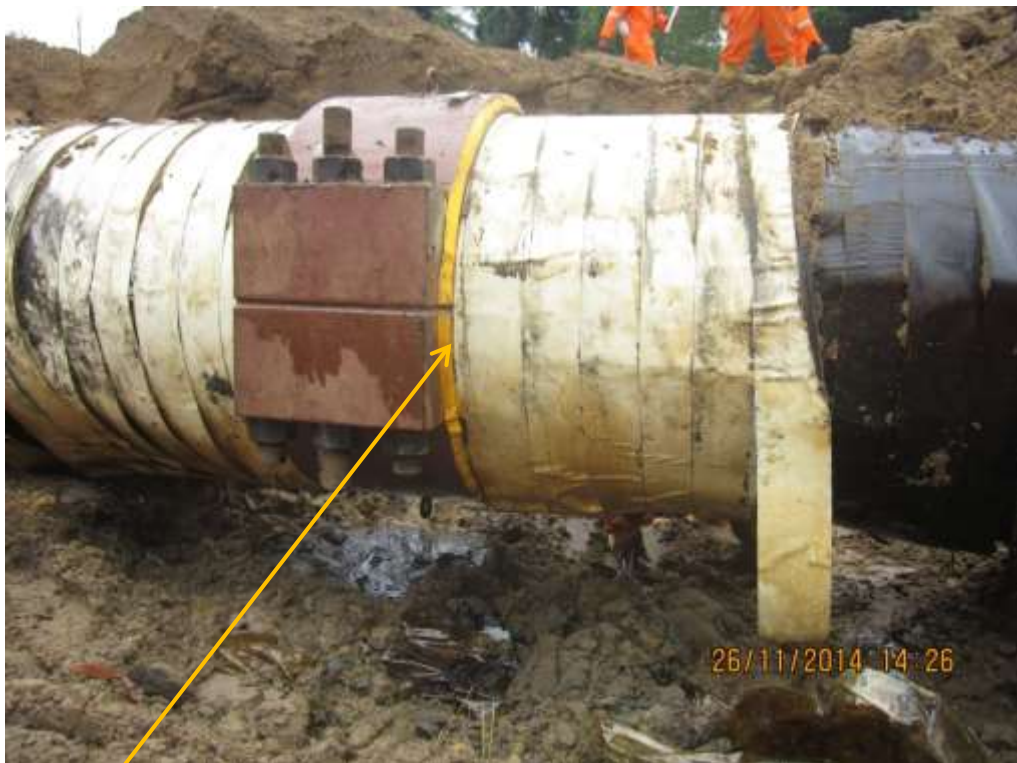
Close-up: Spill due to failed clamp on 28" Nkpoku-Bomu Pipeline at Ekporo. Picture was taken during Joint Investigation of 26<sup>th</sup> November 2014.
