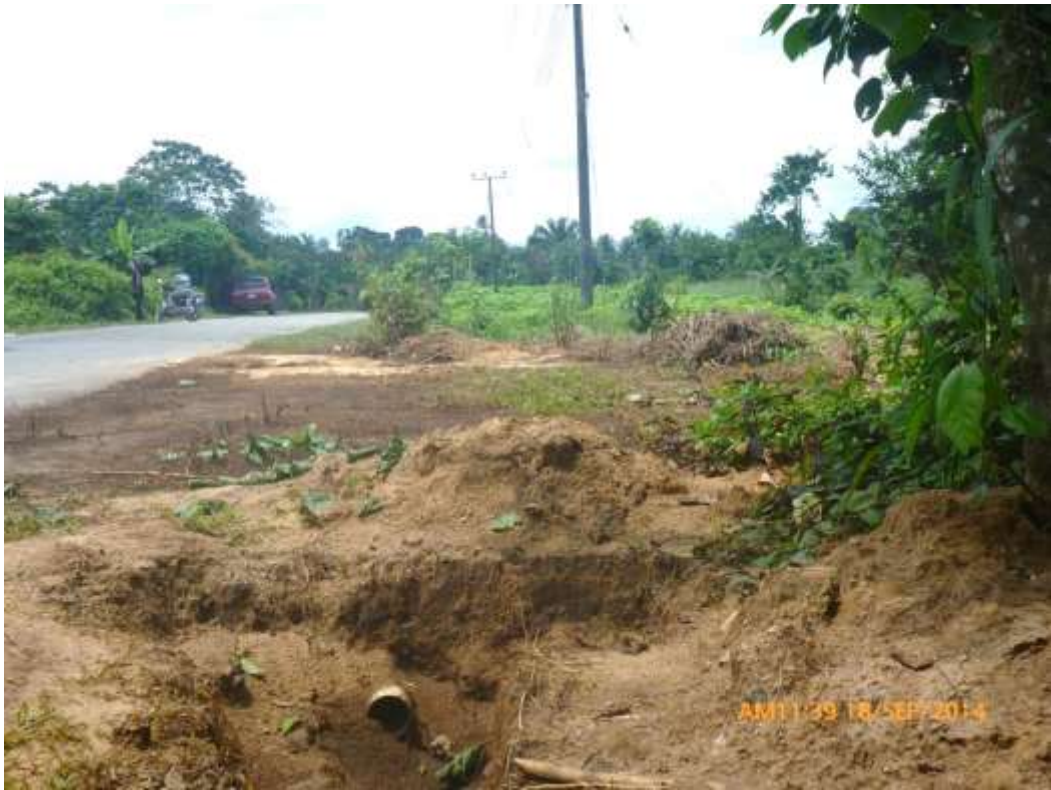
Overview: Part of spill impact on Ubie Well 4S Flowline Right of Way at Idu-Ekpeye. Picture was taken during Joint Investigation of 18th September 2014.

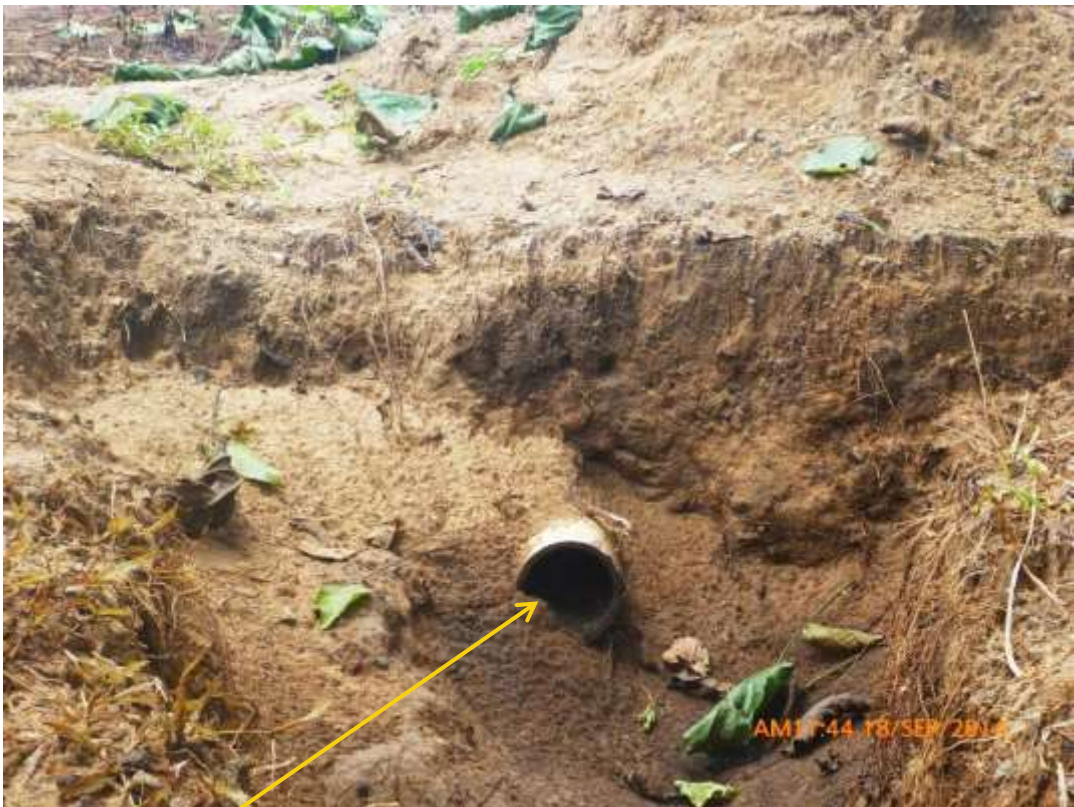
Close-up: Cut section of missing flowline on Ubie Well 4S Flowline at Idu-Ekpeye. Picture was taken during Joint Investigation of 18th September 2014.

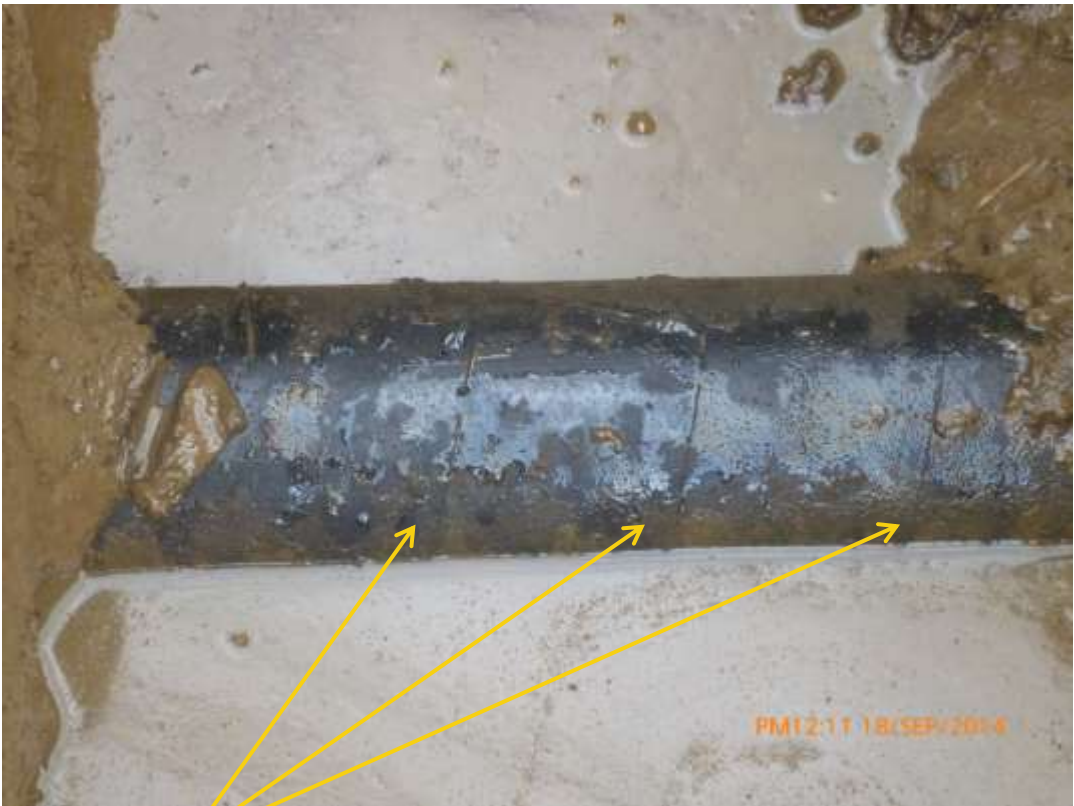
Close-up: Hacksaw cuts on Ubie Well 4S Flowline at Idu-Ekpeye. Picture was taken during Joint Investigation of 18th September 2014.
