JOINT INVESTIGATION REPORT

INCIDENT NO: 1459739 JIV report S/N:

1. Spill incident Number: 1459739 2. Type of incident* OIL SPILL
3. Name of Location 16" TUNU - BRASS CREEK PIPELINE
4. Name of nearest community AGBIDIAMA 5. State: BAYELSA 6. LGA EKEREMOR
7. Type of Production facility/Installation OIL PIPELINE
8. Asset owner/District THE SHELL PETROLEUM DEVELOPMENT COMPANY OF NIGERIA LIMITED / PIPELINE

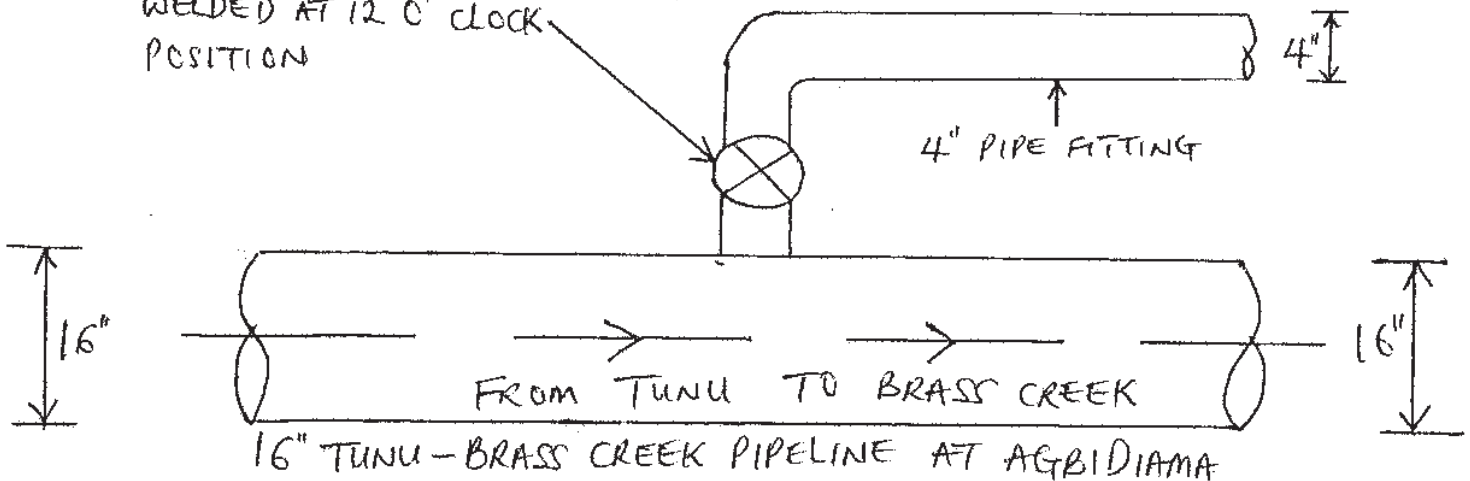
E. GRAPHIC DESCRIPTION OF LEAK POINT (while detail report of the leak point should be contained in the leak report, overview sketch of the site should be added as an appendix 1)

Additional observations around the spill point: ON EXCAVATION, A 4" ILLEGAL HOT-TAP VALVE (CONNECTED TO A 4" PIPE FITTING WAS OBSERVED WELDED) ON THE 16" TUNU - BRASS CREEK PIPELINE AT 12 O' CLOCK POSITION. THE LEAK WAS OBSERVED TO HAVE STOPPED AS AT THE TIME THE JOINT INVESTIGATION TEAM GOT TO SITE.

4" FAILED ILLEGAL HOT-TAP VALVE
 WELDED AT 12 O' CLOCK
 POSITION
