**THE SHELL PETROLEUM DEVELOPMENT COMPANY OF NIGERIA  
JOINT INVESTIGATION REPORT (SPDC)**

**INCIDENT NO: 1465510 JIV report S/N: N<sup>o</sup> 0000041**

1. Spill incident Number: 1465510 2. Type of incident\* OIL SPILL / FIRE  
 3. Name of Location 28" NKPOKU - BOMU PIPELINE  
 4. Name of nearest community G10 5. State: RIVERS 6. LGA GOKANA  
 7. Type of Production facility/Installation OIL PIPELINE  
 8. Asset owner/District THE SHELL PETROLEUM DEVELOPMENT COMPANY OF NIGERIA (SPDC)

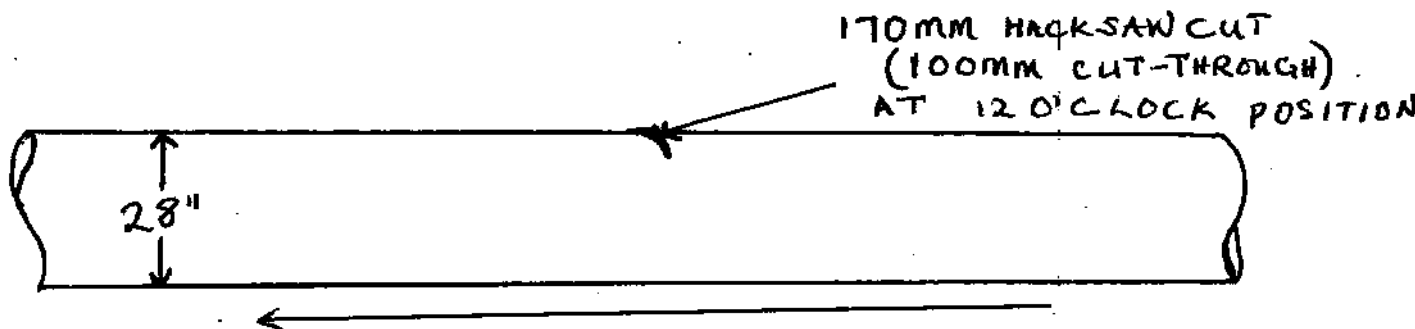
**E. GRAPHIC DESCRIPTION OF LEAK POINT** (while detail report of the leak point should be contained in the leak report, overview sketch of the site should be added as an appendix 1)

A SECTION OF 28" NKPOKU - BOMU PIPELINE AT G10, SHOWING A HUNDRED AND SEVENTY (170 MM) MILIMETRES HACKSAW CUT, AT 12 O'CLOCK POSITION, DONE BY UNKNOWN PERSONS

REPAIR BY CLAMPING
