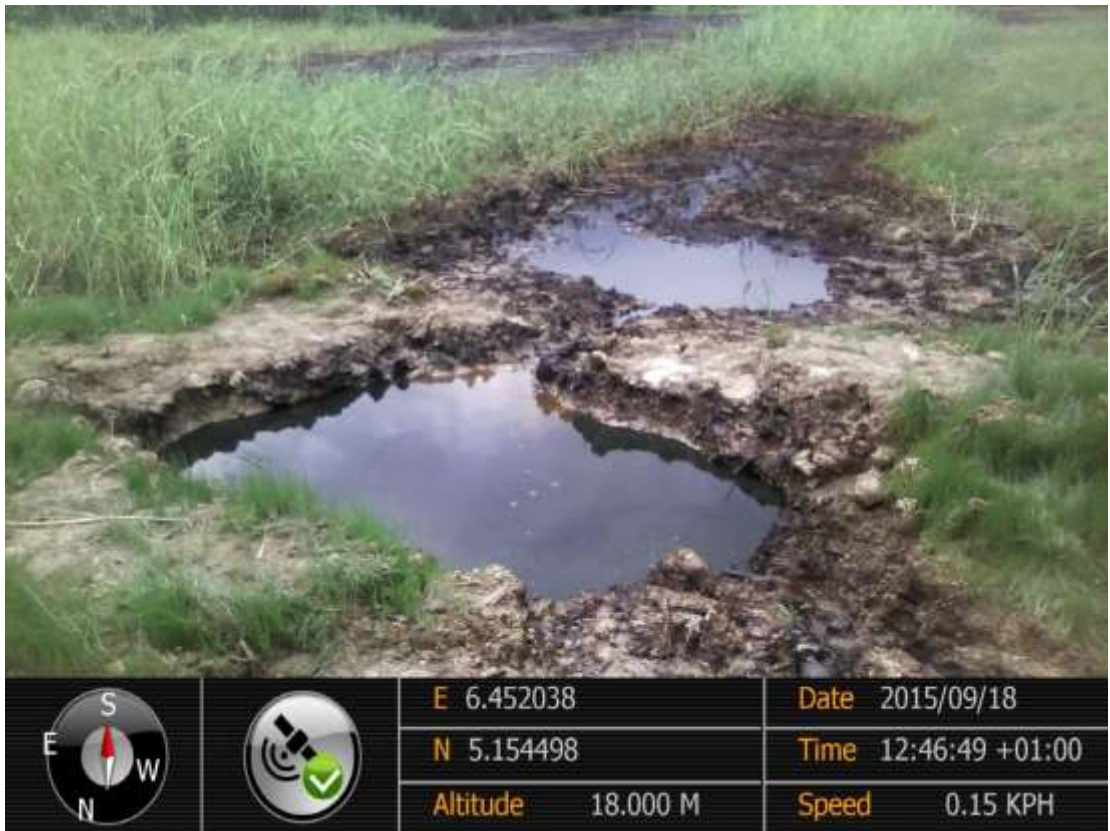
Overview: Part of spill impact on 12" Adibawa – Okordia Pipeline Right of Way at Ikarama. Picture was taken during Joint Investigation of 18th September 2015.

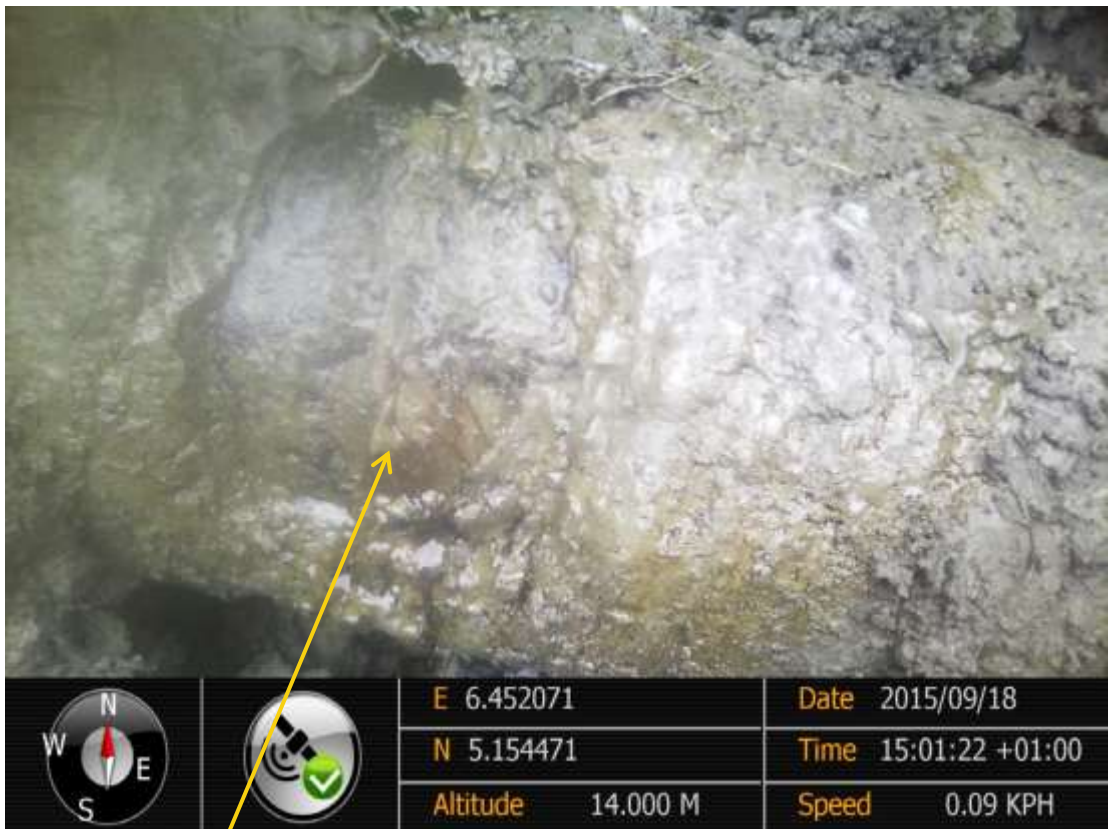
Close-up: Hacksaw cut on 12" Adibawa – Okordia Pipeline at Ikarama. Picture was taken during Joint Investigation of 18th September 2015.
