JOINT INVESTIGATION REPORT

INCIDENT NO: 1535875 JIV report S/N: Nº 0000092

1. Spill incident Number: 1535875 2. Type of incident* FIRE/OIL SPILL
3. Name of Location 28" BONNY - BONNY TRANS NIGER PIPELINE
4. Name of nearest community ANYAMINIMA - OLOMA 5. State: RIVERS 6. LGA BONNY
7. Type of Production facility/Installation OIL PIPELINE
8. Asset owner/District THE SHELL PETROLEUM DEVELOPMENT COMPANY OF NIG LTD

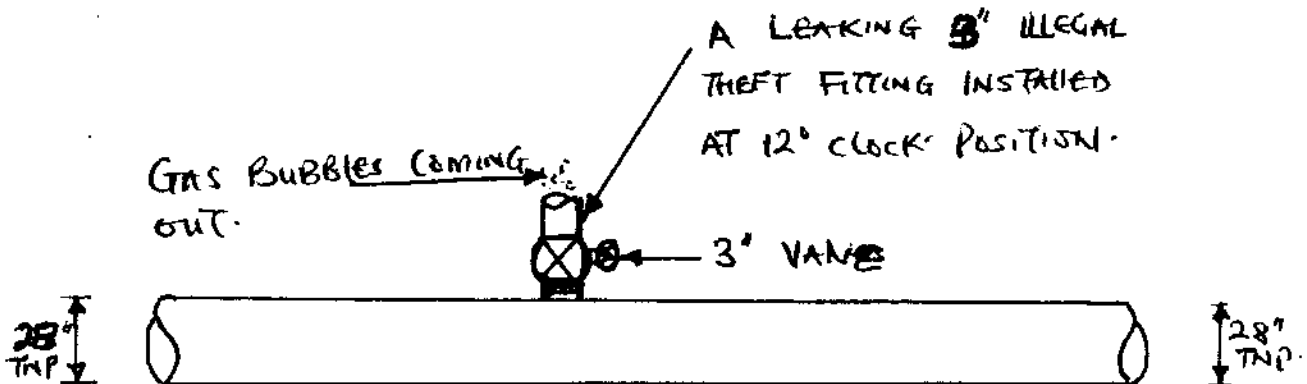
E. GRAPHIC DESCRIPTION OF LEAK POINT (while detail report of the leak point should be contained in the leak report, overview sketch of the site should be added as an appendix 1)

Additional observations around the spill point: AFTER EXCAVATION, THE JOINT INVESTIGATION TEAM OBSERVED GAS BUBBLES COMING OUT FROM THE ILLEGAL THEFT POINT.

| <input checked="" type="checkbox"/> Failed Weld-on illegal hot tap valve | <input type="checkbox"/> Failed Clamp, | <input type="checkbox"/> Missing Pipeline/Flowline |
| <input checked="" type="checkbox"/> Crude oil theft (illegal bunkering) point. | <input type="checkbox"/> Saver-pit over flow | <input type="checkbox"/> Third party tampering with Clamp |

SECTION OF 28" BOMU - BONNY TRAKA NIGER PIPELINE AT ANYAMINIMA - OLOMA SHOWING A FAILED WEED-ON ILLEGAL THEFT POINT.

RECOVERY WORK COMPLETED WHILE
REPAIR WORK PLANNED.
