# JOINT INVESTIGATION REPORT

INCIDENT NO: 1540528 JIV report S/N: Nº 0000111

1. Spill incident Number: 1540528 2. Type of incident\* OIL SPILL  
3. Name of Location 20" Rumuekpe - Akpoku PIPELINE  
4. Name of nearest community OMUKPOBU IBAA 5. State: RIVERS 6. LGA EMOHUA  
7. Type of Production facility/Installation OIL PIPELINE  
8. Asset owner/District SPDC / PIPELINE

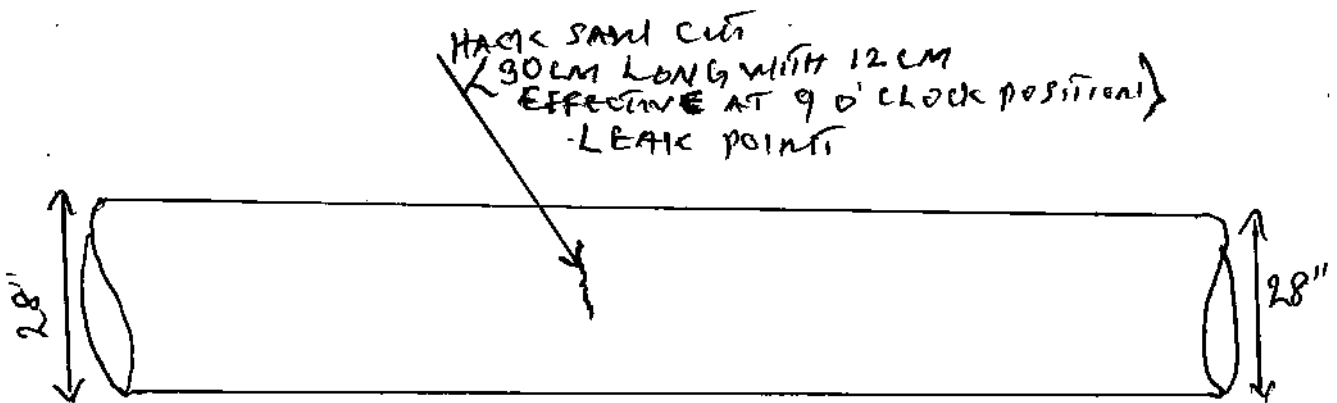
SECTION OF 20" RUMUEKPE - NKPOKU PIPELINE AT OMIKPOBU IBAA SHOWING POSITION OF HACK SAW CUT AT 9 O'CLOCK POSITION.

FROM RUMUEKPE TO NKPOKU

REPAIR ON THE AFFECTED SECTION OF PIPELINE WAS DONE BY CLAMPING. PLANNED TO BE
