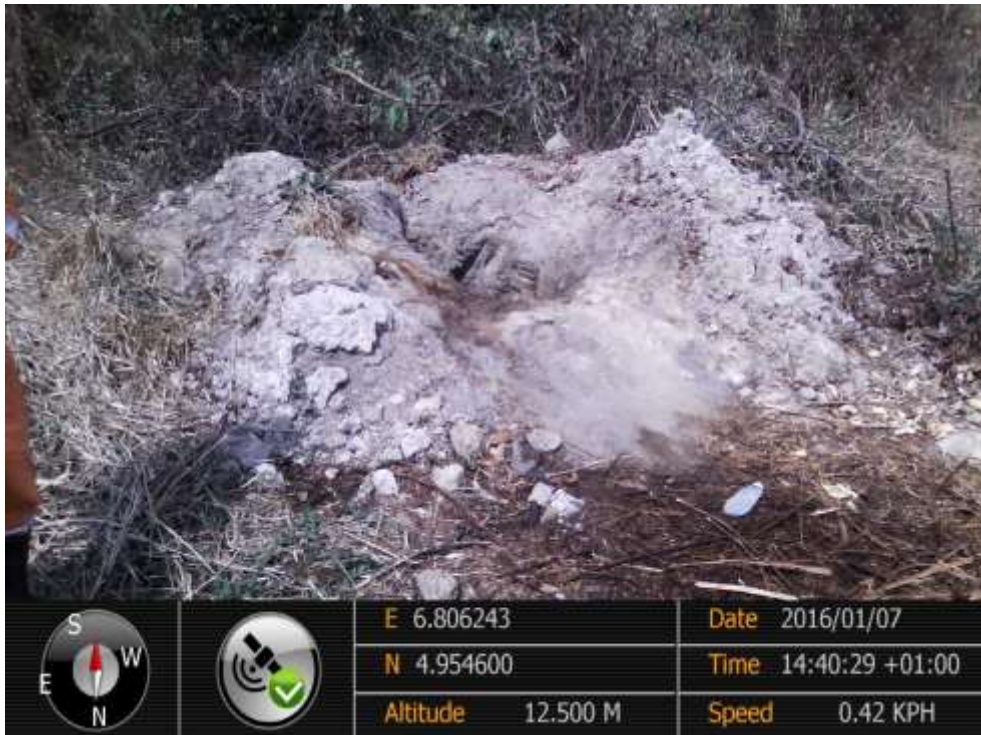
Overview: Part of spill impact on 20" Rumuekpe – Nkpoku Pipeline Right of Way at Omukpobu-Ibaa. Picture was taken during Joint Investigation of 7<sup>th</sup> January 2016.

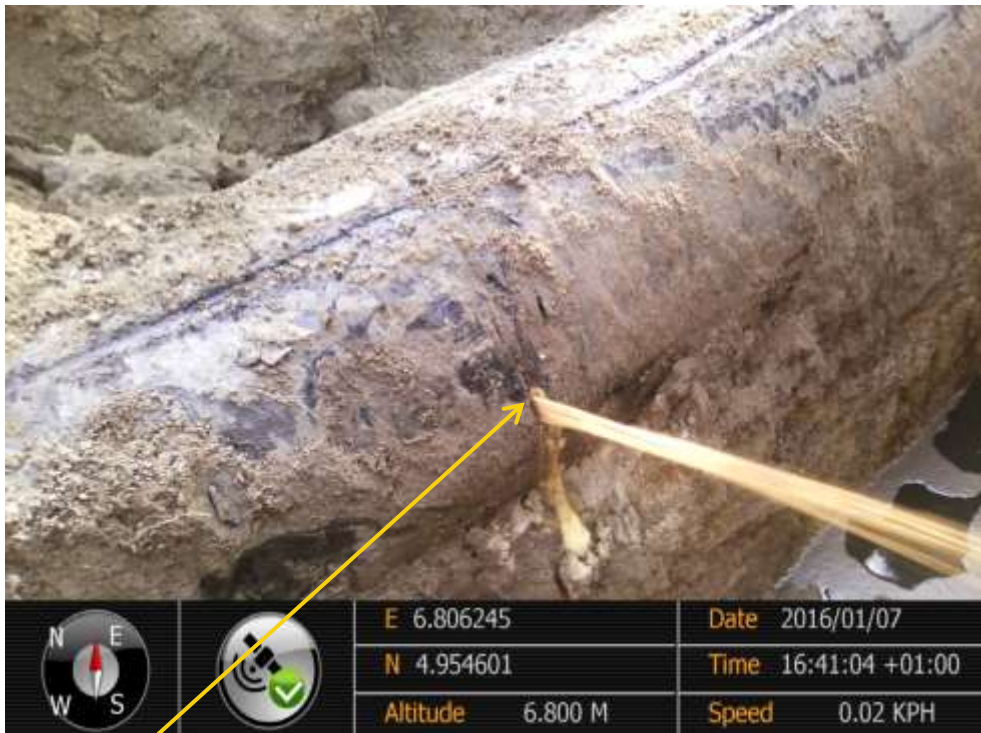
Close-up: Hacksaw cut on 20" Rumuekpe – Nkpoku Pipeline at Omukpobu-Ibaa. Picture was taken during Joint Investigation of 7<sup>th</sup> January 2016.
