JOINT INVESTIGATION REPORT

INCIDENT NO: 1448303 JIV report S/N: Nº 000033

1. Spill incident Number: 1448303 2. Type of incident* OIL SPILL
3. Name of Location NKALI WELL 10L FLOWLINE
4. Name of nearest community ODAGWA-2 5. State: RIVERS 6. LGA ETCHE
7. Type of Production facility/Installation OIL FLOWLINE
8. Asset owner/District THE SHELL PETROLEUM DEVELOPMENT COMPANY OF NIGERIA LIMITED / LAND 1

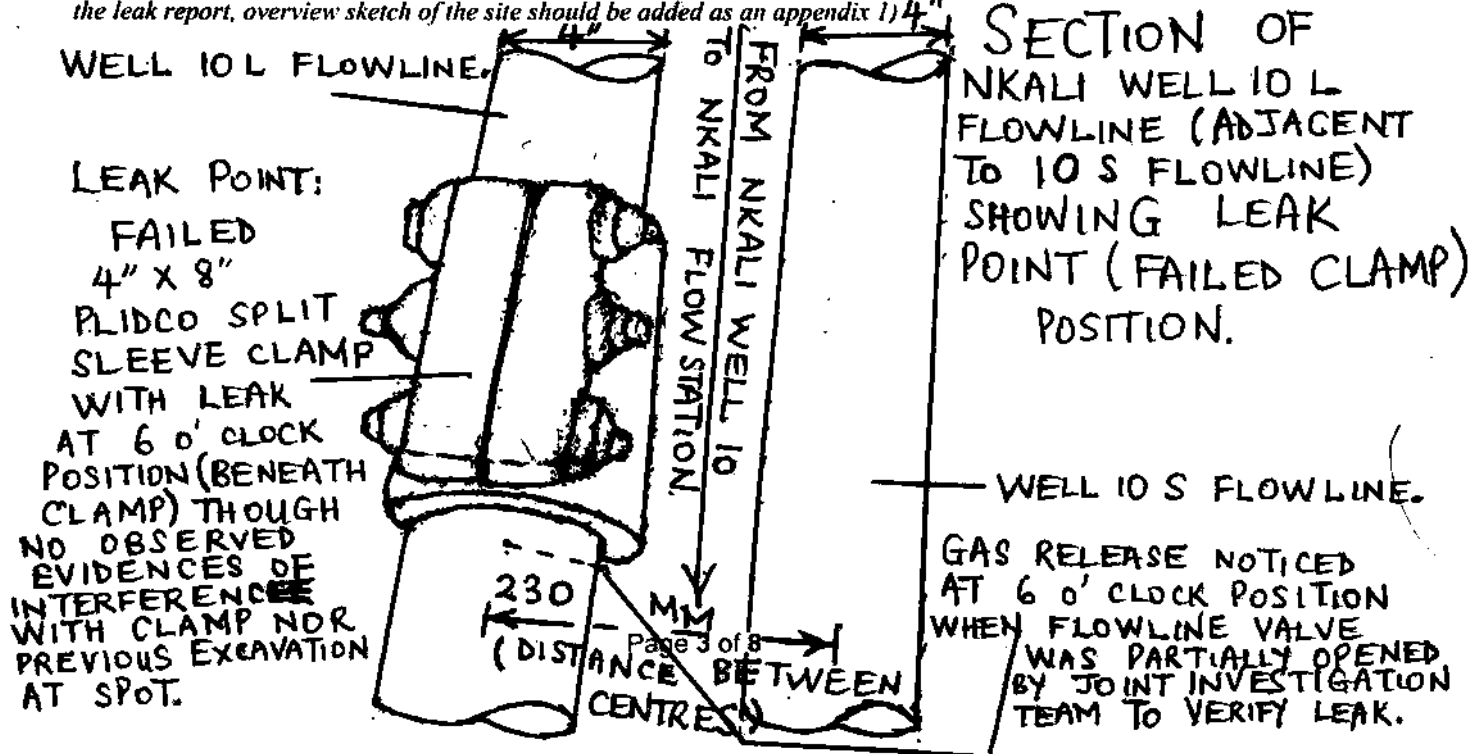
E. GRAPHIC DESCRIPTION OF LEAK POINT (while detail report of the leak point should be contained in the leak report, overview sketch of the site should be added as an appendix 1) 4"

Additional observations around the spill point: **THE JOINT INVESTIGATION TEAM OBSERVED THE SPILL POINT TO BE AT A STRAIGHT LINE DISTANCE OF APPROXIMATELY 69.5 METRES FROM THE WELL 10 LOCATION. THE TEAM ALSO NOTICED A SMALL CRACK ON THE EARTH AT THE SPILL POINT ON ARRIVAL AT SITE UPON EXCAVATION AROUND SPILL POINT DURING JIV AND IN THE COURSE OF SLIGHTLY OPENING A FLOWLINE SAFETY VALVE BETWEEN WELLHEAD AND SPILL POINT TO IDENTIFY LEAK GAS WAS RELEASED BENEATH AN EXISTING FAILED CLAMP.**

| <input type="checkbox"/> Failed Weld-on illegal hot tap valve | <input checked="" type="checkbox"/> Failed Clamp, | <input type="checkbox"/> Missing Pipeline/Flowline |
