INCIDENT NO: 1449239 JIV report S/N:

(Note: As practicable as possible the JIT report is to be signed in the field by all the participating parties) A. GENERAL INFORMATION: 239 2.Type of incident\* OIL SPILL 1. Spill incident Number: UMARA - ESCRAVOS PIPELINE 4. Name of nearest community OGIDI GBEN 5. State: DELTA 6. LGA WARRI SOUTH-WEST 7. Type of Production facility/Installation OIL PIPELINE 8. Asset owner/District THE SHELL PETROLEUM DEVELOPMENT COMPANY

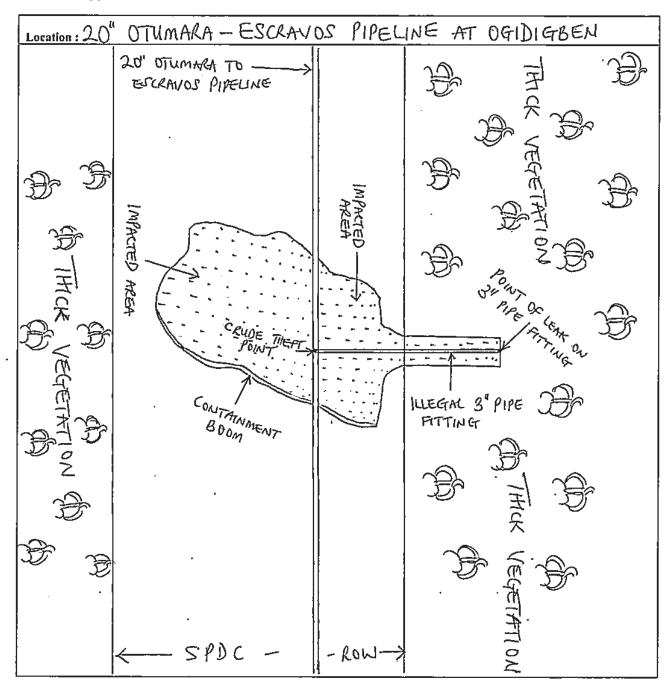
f. Appendix 1: Overview sketch of the site

19. Others (Specify) i.e. Animal Traps	
S/N Others Description	Quantity/Size Comments
HONE WITHN	AREA OF IMPACT
E. GRAPHIC DESCRIPTION OF LEAK POINT (while the leak report, overview sketch of the site should be added to	e detail report of the leak point should be contained in is an appendix 1)
4" FAILED ILLEGAL HOT-TAP VALVE	
WELDED AT 12 0' CLOCK	$\delta \hat{\downarrow}^2$
POSITION	
	3" ILLEGAL PIPE FITTING
—————————————————————————————————————	26"
FROM OTUMARA	
20" OTUMARA - ESCRAVOS PI Page 3	PELINE AT DGIDIGBEN
