# JOINT INVESTIGATION REPORT

INCIDENT NO: 1413604 JIV report S/N: Nº 000025

1. Spill incident Number: 1413604 2. Type of incident\* OIL SPILL  
3. Name of Location 28" NKPOKU - BOMU PIPELINE  
4. Name of nearest community B-DERE 5. State: RIVERS 6. LGA GOKANA  
7. Type of Production facility/Installation OIL PIPELINE  
8. Asset owner/District THE SHELL PETROLEUM DEVELOPMENT COMPANY OF NIGERIA LTD

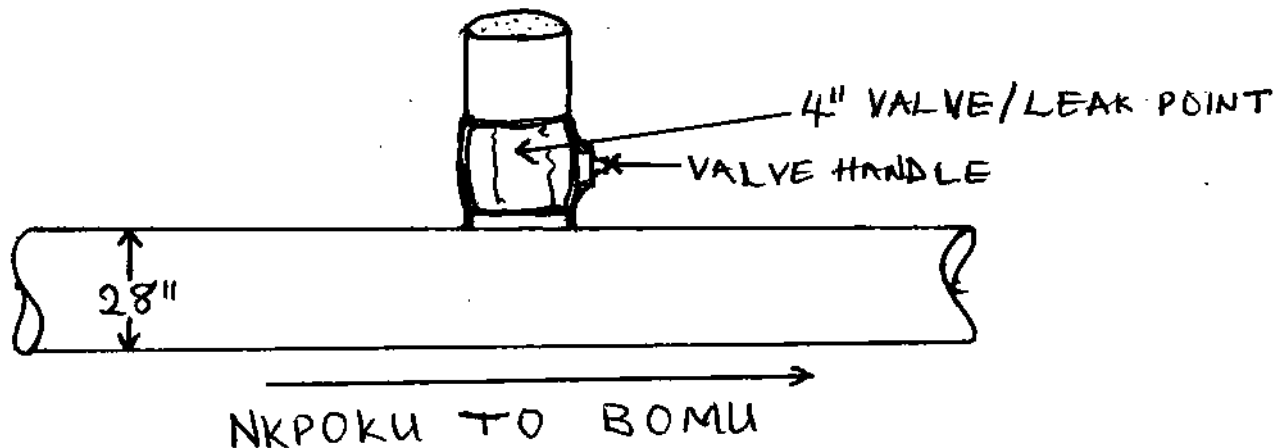
SECTION OF 28" NKPOKU - BOMU PIPELINE AT B-DERE SHOWING 4" VALVE CRUDE THEFT POINT INSTALLED AT 12 O'CLOCK POSITION

RER REPAIR BY CLAMPING
