THE SHELL PETROLEUM DEVELOPMENT COMPANY OF NIGERIA LIMITED.

JOINT INVESTIGATION REPORT FOR INCIDENT NO: 1354630 JIV report S/N: 00850

1. Spill incident Number: 1354630 2. Type of incident\* OIL SPILL  
3. Name of Location 28" BOMU - BONNY TRANS NIGER PIPELINE  
4. Name of nearest community BODO WRET 5. State: RIVERS 6. LGA GOKANA  
7. Type of Production facility/Installation OIL PIPELINE 8. Asset owner/District PIPELINE / SWAMP <sup>OGONI</sup>

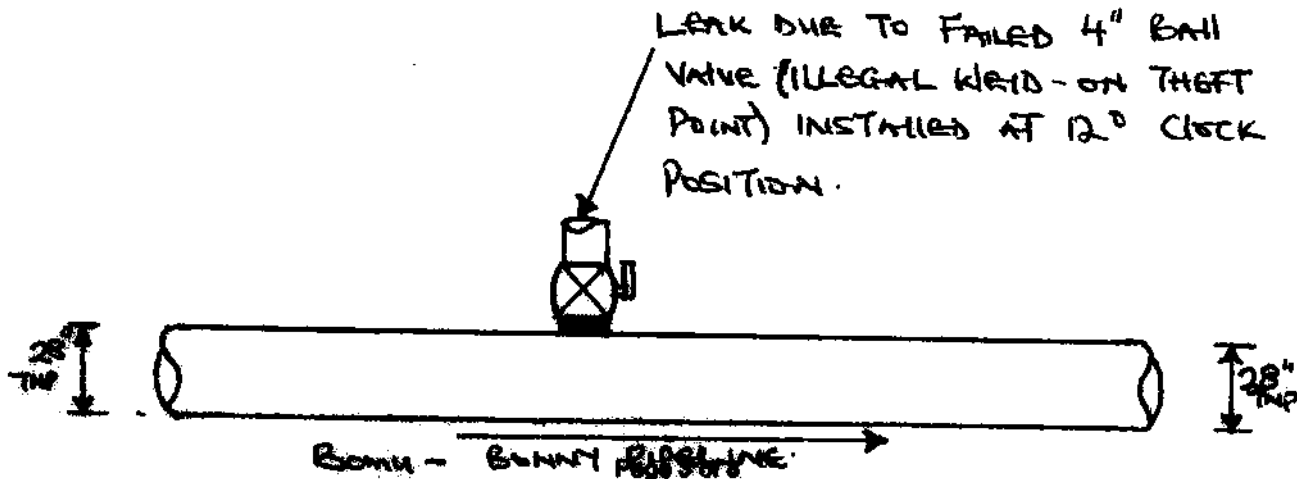
E. GRAPHIC DESCRIPTION OF LEAK POINT (while detail report of the leak point should be contained in the leak report, overview sketch of the site should be added as an appendix 1)

| <input checked="" type="checkbox"/> Failed Weld-on illegal hot tap valve, | <input type="checkbox"/> Failed Clamp | <input type="checkbox"/> Missing Pipeline/Flowline |
| <input checked="" type="checkbox"/> Crude oil theft (illegal bunkering) point, | | <input type="checkbox"/> Third party tampering with Clamp |

SECTIONAL VIEW OF 28" BONNY - BONNY TRANS NIGER PIPELINE AT BODO

WEST. SHOWING :- FAILED WELD - ON ILLEGAL THEFT POINT.

If yes to item 14, give brief description: REPAIR WORK BY CLAMPING IS PLANNED FOR NEXT DAY.
