JOINT INVESTIGATION REPORT

1. Spill incident Number: 1402479 2. Type of incident* OIL SPILL
3. Name of Location 12" IMP RIVER - OGALE PIPELINE
4. Name of nearest community KOMKOM 5. State: RIVERS 6. LGA OTIGBO
7. Type of Production facility/Installation OIL PIPELINE
8. Asset owner/District SPDC (PIPELINE/PNPE)

SECTION OF 12" IMO RIVER - OGALE PIPELINE AT KOMKONG
SHOWING 4 NOS OF CRUDE OIL THEFT POINTS AT 12 O'CLOCK POSITION ON:

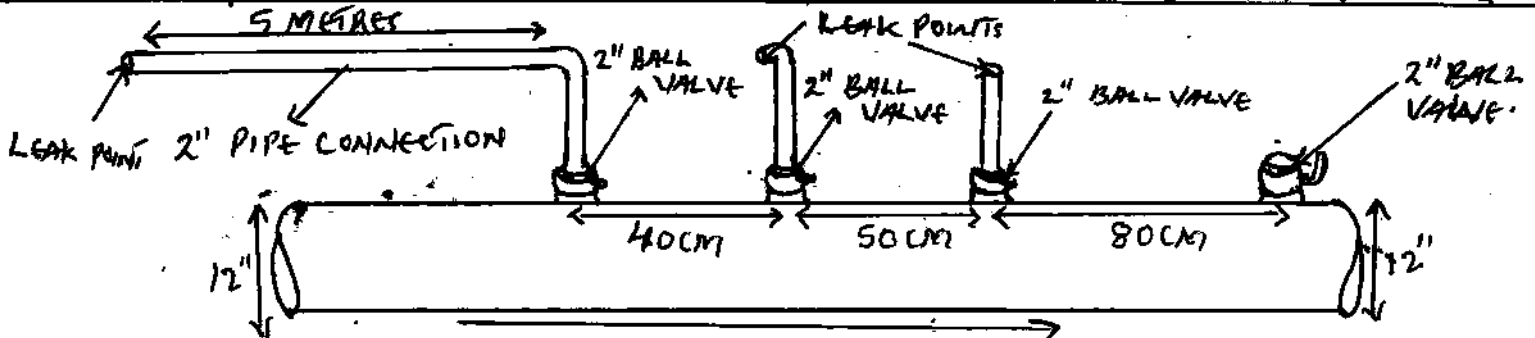
| <input checked="" type="checkbox"/> Failed Weld-on illegal hot tap valve | <input type="checkbox"/> Failed Clamp, | <input type="checkbox"/> Missing Pipeline/Flowline |
| <input checked="" type="checkbox"/> Crude oil theft (illegal bunkering) point, | <input type="checkbox"/> Saver-pit over flow | <input type="checkbox"/> Third party tampering with Clamp |

FROM IMO RIVER TO OGALE

RECOVERY AND REPAIR ACTIVITIES
ARE ON GOING.
