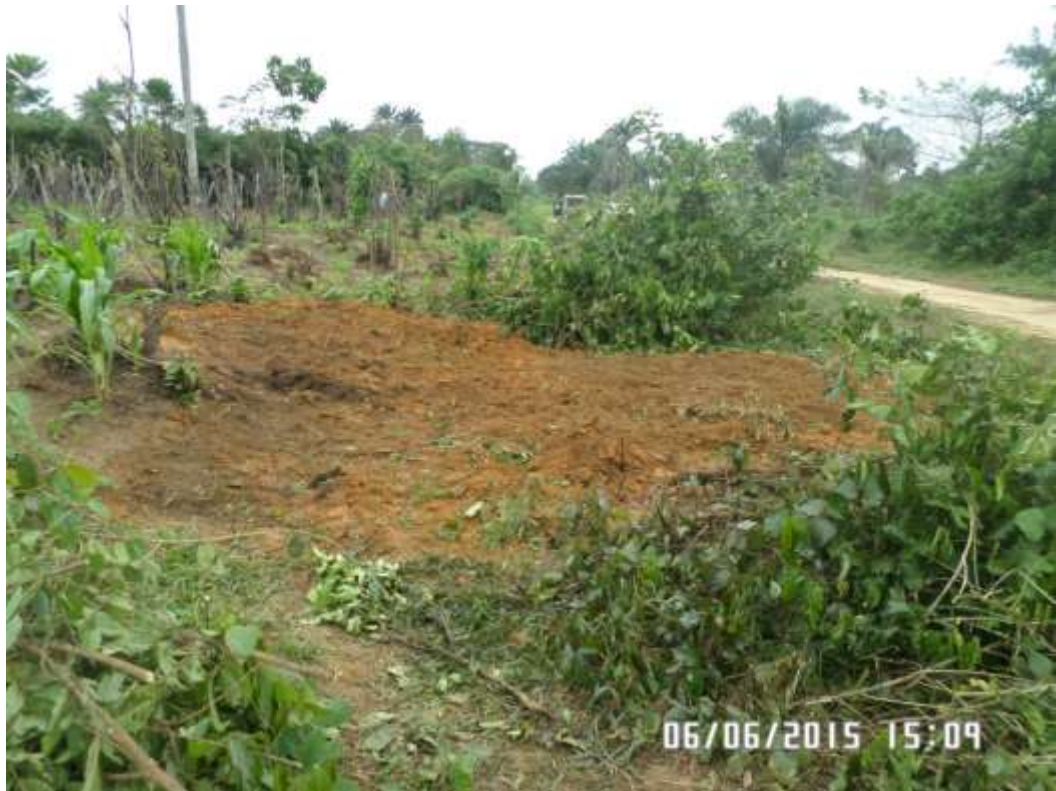
Overview: Part of spill impact on 6" Obigbo – North Ogale Pipeline Right of Way at Ogale. Picture was taken during Joint Investigation of 6th June 2015.

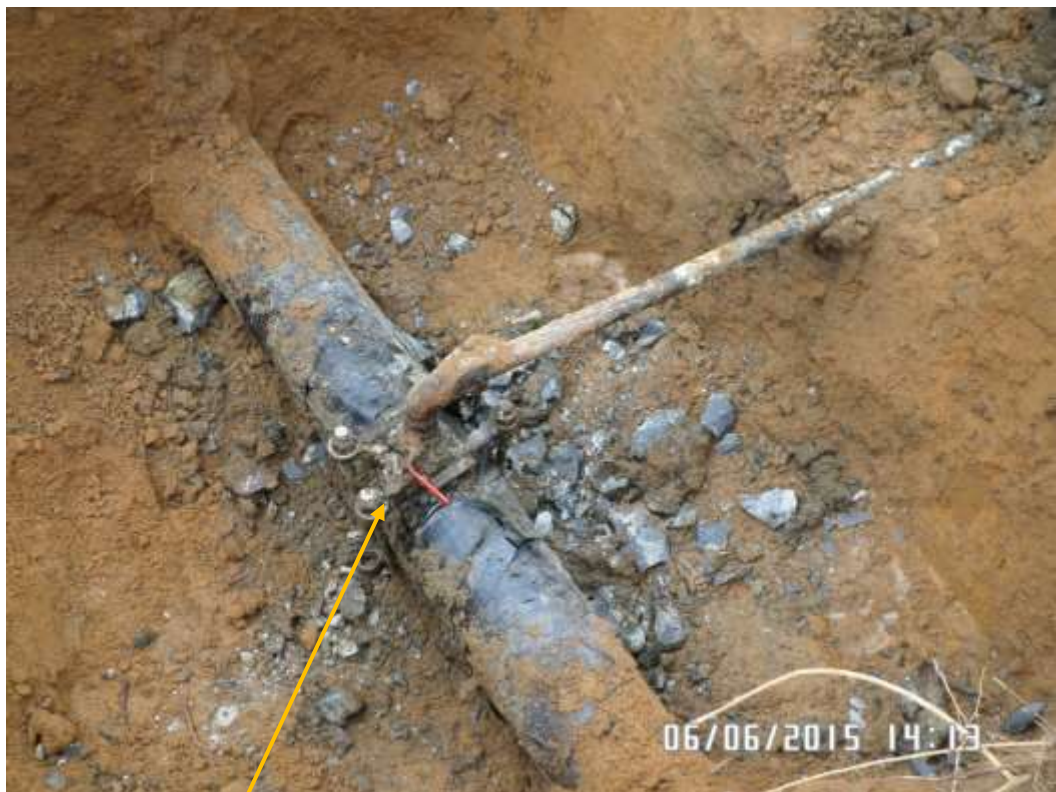
Close-up: Illegal fitting on 6" Obigbo – North Ogale Pipeline at Ogale. Picture was taken during Joint Investigation of 6th June 2015.
