JOINT INVESTIGATION REPORT

INCIDENT NO: 1520850 JIV report S/N: Nº 0000392

1. Spill incident Number: 1520850 2. Type of incident* OIL/CHEMICAL SPILL
3. Name of Location FORCADOS TERMINAL FOAM STATION A-901
4. Name of nearest community OGULAGHA 5. State: DELTA 6. LGA BURUTU
7. Type of Production facility/Installation FOAM CHEMICAL LINE
8. Asset owner/District THE SHELL PETROLEUM DEVELOPMENT COMPANY OF NIGERIA LIMITED /SWAMP WEST.

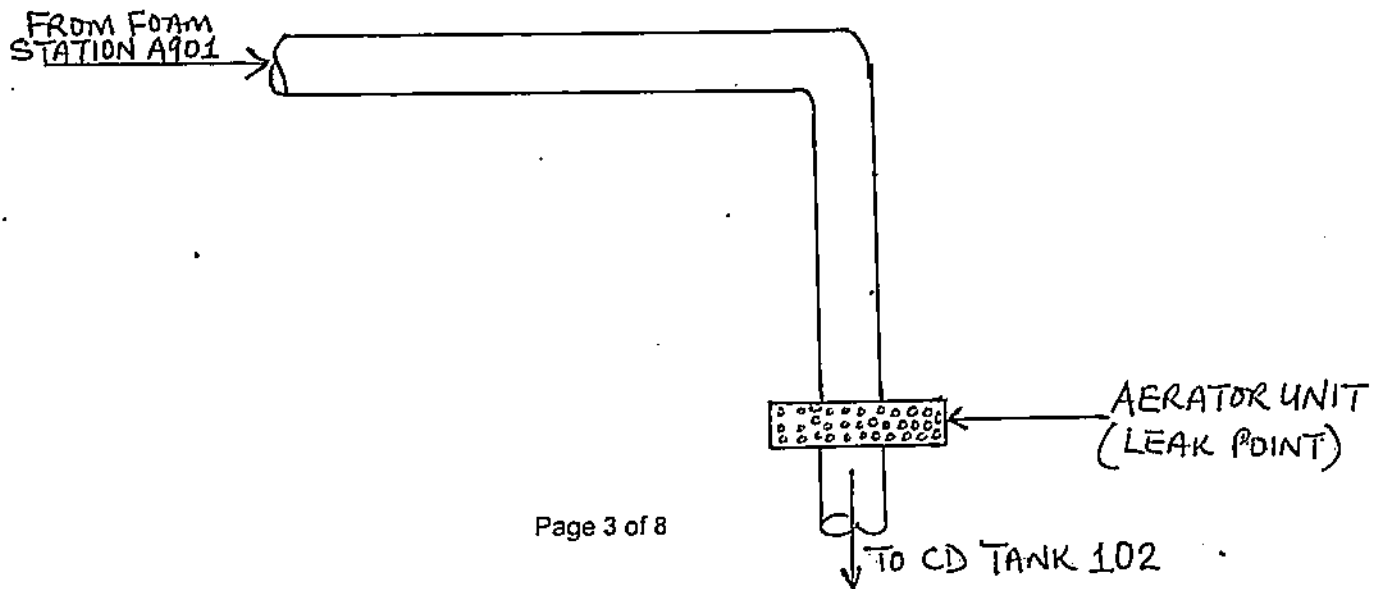
E. GRAPHIC DESCRIPTION OF LEAK POINT (while detail report of the leak point should be contained in the leak report, overview sketch of the site should be added as an appendix 1)

Additional observations around the spill point: ON ARRIVAL AT SITE, WE OBSERVED THAT THE LEAK POINT IS ABOUT 0.5m ABOVE GROUND LEVEL. THE J.I.T. ESTABLISHED THAT THE LEAK WAS AS A RESULT OF CHECK VALVE FAILURE FROM THE FIRE FOAM CHEMICAL AERATOR LINE.

SECTION OF FIRE FOAM COMPOUND LINE SHOWING THE AERATOR UNIT.
