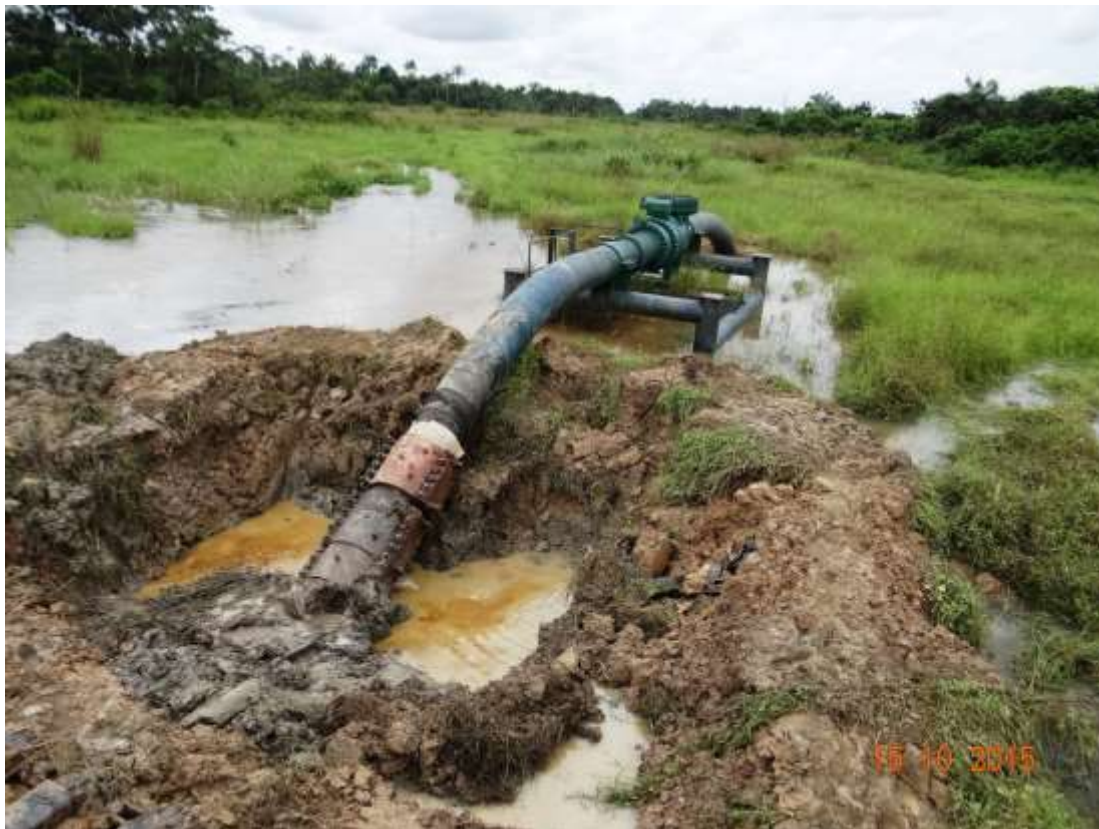
Overview: Part of spill impact on 20" KoloCreek – Rumuekpe Pipeline Right of Way at Aminigboko. Picture was taken during Joint Investigation of 15<sup>th</sup> October 2015.

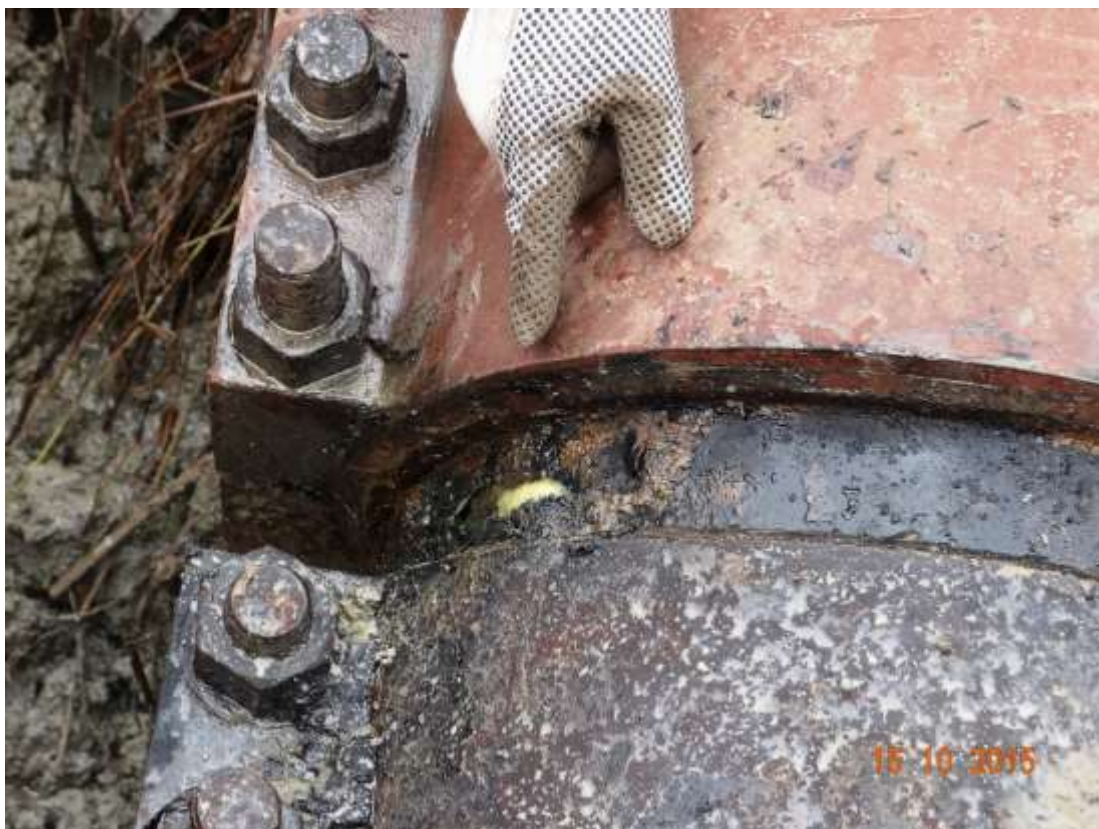
Close-up: Failed clamp on 20" KoloCreek – Rumuekpe Pipeline at Aminigboko. Picture was taken during Joint Investigation of 15<sup>th</sup> October 2015.
