JOINT INVESTIGATION REPORT

INCIDENT NO: 1504299 JIV report S/N: Nº 0000382

1. Spill incident Number: 1504299 2. Type of incident* OIL SPILL
3. Name of Location 6" YOKRI MANIFOLD-1 DISUSED FLOWLINE TO CLUSTER-95
4. Name of nearest community OBOTOBO 5. State: DELTA 6. LGA BURUTU
7. Type of Production facility/Installation FLOWLINE
8. Asset owner/District THE SHELL PETROLEUM DEVELOPMENT COMPANY OF NIGERIA LIMITED / SWAMP WEST

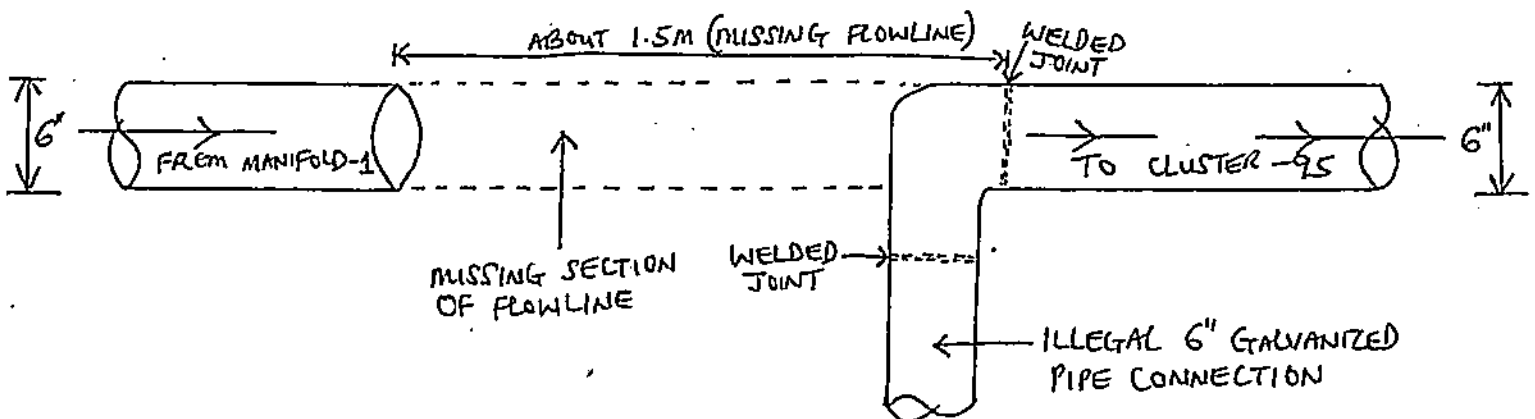
Additional observations around the spill point: ON EXCAVATION, THE JOINT INVESTIGATION TEAM OBSERVED A 1.5m MISSING LENGTH OF FLOWLINE REMOVED BY UNKNOWN PERSON(S), WITH A 6" ILLEGAL PIPE CONNECTION AT ONE OF THE TWO CUT ENDS.

SECTION OF YOKRI MANIFOLD-1 DISUSED FLOWLINE TO CLUSTER-95 AT OBOTOBO SHOWING 1.5M MISSING LENGTH OF FLOWLINE AND 6" ILLEGAL PIPE CONNECTION
