JOINT INVESTIGATION REPORT

INCIDENT NO: 1514020 JIV report S/N: Nº 0000096

1. Spill incident Number: 1514020 2. Type of incident* OIL SPILL
3. Name of Location IMO RIVER 3 WELL 33 L FLOWLINE
4. Name of nearest community IPI WEST 5. State: ABIA 6. LGA UKWA WEST
7. Type of Production facility/Installation OIL FLOWLINE
8. Asset owner/District THE SHELL PETROLEUM DEVELOPMENT COMPANY OF NIGERIA LIMITED / LAND 1

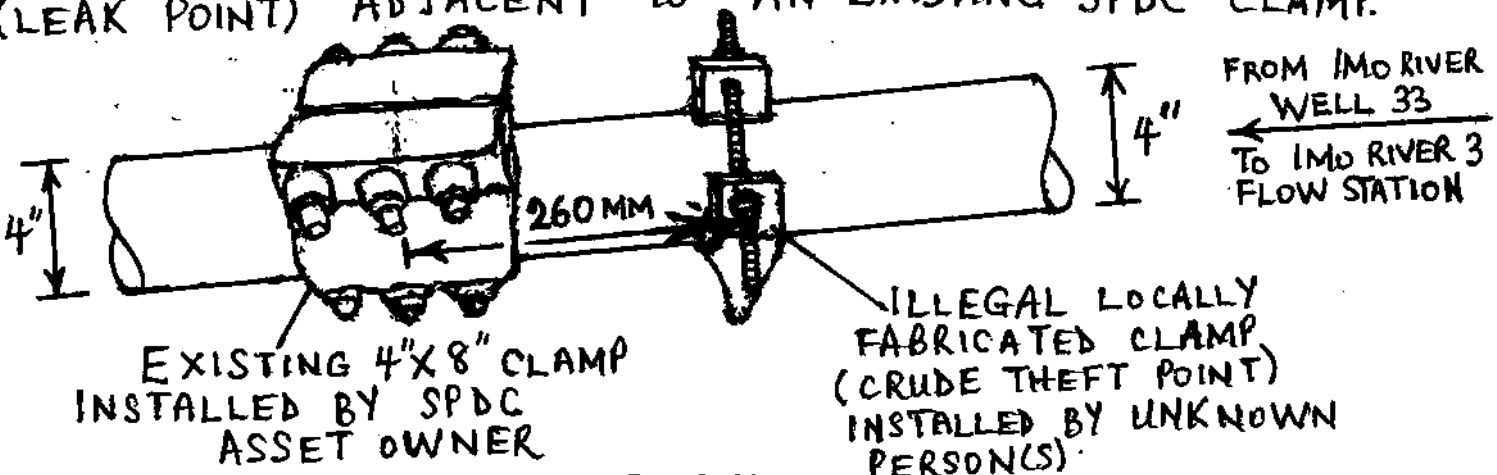
Additional observations around the spill point: BUBBLES WERE OBSERVED AT THE LEAK POINT WHEN THE JOINT INVESTIGATION TEAM ARRIVED SITE. ADJACENT TO THE LEAK POINT WAS AN EXISTING CLAMP PREVIOUSLY INSTALLED BY THE SPDC ASSET OWNER.

SECTION OF IMO RIVER 3 WELL 33 L FLOW LINE AT IPU WEST SHOWING A LOCALLY FABRICATED CLAMP (LEAK POINT) ADJACENT TO AN EXISTING SPDC CLAMP.
