# JOINT INVESTIGATION REPORT

INCIDENT NO: 1479080 JIV report S/N: Nº 000055

1. Spill incident Number: 1479080 2. Type of incident\* OIL SPILL  
3. Name of Location DIEBM CREEK FLOWSTATION 24" FLAREHEAD LINE  
4. Name of nearest community PEREMABIA 5. State: BAYELGA 6. LGA SOUTHERN ISAW  
7. Type of Production facility/Installation FLOWSTATION/FLAREHEAD LINE  
8. Asset owner/District SPDC / LAND 2.

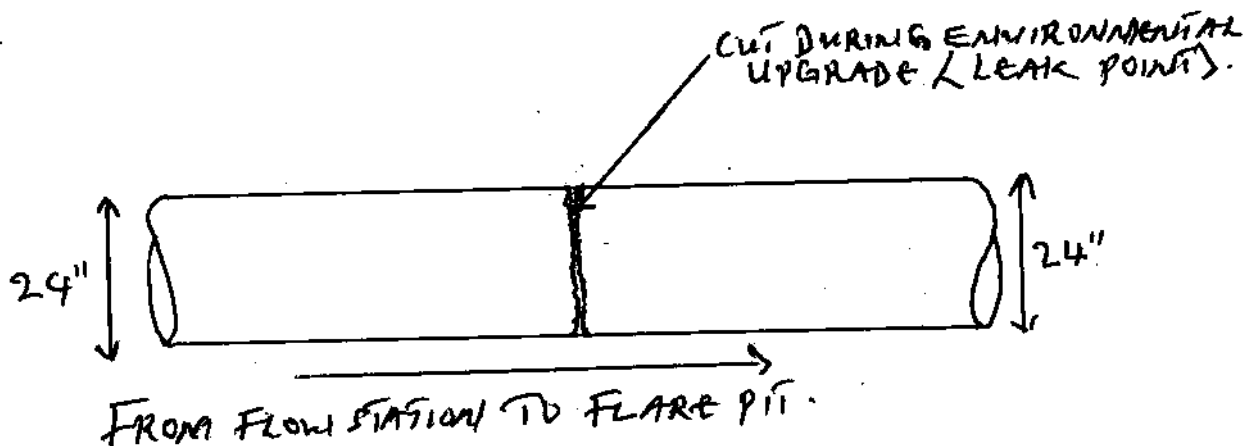
**E. GRAPHIC DESCRIPTION OF LEAK POINT** (while detail report of the leak point should be contained in the leak report, overview sketch of the site should be added as an appendix 1)

SECTION OF DIEB CREEK FLOW STATION 24" FLARE HEAD LINE AT PEREMABIAI SHOWING THE CUT DUE TO ENVIRONMENTAL UPGRADE.

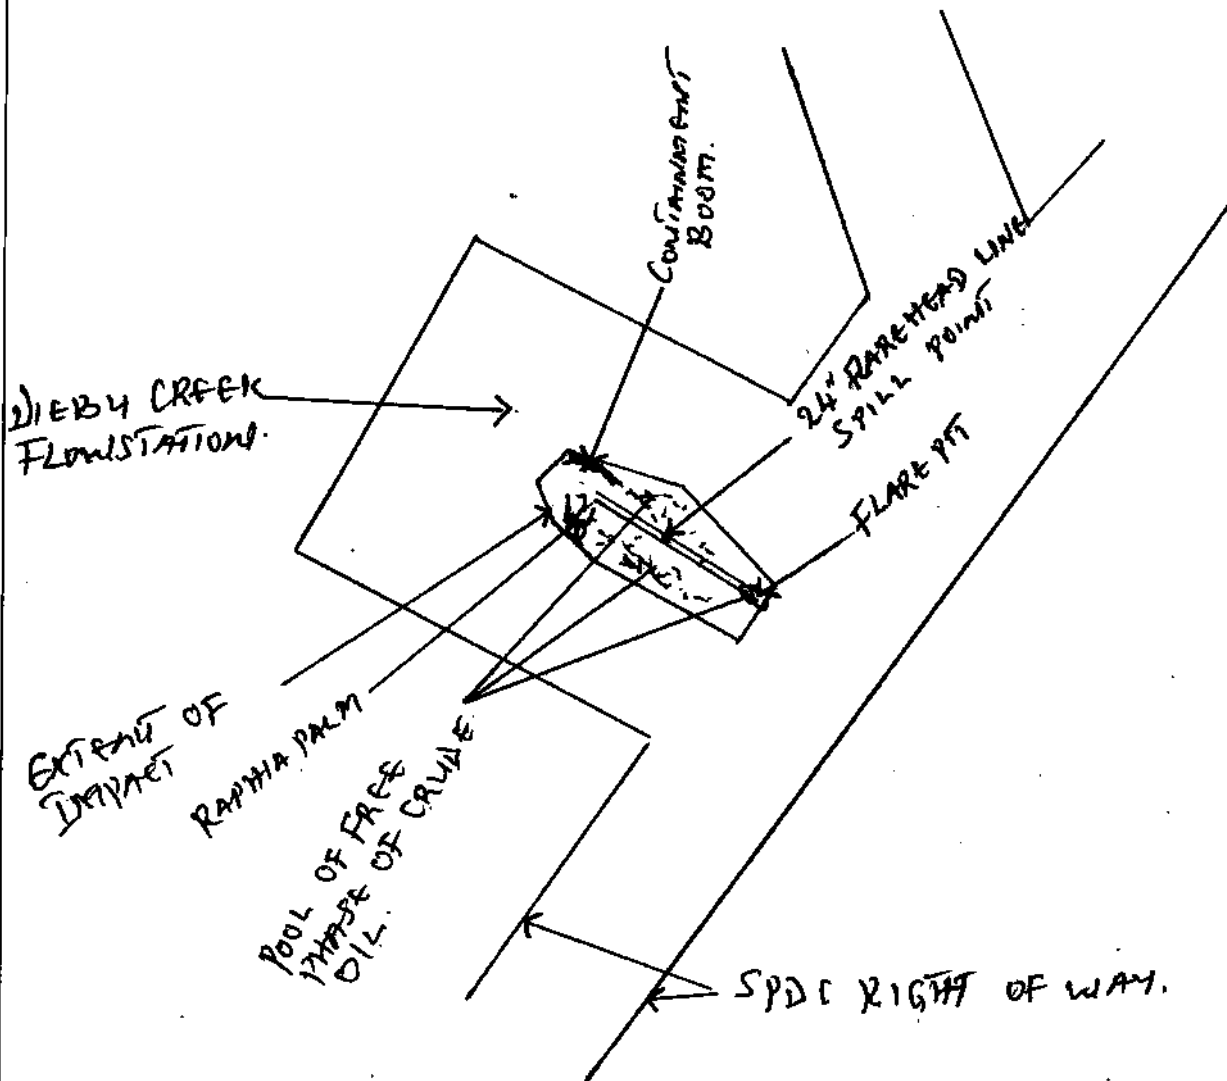
f. Appendix I: Overview sketch of the site

Location: DIEBY CREEK FLOWSTATION 24" FLAREHEAD LINE AT PEREMABIAI
