Overview: Part of spill impact on 20" Rumuekpe-Nkpoku Pipeline Right of Way at Omuigwor/Ibaa. Picture was taken during Joint Investigation of 4<sup>th</sup> September 2015.

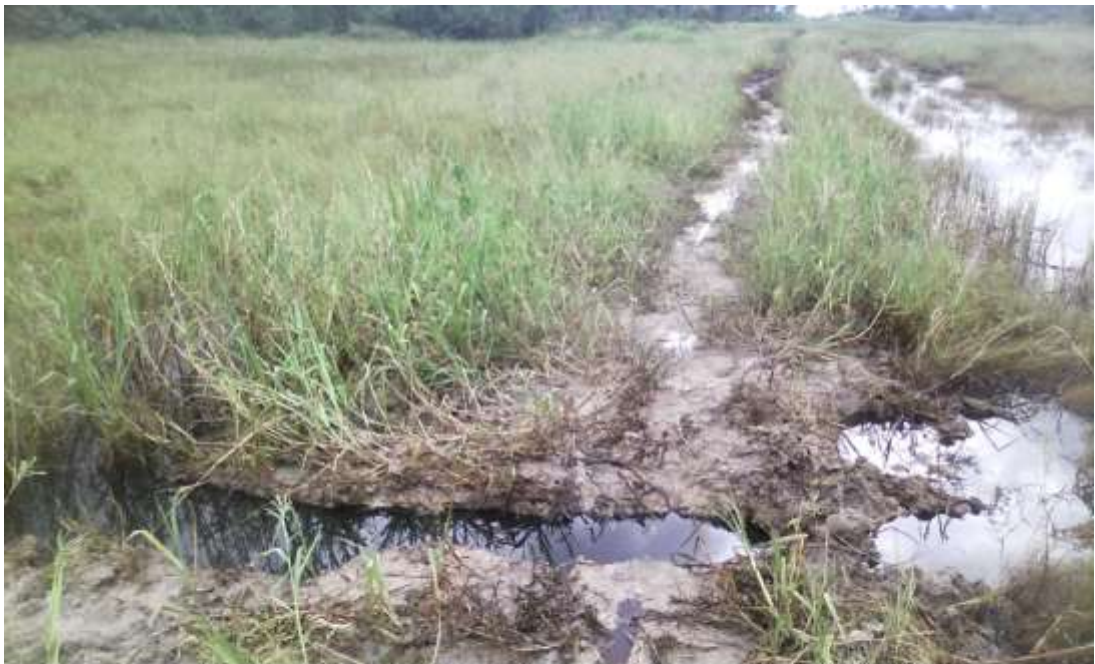
E 6.837356	Date 2015/09/04
		N 4.953253	Time 14:39:24 +01:00
		Altitude 23.000 M	Speed 1.09 KPH

Overview: Part of spill impact on 20" Rumuekpe-Nkpoku Pipeline Right of Way at Omuigwor/Ibaa. Picture was taken during Joint Investigation of 4<sup>th</sup> September 2015.

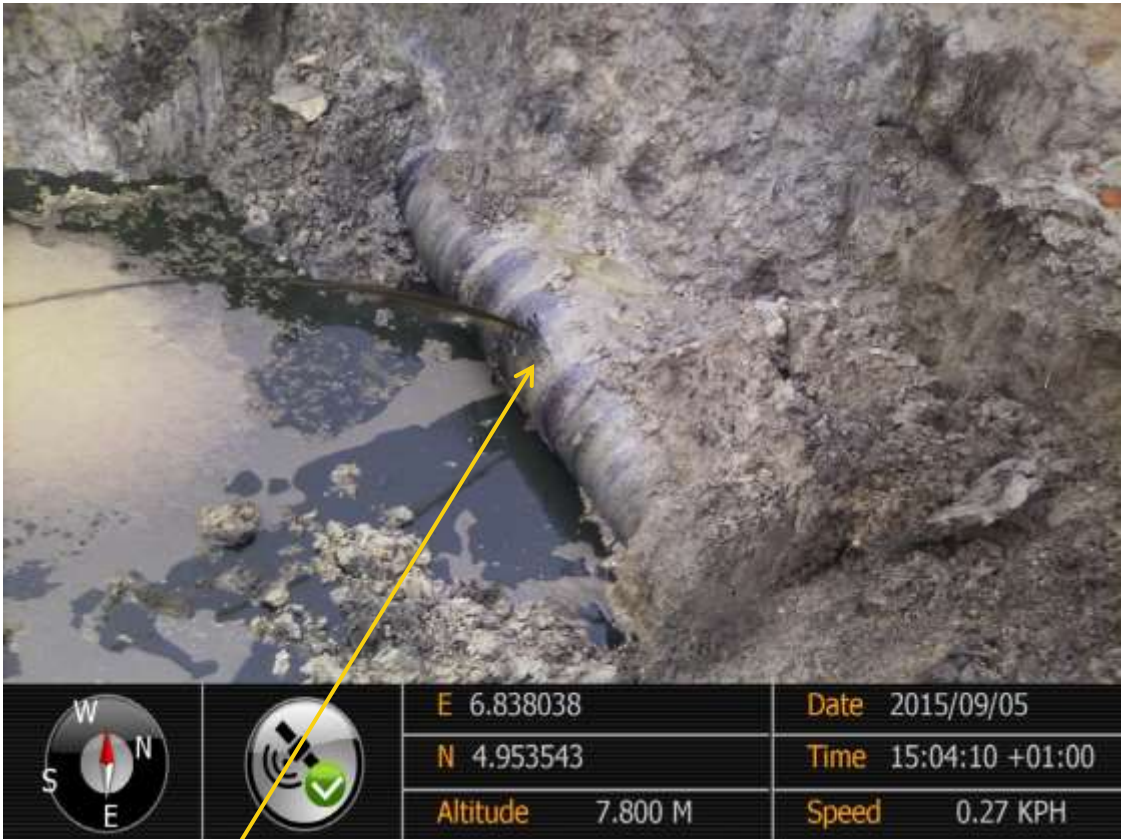
Close-up: Drilled hole on 20" Rumuekpe-Nkpoku Pipeline at Omuigwor/Ibaa. Picture was taken during Joint Investigation of 5<sup>th</sup> September 2015.
