JOINT INVESTIGATION REPORT

INCIDENT NO: 1483495 JIV report S/N: Nº 0000057

1. Spill incident Number: 1483495 2. Type of incident* OIL SPILL
3. Name of Location 28" BOMU - BONNY PIPELINE
4. Name of nearest community BODO WEST 5. State: RIVERS 6. LGA GOKANA
7. Type of Production facility/Installation OIL PIPELINE
8. Asset owner/District SPDC / PIPELINE.

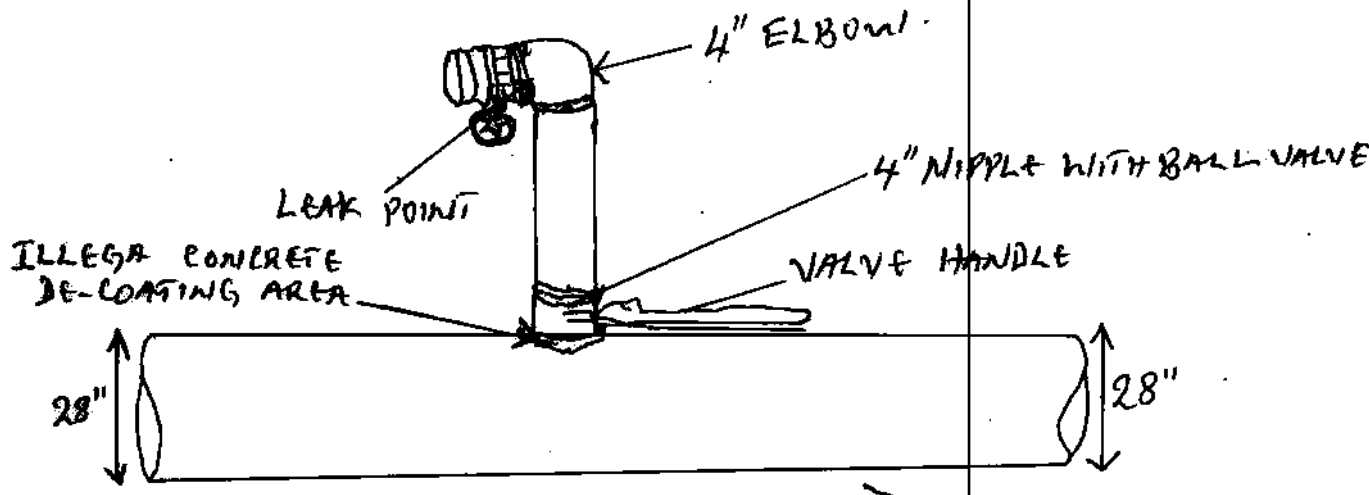
| <input checked="" type="checkbox"/> Failed Weld-on illegal hot tap valve | <input type="checkbox"/> Failed Clamp, | <input type="checkbox"/> Missing Pipeline/Flowline |
| <input checked="" type="checkbox"/> Crude oil theft (illegal bunkering) point, | <input type="checkbox"/> Saver-pit over flow | <input type="checkbox"/> Third party tampering with Clamp |

SECTION OF 28" BOMU - BONNY PIPELINE AT BODO WEST STANDING POSITION OF CANDE OIL THEFT POINT AT 12 O'CLOCK POSITION.

FROM BOMU TO BONNY.

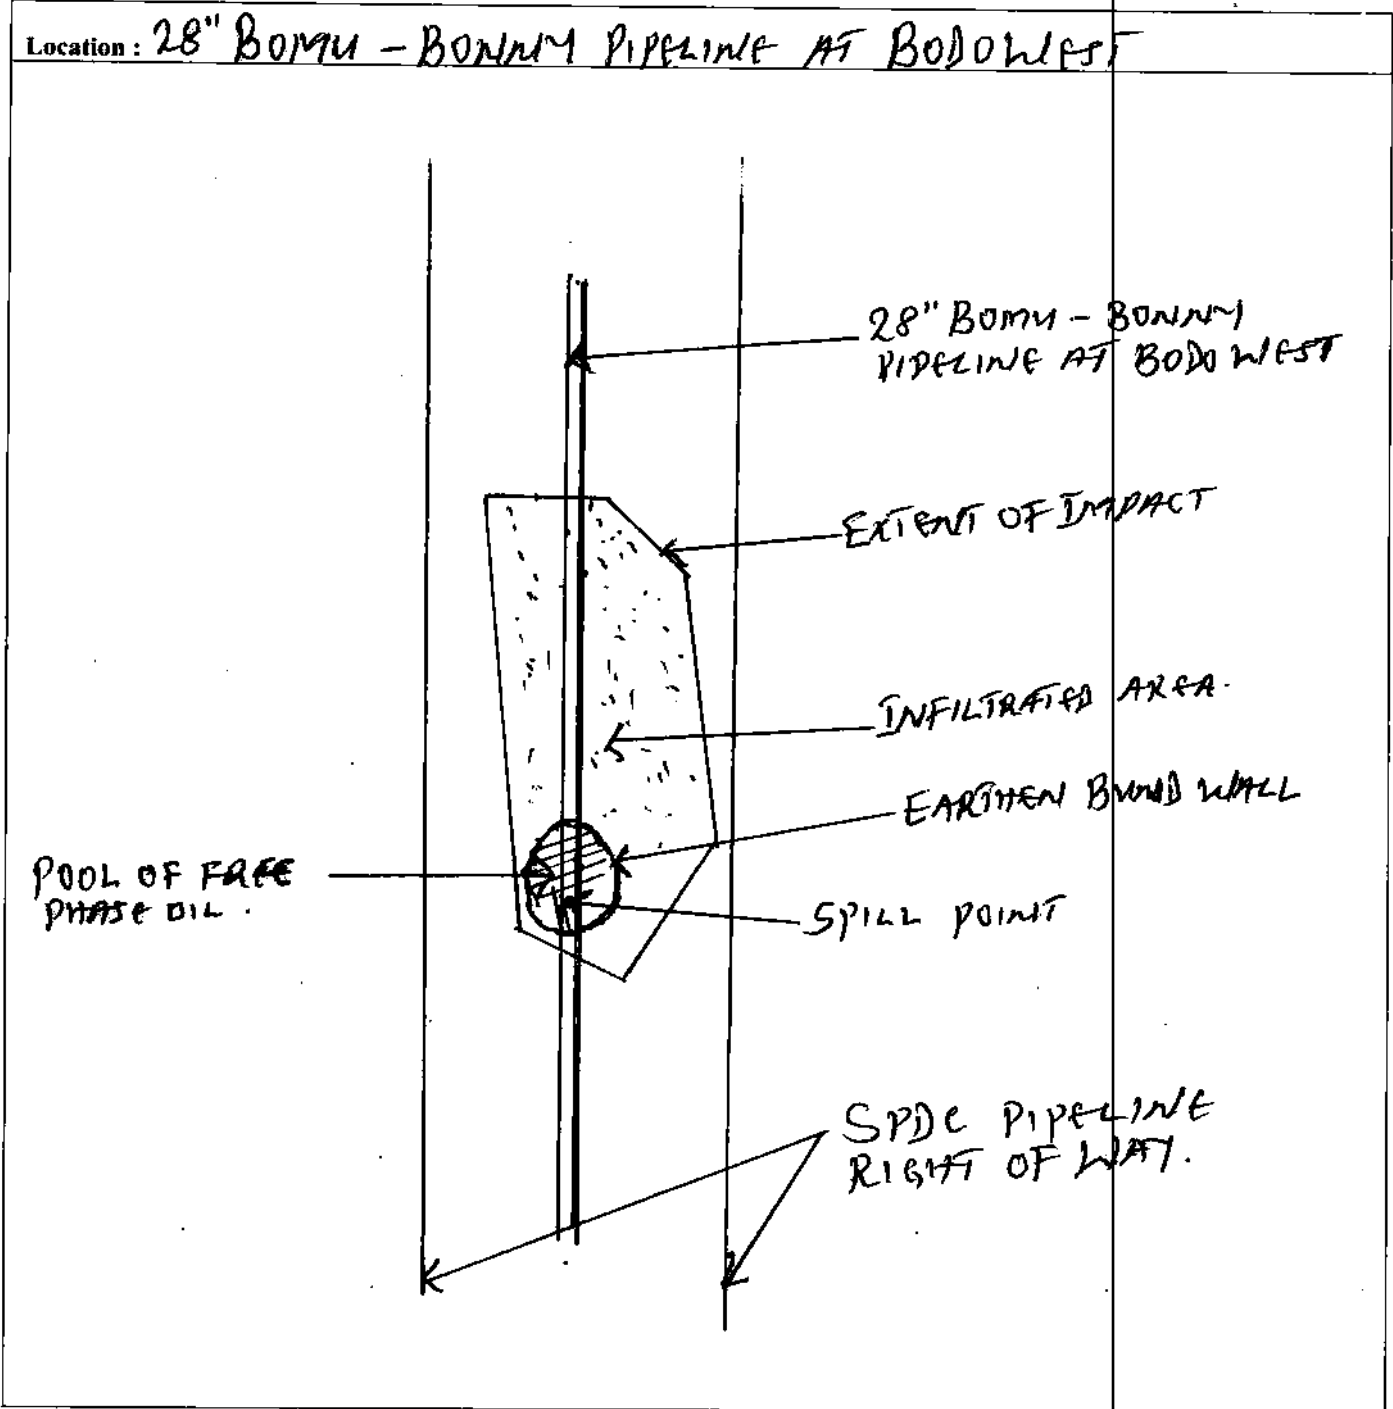
f. Appendix 1: Overview sketch of the site

Additional observations around the spill point: ON ARRIVAL AT SITE THE JOINT INVESTIGATION TEAM OBSERVED BUND WALL AROUND THE SPILL POINT.

Others: BUND WALL
