JOINT INVESTIGATION REPORT

INCIDENT NO: 1481955

1. Spill incident Number: 1481955 2. Type of incident* OIL SPILL
3. Name of Location OBIGBO SOUTH WELL 3L WELL HEAD
4. Name of nearest community UMUSIA 5. State: RIVERS 6. LGA OYIGBO
7. Type of Production facility/Installation WELL HEAD
8. Asset owner/District THE SHELL PETROLEUM DEVELOPMENT COMPANY OF NIG LTD.

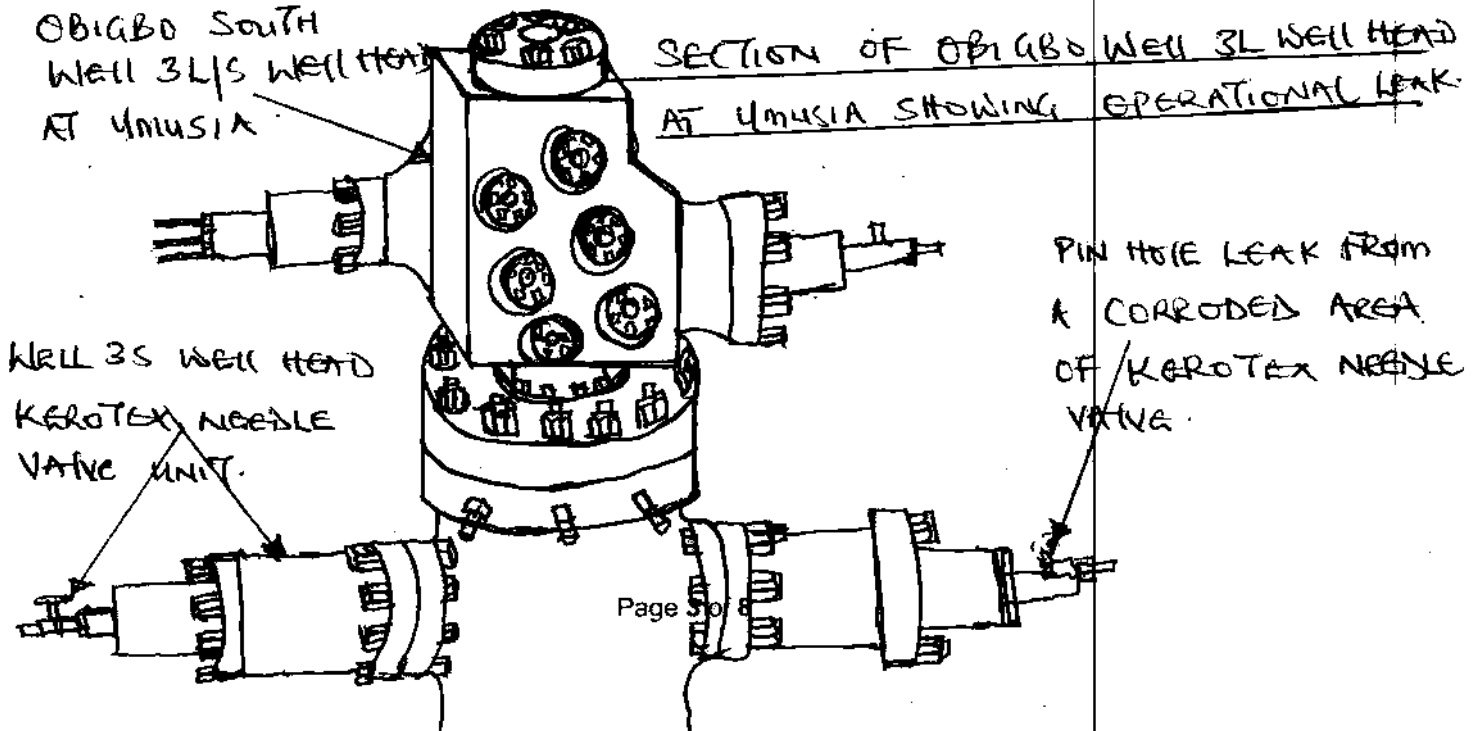
E. GRAPHIC DESCRIPTION OF LEAK POINT (while detail report of the leak point should be contained in the leak report, overview sketch of the site should be added as an appendix 1)

| <input checked="" type="checkbox"/> Others (specify) <u>PIN HOLE LEAK FROM A CORRODED AREA OF KEROTEXT NEEDLE</u>

<u>VALVE</u> | | |

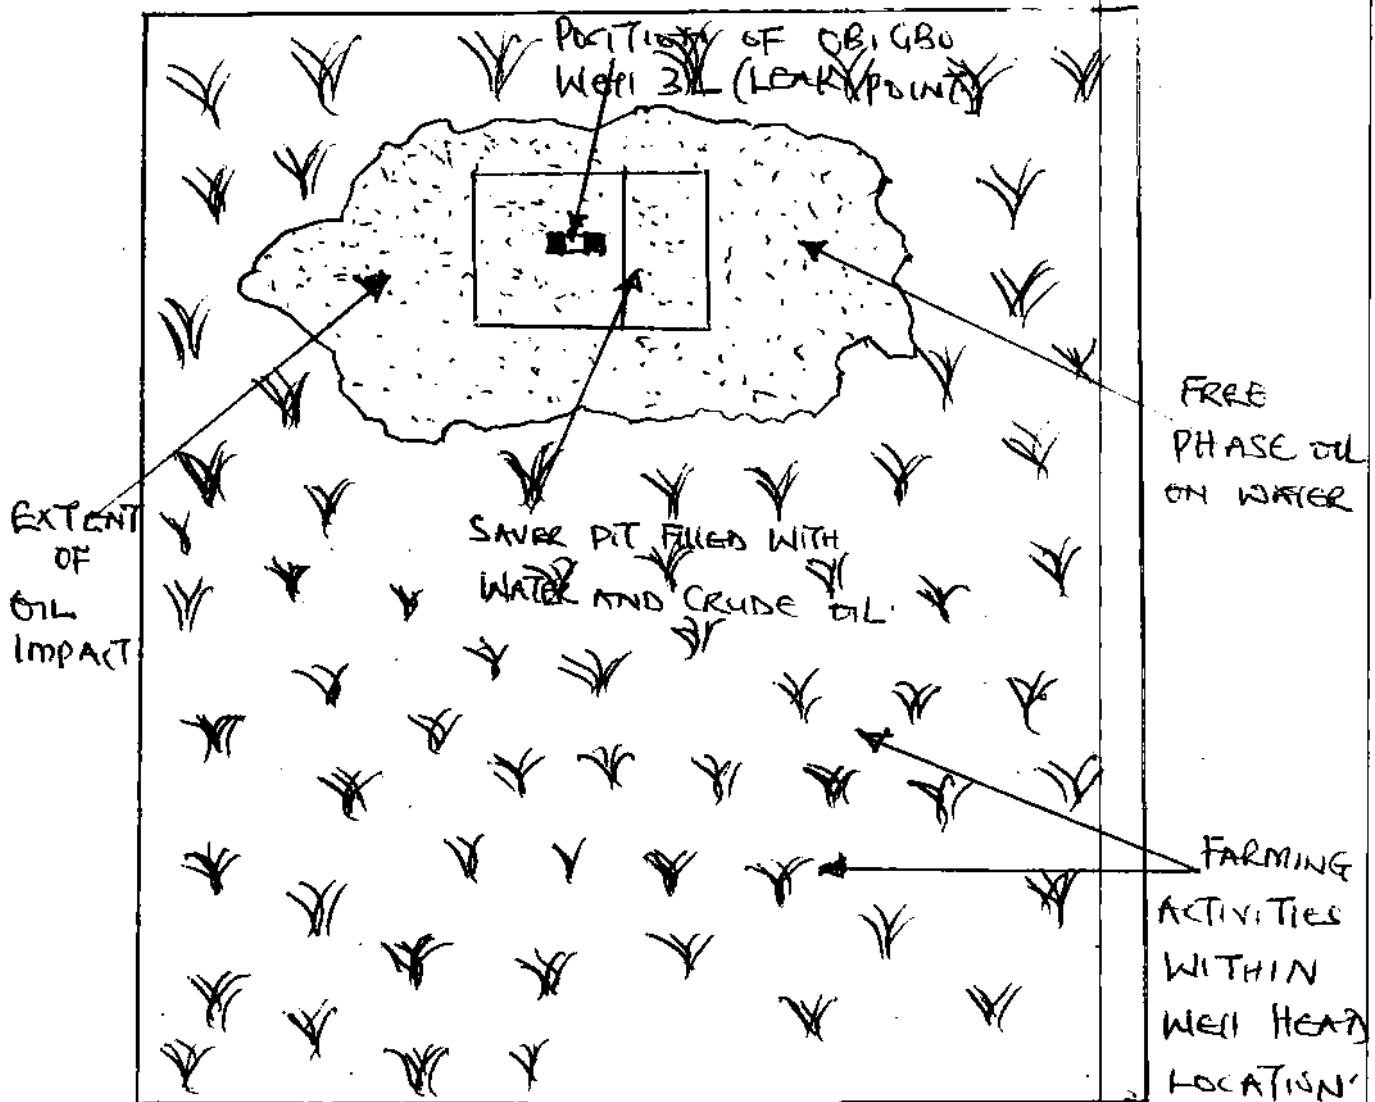
f. Appendix 1: Overview sketch of the site

Location: OBIGBO SOUTH WELL 3L WELL HEAD AT UMUSIA
