Overview: Fire on 28" Nkpoku-Bomu Pipeline Right of Way at Norkpo. Picture was taken during Joint Investigation of 5<sup>th</sup> September 2015.

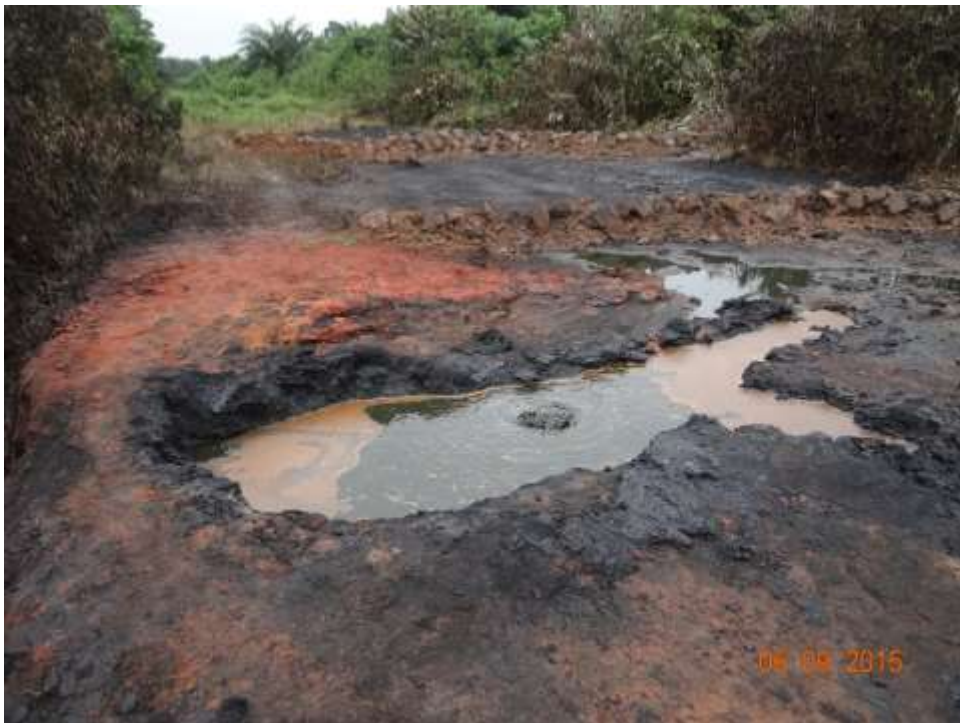
Overview: Part of spill impact on 28" Nkpoku-Bomu Pipeline Right of Way at Norkpo. Picture was taken during Joint Investigation of 6<sup>th</sup> September 2015.

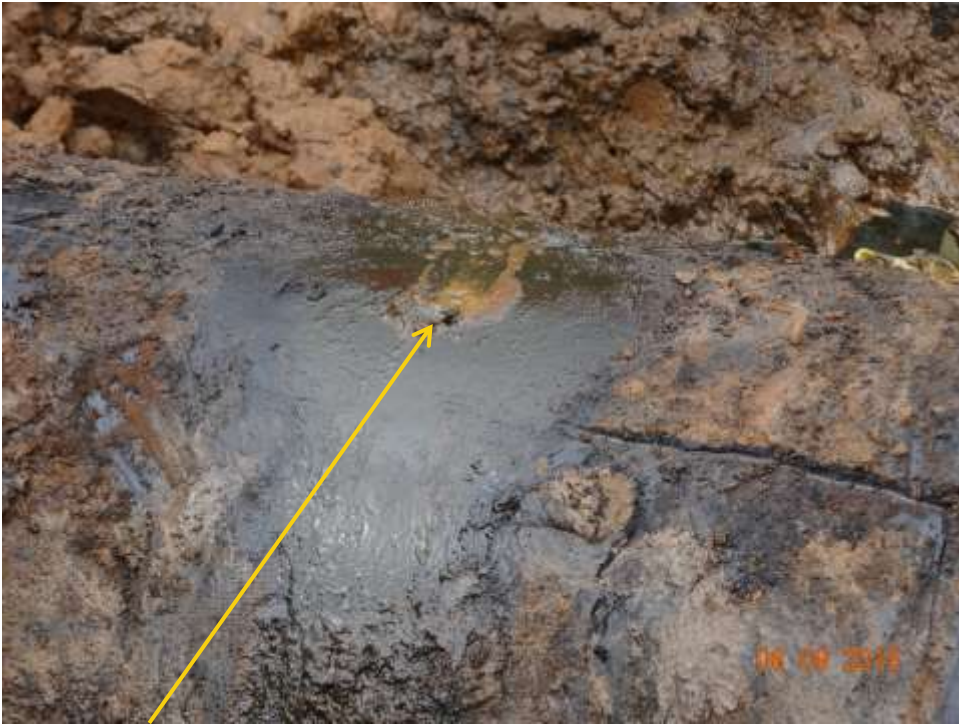
Close-up: Multiple drilled holes clustered together pictured after plugging on 28" Nkpoku-Bomu Pipeline at Norkpo. Picture was taken during Joint Investigation of 6<sup>th</sup> September 2015.
