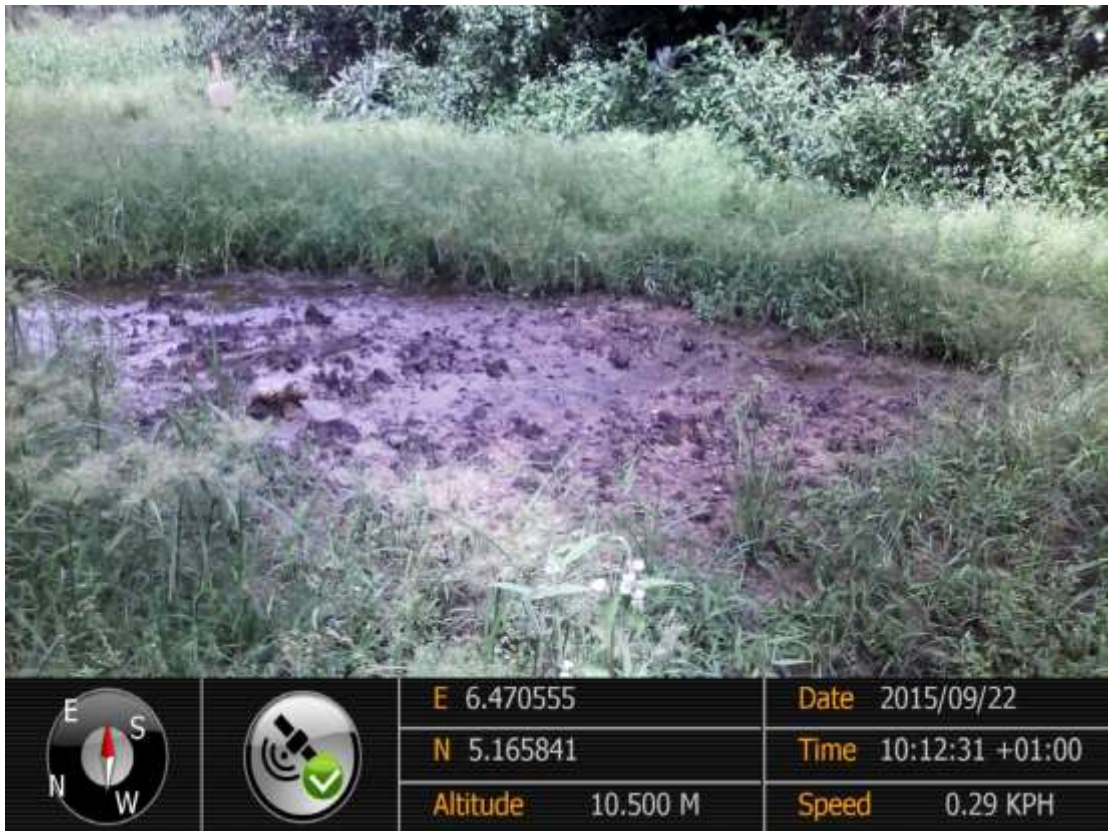
Overview: Part of spill impact on 12" Adibawa – Okordia Pipeline Right of Way at Ikarama. Picture was taken during Joint Investigation of 22<sup>nd</sup> September 2015.

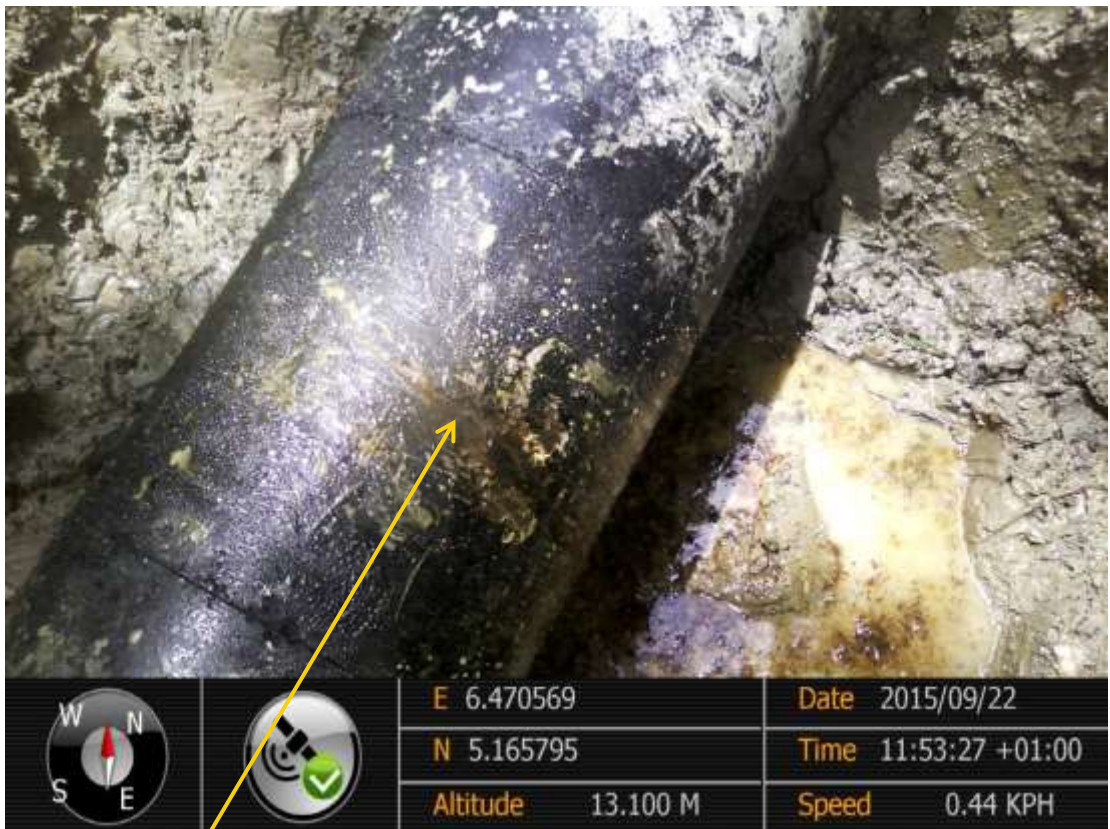
Close-up: Hacksaw cut on 12" Adibawa – Okordia Pipeline at Ikarama. Picture was taken during Joint Investigation of 22<sup>nd</sup> September 2015.
